Model(s)	Year(s)	Eng. Code	Trans. Code	VIN Range From	VIN Range To
Jetta	2017	All	All	AJ_HM200001	AJ_HM258458

70 16 01 October 25, 2016 2045671

Car-Net Module Housing Loose at PDI

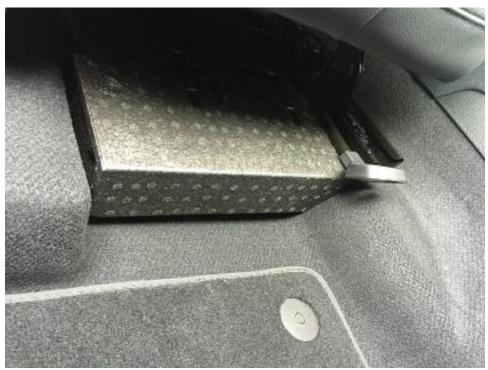
The Car-Net module housing may be loose underneath the passenger seat. This may be found during PDI or from a customer complaint.

Cut-outs in the carpet may not have been removed in the factory which prevents the Car-Net module housing from being properly installed.

Figure 1: Car-Net module housing loose

During PDI inspect the Car-Net module housing which is mounted underneath the passenger front seat (Figure 1).

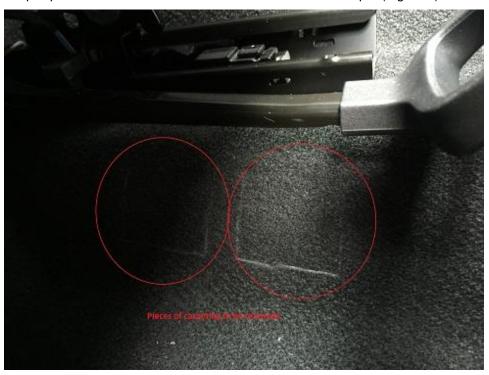
If the module housing is loose, not flat against the floor, or is rubbing the seat fore/aft adjustment lever, check that the pre-perforated cut-outs have been removed from the carpet (Figure 2).

Figure 2: Pre-perforated carpet cut-outs not removed

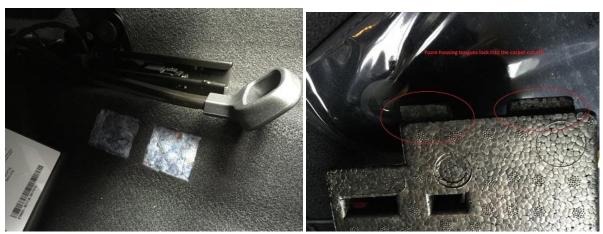
Figures 3 and 4: Carpet cut-outs removed and locking tabs on housing

Remove the carpet cut-outs if they haven't already been removed and reinstall the module housing by first inserting the tabs on the housing through the cut-outs in the carpet, then pressing the housing down onto the carpet to secure the Velcro fastener (Figures 3 and 4).

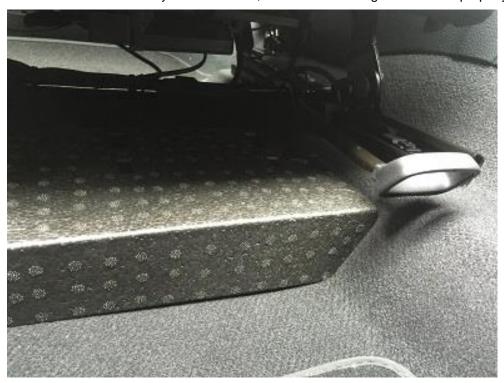
Figure 5: Car-Net module housing properly installed.

If the cut-outs have already been removed, ensure the housing is reinstalled properly (Figure 5).
