Technical Bulletin

85 16 03 October 25, 2016 2041609 Supersedes Technical Bulletin V851601 dated March 8, 2016 to add additional model years.

Fresh Air Blower Inoperative

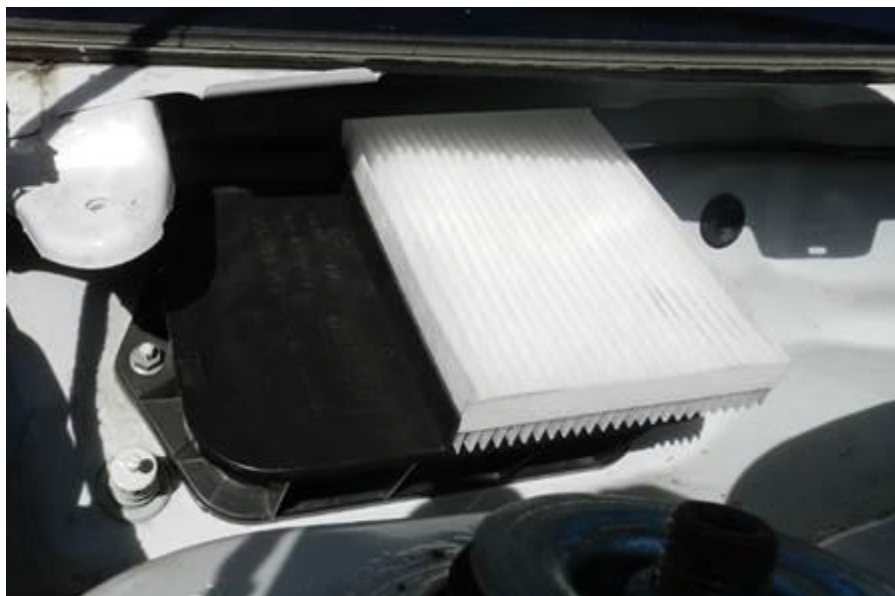
Figure 1: example Jetta: filter housing (part number 5C6 819 343). Figure 2) red arrows mark the mounting points of the clips (part number 7L6 133 847 A).

- Remove and inspect the blower motor, see Repair Manual Group 68 Storage Compartments and Covers in Elsa.
- Replace the blower motor **only** if the following conditions are found:
 - Noise from blower bearings.
 - Blower motor is hard to turn or binding.
- On vehicles equipped with manual HVAC system, replace the resistor for the fresh air blower if required.
- Remove the plenum chamber cover.
- Remove the air intake grille according to the repair manual.
- Position the filter housing (part number 5C6 819 343) with 3 clips (part number 7L6 133 847 A) on the induction flange, see figure 1 and 2, red arrows.

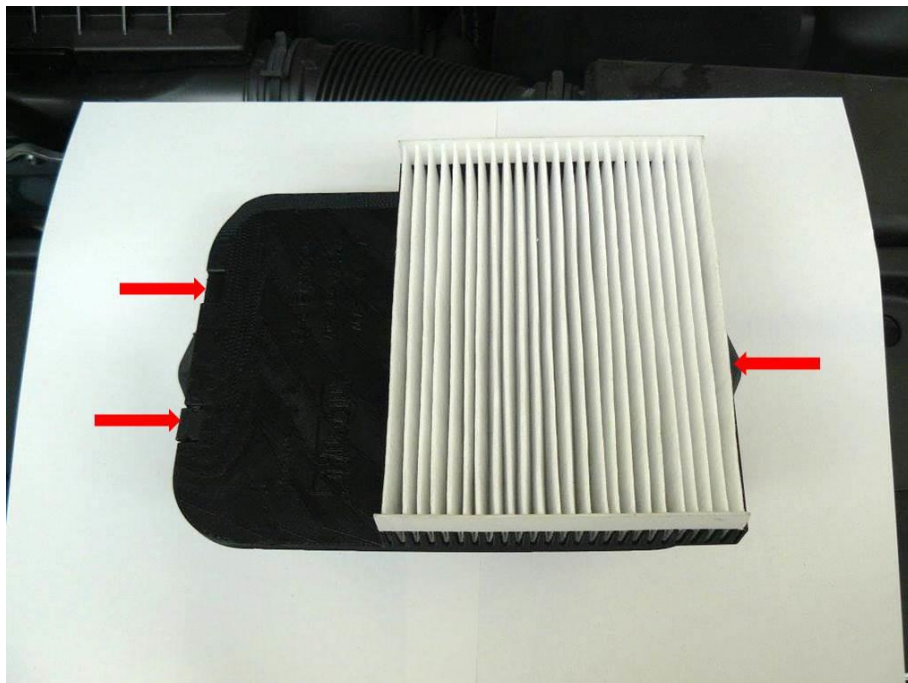
Figure 2: Figure 2) red arrows mark the mounting points of the clips.

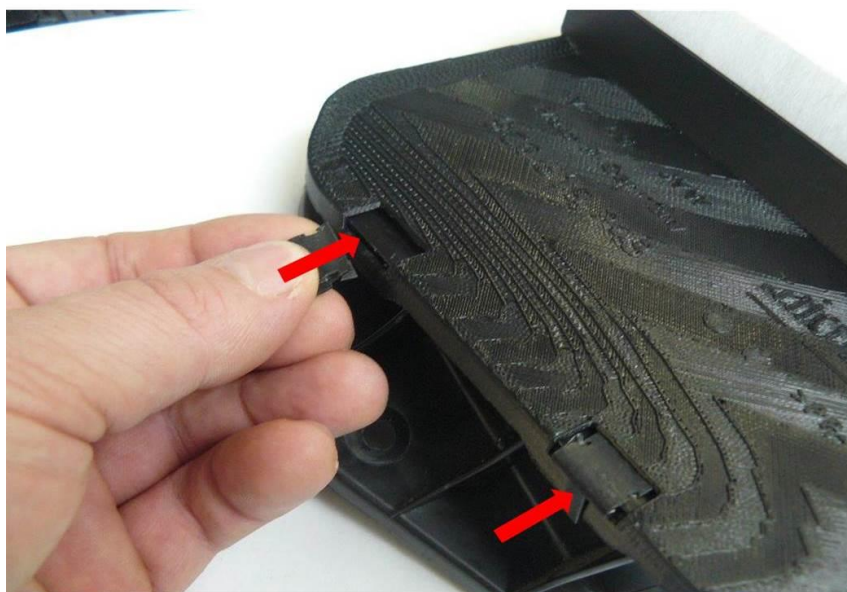
Figure 3: example Jetta: attachment of the filter housing on the air intake grille with clips part number 7L6 133 847 A (red arrows).

- Re-install the air intake grille with filter housing according to the repair manual.
