Technical Bulletin

Model(s)	Year(s)	Eng. Code	Trans. Code	VIN Range From	VIN Range To
Golf Sportwagen	2015-2017	All	All	AU_FM500001	AU_HM508074

60 16 07 October 24, 2016 2045672

Water Leaks from the Rear of the Panoramic Sunroof

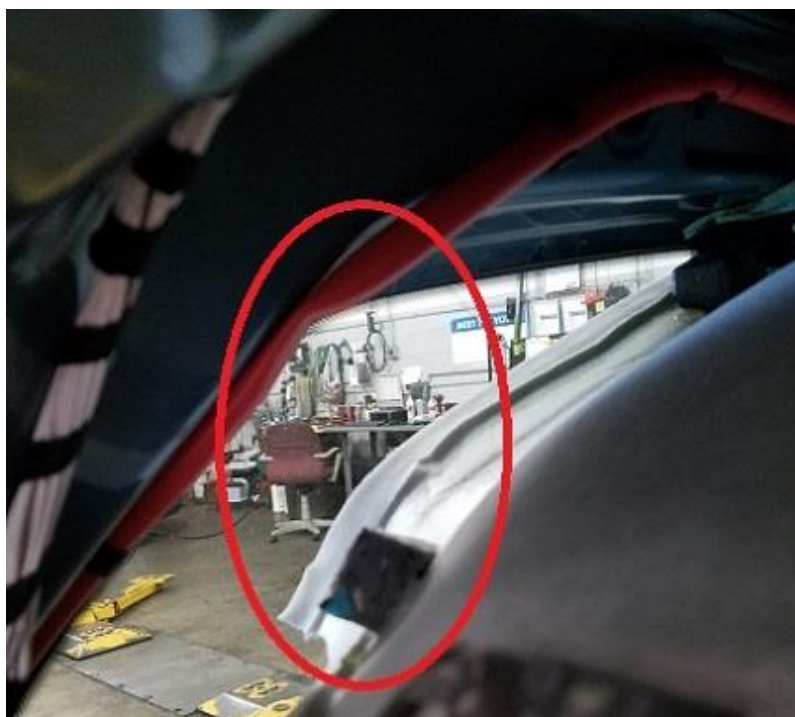
The rear sunroof drains may be pinched shut by foam blocks on the headliner, not allowing the sunroof frame to drain properly (See Figure 1).

Figure 1: Sunroof drain pinched by foam block on headliner

Incorrect assembly in production allows too much length in the sunroof drain between the second and third securing clips. This causes excess slack in the drain hose allowing the foam block to contact the hose.

During installation of the new drain hoses, ensure the hose is pulled taut between the 2nd and 3rd mounting clips and that there is no excess slack in the hose (See Figures 4 and 5).

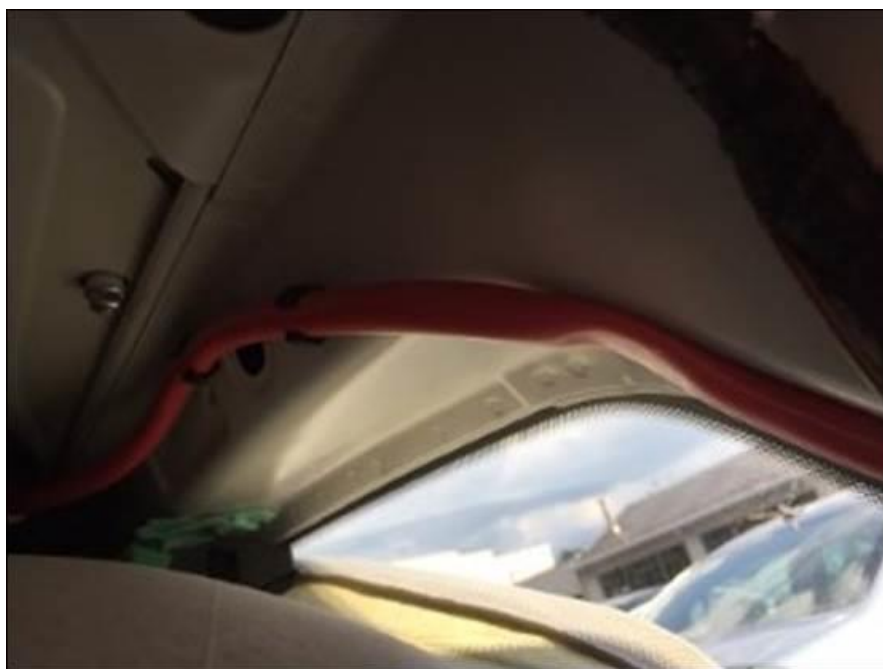
Figure 3: Impression on rear sunroof drain from contact with headliner foam block.

1. Finish removing the headliner. See repair manual group 70 in ELSA.
2. Remove and replace the rear sunroof drain hoses. See repair manual group 60 in ELSA.

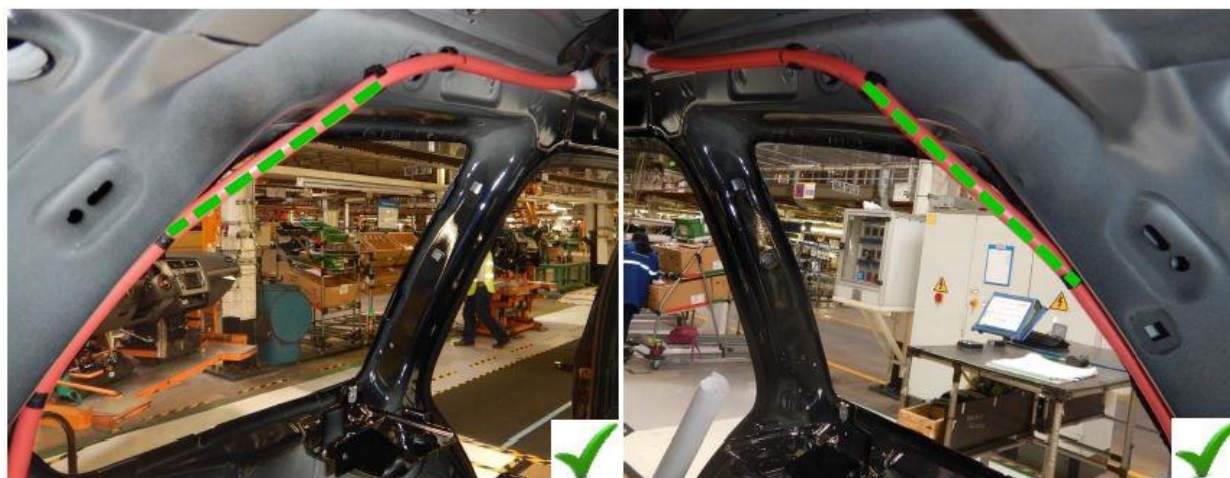
Figures 4 and 5: Correct routing of left and right rear drain hoses with no slack between the 2nd and 3rd mounting clips.

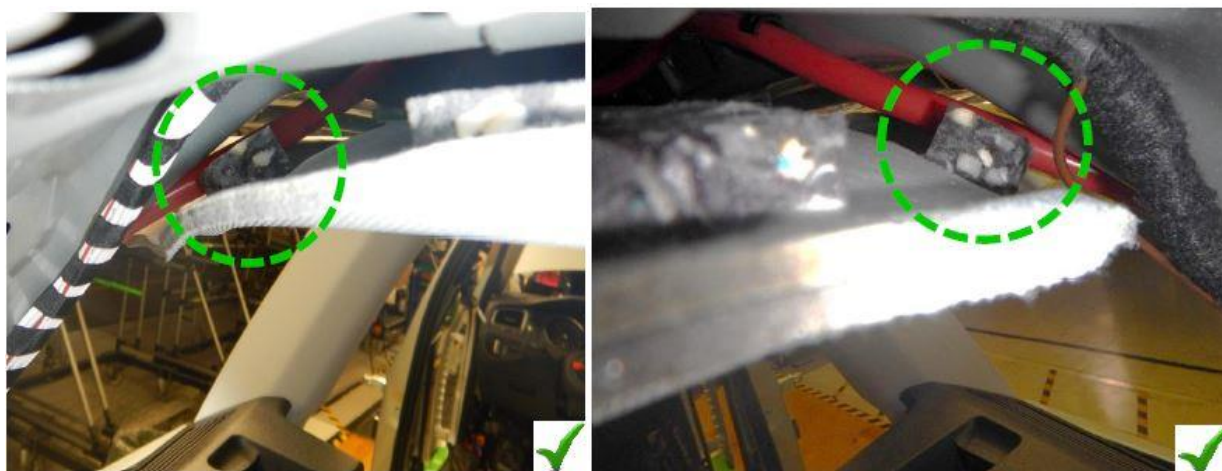
Figures 6 and 7, Rear drain hoses routed behind foam blocks on headliner.

3. Reinstall the headliner ensuring the foam blocks do not contact either of the sunroof drain hoses (See Figures 6 and 7).
