Technical Bulletin

15 16 02 October 18, 2016 2045454

MIL ON, Fault Code P0016 Camshaft Position Sensor Stored in ECM Fault Memory

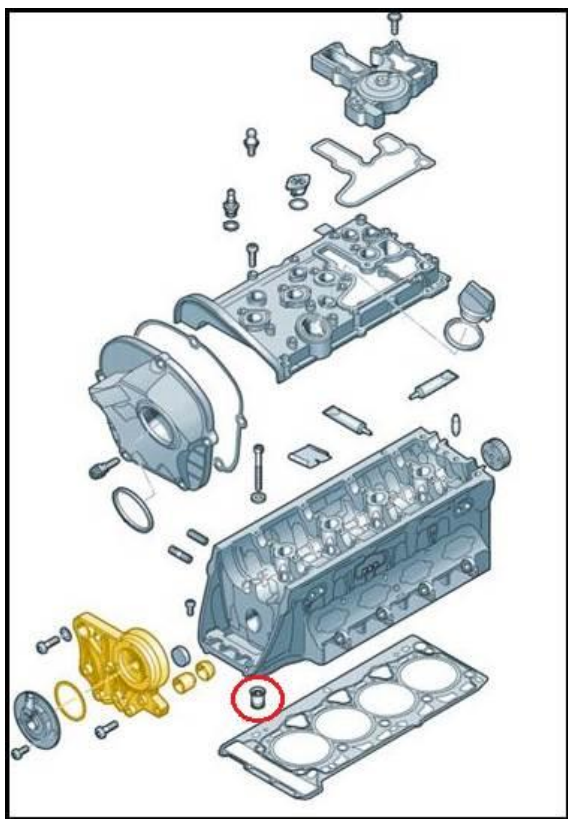
Figure 1. Camshaft bearing bracket

- Check fault codes using Guided Fault Finding.
- Remove the camshaft bearing bracket (Figure 1. in yellow) see Repair Group 15 in Elsa.
- Check the non-return valve in the bearing bracket.
- Check the bearing points and the camshafts on the bearing bracket.
 - If scoring can be felt on the camshaft bearing in the bearing bracket or on the camshafts, replace the camshaft bearing bracket and the camshaft according to the repair manual/parts catalog.
- Check the non-return valve in the cylinder head (Figure 1. red circle).

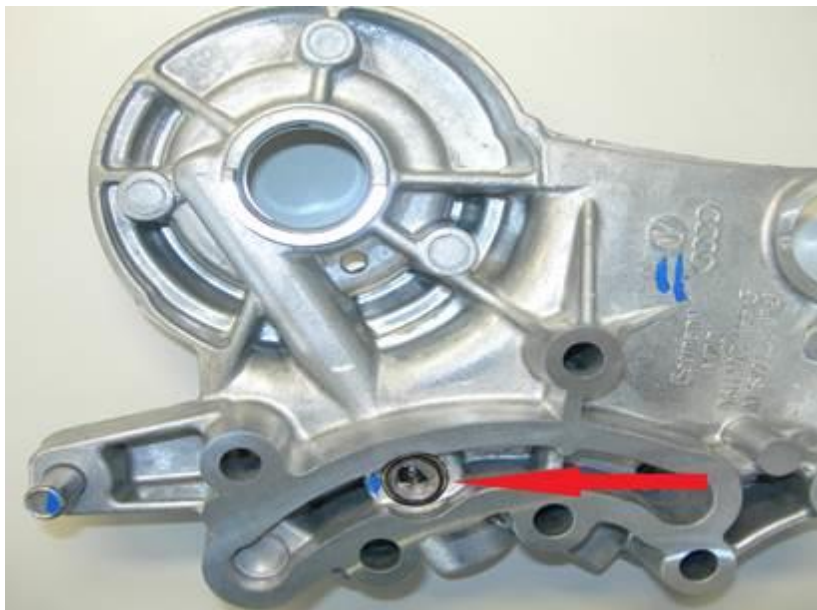
Figure 2. Torn strainer

The strainer screen in the camshaft bearing bracket can tear and cause camshaft adjuster issues.

- Check the non-return valve in the camshaft bearing bracket (Figure 2. red arrow).

In case of damage as shown in figure 2, proceed as follows:

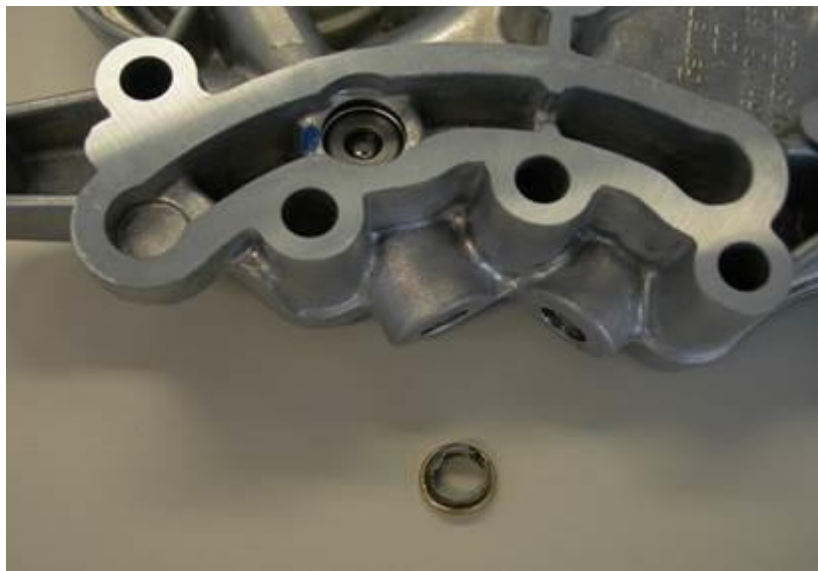
Figure 4. Camshaft bearing bracket with metal non-return valve (without strainer)

Metal non-return valve (Figure 4.):

- The camshaft bearing bracket can be reused after removing the strainer.

The remnants of the strainer for the non-return valve must be removed from the oil duct. Remnants can clog up the oil duct in the camshaft bearing bracket or drift into the camshaft bearing. This can damage other components. Check the oil sump for debris and thoroughly clean if necessary.

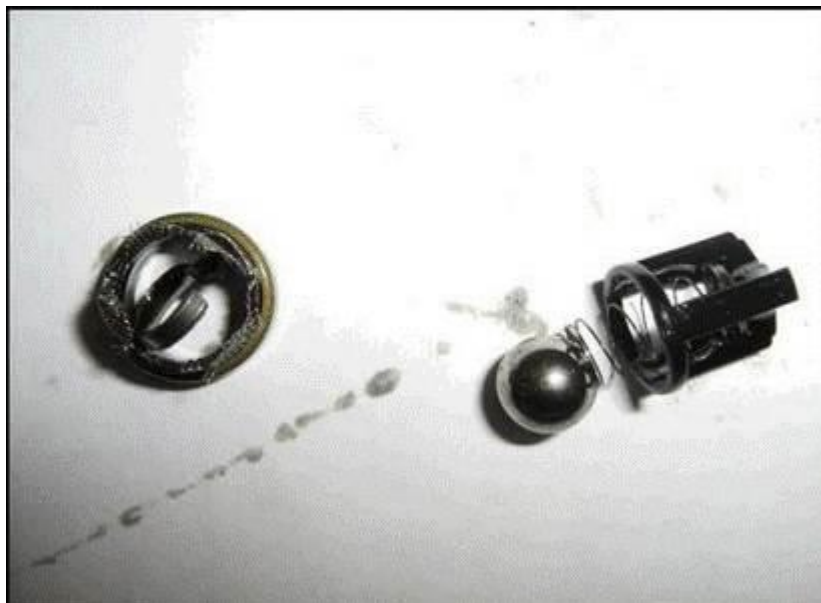
Figure 5. Plastic non-return valve

Plastic non-return valve (Figure 5.):

- Replace the camshaft bearing bracket according to the repair manual/parts catalog.

The remnants of the strainer for the non-return valve must be removed from the oil duct. Remnants can clog up the oil duct in the camshaft bearing bracket or drift into the camshaft bearing. This can damage other components. Check the camshaft adjuster for debris and thoroughly clean if necessary.

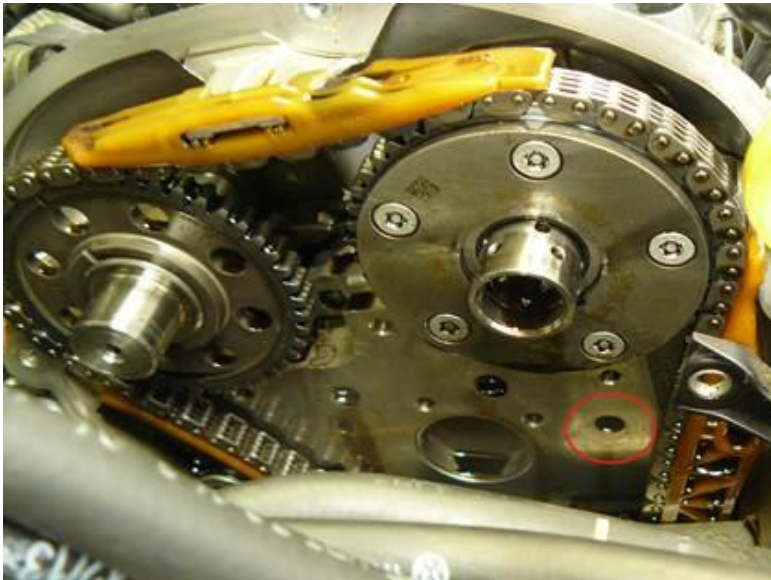
Figure 6. Test point of oil duct (red circle) to non-return valve in cylinder head

Check and if necessary replace the non-return valve in the cylinder head (Figure 6. red circle).

- The non-return valve in the cylinder head can only be checked if the bearing bracket for camshafts has been removed.

If check valve requires replacement the cylinder head must be removed. The brass colored check valve is located in the left front underside of cylinder head. To remove check valve a small hook or screw driver may be used to pull check valve from cylinder head. The valve is only held in position by an o-ring, which is part of the valve assembly.
