Technical Journal

Difficult to add/program remote key, T8

REF NO: TJ 31698.1.0	ISSUING DEPARTMENT: Technical Service	CAR MARKET: United States and Canada	
PARTNER: 3 US 7510 Volvo Car USA		ISSUE DATE: 2016-06-29	STATUS DATE: 2016-07-07
FUNC GROUP: 3400	FUNC DESC: Ignition system (Not for new design 2004)	Page 1 of 4

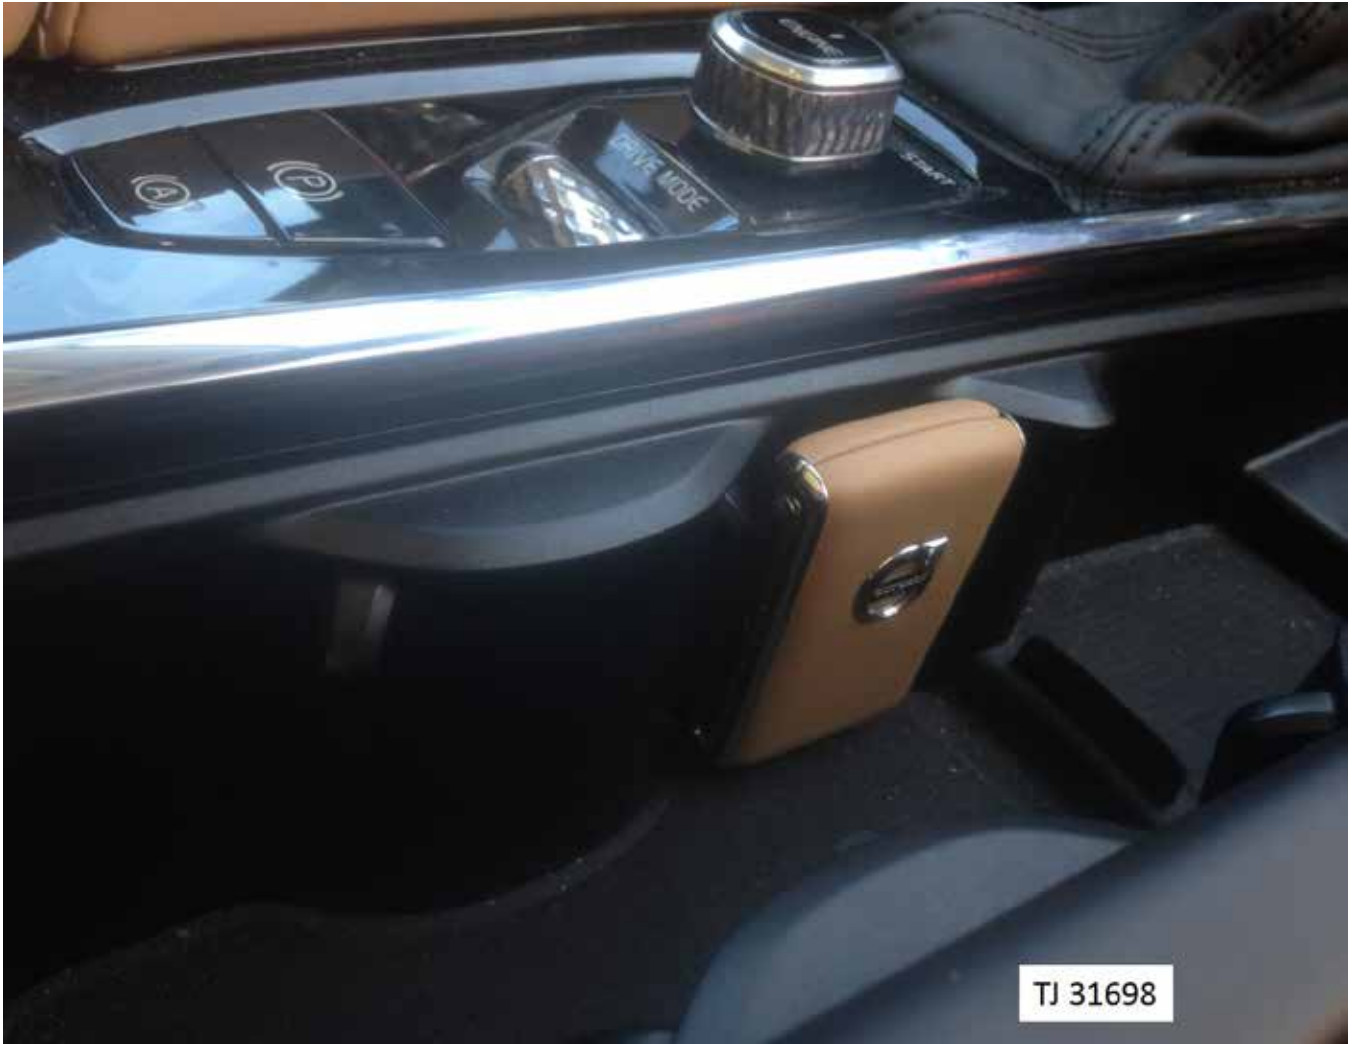
If you experience difficulty programming remote keys on T8 vehicles, please follow the advice under **SERVICE**.

- 1) Place the remote in the position shown in attachment. The Volvo logo must face outward. Proceed to add key.
- 2) If it is still difficult to add keys, unfasten the center console and lift the rear of the console several inches/centimeters from the car body as shown in attachment. Proceed to add key.
