Technical Journal

Parking brake (EPB), Not possible to get brake caliper in service position

REF NO: TJ 27500.6.0	ISSUING DEPARTMENT: Technical Service	CAR MARKET: United States and Canada	
PARTNER: 3 US 7510 Volvo Car USA		ISSUE DATE: 2016-07-08	STATUS DATE: 2016-07-14
FUNC GROUP: 5127	FUNC DESC: Brake caliper	Page 1 of 4

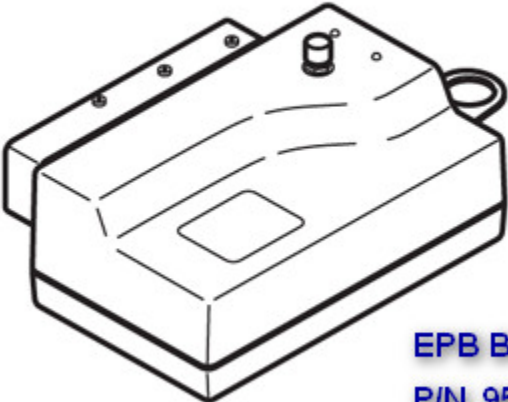
EPB Box
P/N 9513014

If the actuators does not respond from VIDA command (there is no sound from actuator), then try this:

- Release the EPB by using the tool PN 9513014 (see picture #1), which override PBM control unit.
- If the tool is not available, try to close all doors, lock the car, wait at least one minute, unlock the car and open one door and try again with VIDA activation, repeat if necessary.
- Fault trace any DTC's according to VIDA (including wires/terminals etc)

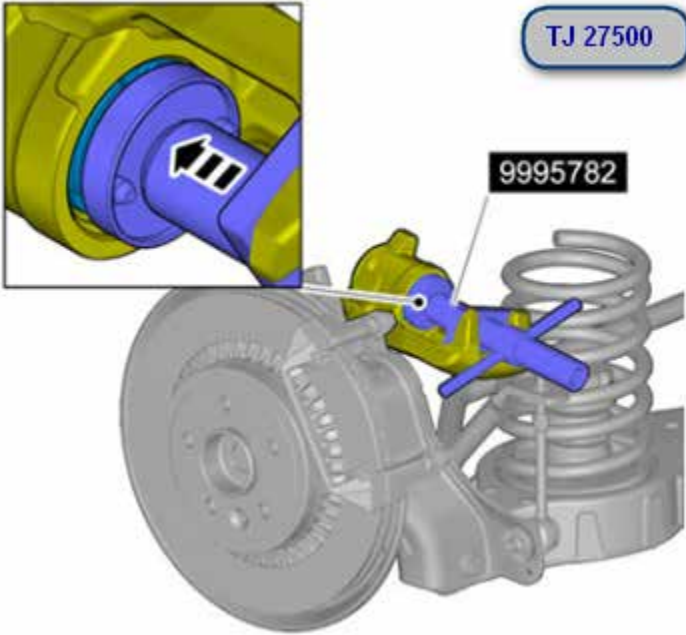
If the actuator start to retract the caliper pistons, but stops before the pistons are fully retracted, then try this:

- Blow clean the caliper/actuator with high pressure air.
- Remove the actuator from caliper housing by loosening the two screws.
- Check the caliper to see if the activation shaft has been rewinded, if necessary manually screw back the activation shaft clockwise by using a suitable torx screw drive (refer to video file #2).
- Reinstall the actuator to the caliper.
- Push the piston into caliper housing all the way once the activation shaft is fully returned. Note: if needed use special tool 9995782 (refer to picture #2).
