# Customer Satisfaction Campaign

## Code: 91N9

<b>Subject</b>	<b>MIB2 MQB Radio (Modular Infotainment System) Software</b>
<b>Release Date</b>	December 16, 2016
<b>Revision Summary</b>	<b>SD cards are no longer available. SD card software files are available for download from ServiceNet. See Technical Bulletin Instance # 2044695 for instructions on downloading Infotainment Software Updates.</b>
<b>Affected Vehicles</b>	<p><b>U.S.A. &amp; CANADA: Certain 2016 MY Volkswagen Vehicles with the MIB2 MQB Radio (Modular Infotainment System)</b></p> <p><i>Check Campaigns/Actions screen in Elsa on the day of repair to verify that a VIN qualifies for repair under this action. Elsa is the <u>only</u> valid campaign inquiry &amp; verification source.</i></p> <ul style="list-style-type: none"> <li>✓ Campaign status must show "open."</li> <li>✓ If Elsa shows other open action(s), inform your customer so that the work can also be completed at the same time the vehicle is in the workshop for this campaign.</li> </ul>

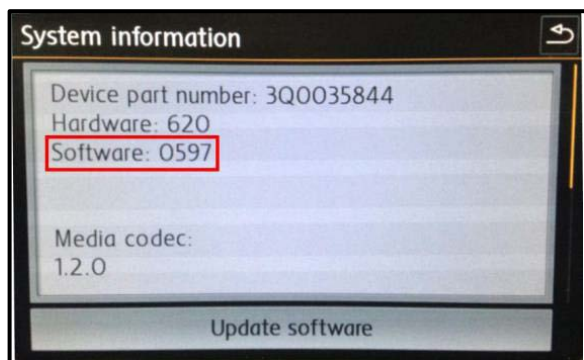
- If the currently installed software level is LOWER than **0613** <as shown>, proceed with these repair instructions.
- If the currently installed software level is GREATER than or EQUAL to **0613**, **work complete, proceed to section C.**

This software update only applies to Delphi radios. If the software level shown is 241 or 245, a TechniSat radio is installed in the vehicle and this work procedure does not apply.
