Technical Service Bulletin

19 Coolant pipe seepage on turbocharger, 4.0TFSI

19 16 74 2036167/3 October 4, 2016. Supersedes Technical Service Bulletin Group 19 number 15-60 dated June 24, 2015 for reasons listed below.

Model(s)	Year	VIN Range	Vehicle-Specific Equipment
S6	2013 - 2014	All	4.0 T
S7	2013 - 2014	All	4.0 T
S8	2013 - 2014	All	4.0 T
A8	2013 - 2014	All	4.0 T

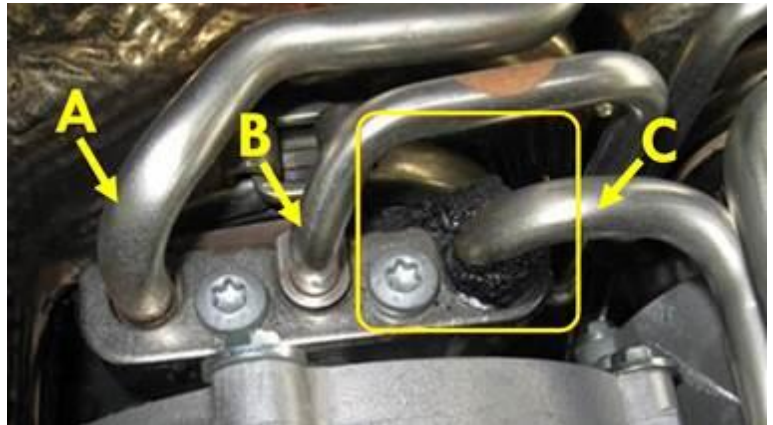
There may be slow coolant loss from the connections at the coolant feed pipe and the coolant return pipe. High temperatures cause the coolant to become encrusted on the connection flange of the turbocharger (Figure 1).

Figure 1. Black, encrusted coolant residue (outlined area), coolant feed pipe (A), oil feed pipe (B), and coolant return pipe (C).

The resulting heat after switching off the engine can, under special operating conditions, lead to very high temperatures on the coolant seals of the turbocharger. This can damage the O-ring.

Replace the respective O-rings on the coolant supply and return pipes according to the table listed below.

! **Note:** The O-ring assignment can be based on one part number on the coolant pipes, as there is no mixed installation allowed. The original coolant pipes had a 2.5 mm O-ring groove which require the 2.0 mm (blue) O-rings. The later/replacement coolant pipes had larger 3.5 mm groove which require the 2.8 mm (black) O-rings. Special tool 3371 can be used to measure the thickness of the O-ring groove to determine the correct O-ring fitment. Replacing the coolant pipes is not allowed!
