# Technical Service Bulletin

## PSS 91 Audi connect GEN2: Remote Vehicle Services INOP or Cannot Enter Vehicle Code for Key User

91 16 80 2045570/1 October 5, 2016.

Model(s)	Year	VIN Range	Vehicle-Specific Equipment
A4, Q7	2016 - 2017	All	With Audi connect

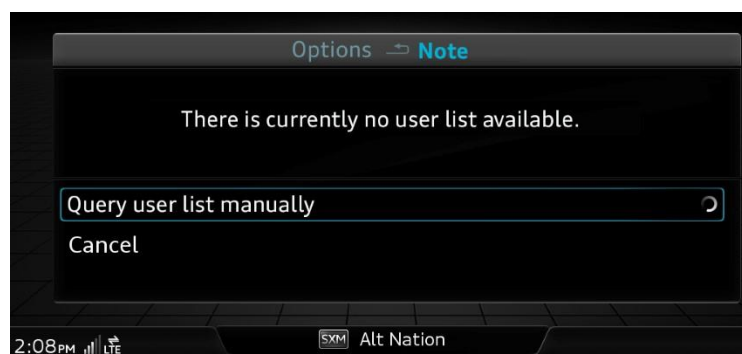
- The customer sees the warning message “There is currently no user list available” (Figure 1) when accessing the Audi connect user management screen in the MMI and cannot enter the vehicle code to become key user.

**Figure 1.** Warning message.

The customer complaint is created when the connected gateway logs off the mobile data network due to a known software concern. When this occurs, the connected gateway cannot communicate with the Audi connect backend server (MBB) despite the car being parked in an area where the mobile data network provides a strong signal. This can be a static condition that does not change when cycling the ignition nor when allowing the vehicle to go through a sleep cycle.

Follow TSB 2045540 91 *Audi connect GEN2: Vehicle Code Entry Fails for Key User Setup or RLU, Veh. Status, Warning Messages Fail to Update.*

This issue is only temporarily resolved after following the repair procedure, it can return. Create a PSS record in the PSS application through the Pending Service Solutions (PSS) link in AccessAudi (under Related Links>>Service), or through the Technical Assistance page in Elsa.
