# Technical Service Bulletin

## 91 MMI3G+ GPS navigation location inaccurate or navigation takes a very long time to acquire location

91 16 81 2040406/7 October 5, 2016. Supersedes Technical Service Bulletin Group 91 number 16-71 dated September 8, 2016 for reasons listed below.

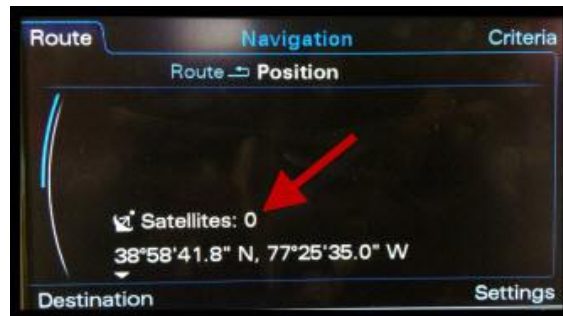
Figure 1. No satellite reception.

- When the issue occurs, the GPS navigation system satellite reception shows 0 satellites. Due to the infrequency of the issue, this might not be verifiable. (To view the number of satellites being received, go to *Nav >> Route >> Select Current Position* (first item in list) and scroll up (Figure 1)).

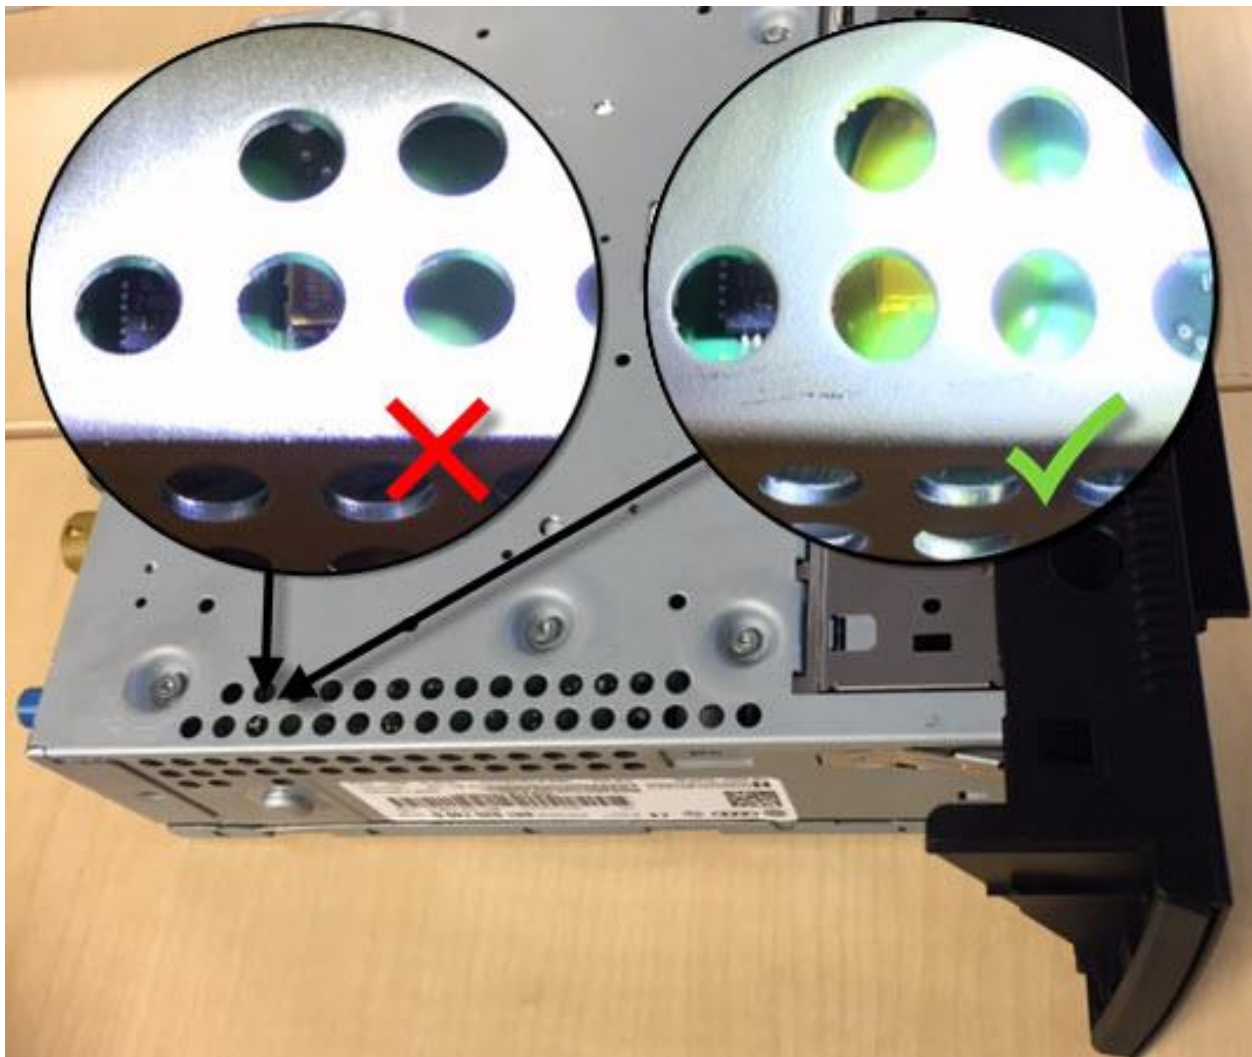
**Figure 2.** Example of integrated circuit chip without coating (left) and with coating (right). Parts without the coating over the integrated circuit chip are not okay and should be replaced.

Some early service parts did not have the coating despite the updated hardware part number (G suffix) and build date. All parts built after November 08, 2014 should have the coating over the integrated circuit chip. If the part does not have the coating over the integrated circuit chip, return the part and order a replacement.

- Order a replacement MMI main unit using the applicable part number listed in the parts table below. There are different variants of main units that have support for a SIM card slot and some variants that do not. Once the new part arrives, check the integrated circuit chip of the GPS oscillator on the internal circuit board. The chip should have a translucent yellow coating (Figure 2).

If the parts department has problems getting updated parts with the integrated circuit chip coating, contact TAC. A small amount of specially modified parts are available for shipping directly from Audi of America.
