Technical Service Bulletin

91 Audi connect GEN2: Audi connect INOP with No LTE Symbol in MMI screen

91 16 83 2045614/1 October 11, 2016.

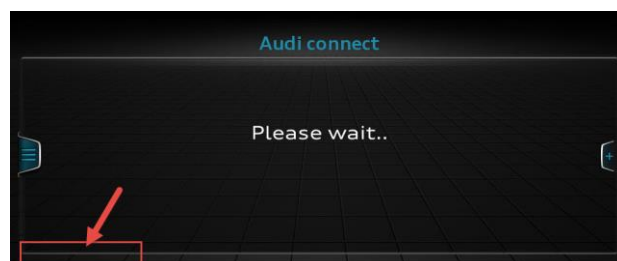
The customer complains that Audi connect is inoperative in the MMI and there is no LTE symbol in the lower left hand corner of the MMI (Figure 1).

Figure 1. No LTE symbol in MMI.

The incorrect hardware was installed at the factory which prevents the MMI from registering with AT&T. When the MMI is first powered on after coming out of transport mode, the system may show a 2G/3G/4G signal instead of an LTE symbol during the registration process with AT&T.

- If this bulletin is showing for the customer's vehicle then please replace the Information Electronics Control Unit 1 (J794) (address word 5F). If this repair has already been performed previously in the past, then please contact TAC.
- Ensure the proper Guided Functions Test Plan is executed to "Replace control module". This will ensure the SVM coding, parameterization, calibration, and activations are performed.
