Technical Service Bulletin

91 Audi connect GEN2: Audi connect INOP with No LTE Symbol in MMI screen

91 16 84 2045614/2 October 12, 2016. Supersedes Technical Service Bulletin Group 91 number 16-83 dated October 11, 2016 for reasons listed below.

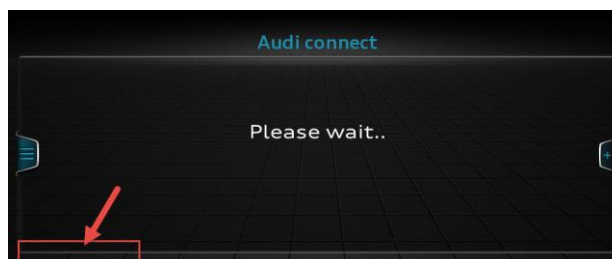
The customer complains that Audi connect is inoperative in the MMI and there is no LTE symbol in the lower left hand corner of the MMI (Figure 1).

The signal bars may be present.

Figure 1. No LTE symbol in MMI.

The incorrect hardware was installed at the factory which prevents the MMI from registering with AT&T. When the MMI is first powered on after coming out of transport mode, the system may show a 2G/3G/4G signal instead of an LTE symbol during the registration process with AT&T.

- If this bulletin is showing for the customer's vehicle then please replace the Information Electronics Control Unit 1 (J794) (address word 5F). If this repair has already been performed previously in the past, then please contact TAC.
- Once the Information Electronics Control Unit 1 (J794) (address word 5F) is replaced, ensure the proper Guided Functions Test Plan is executed to "Replace control module". This will ensure the SVM coding, parameterization, calibration, and activations are performed.

- Ensure the "LTE" symbol is seen after the 2nd ignition sleep cycle. The first ignition on cycle will show only "3G or 4G" during the initial registration with AT&T. Once the vehicle is left to go to sleep with ignition off (roll windows up and lock doors and wait three minutes), the next ignition cycle the MMI will show "LTE". If no data symbol is seen in the lower left hand corner of the MMI screen then please contact TAC.
