Technical Service Bulletin

91 Audi connect GEN2: Audi connect INOP with No LTE Symbol in MMI screen

91 16 86 2045614/3 October 18, 2016. Supersedes Technical Service Bulletin Group 91 number 16-84 dated October 12, 2016 for reasons listed below.

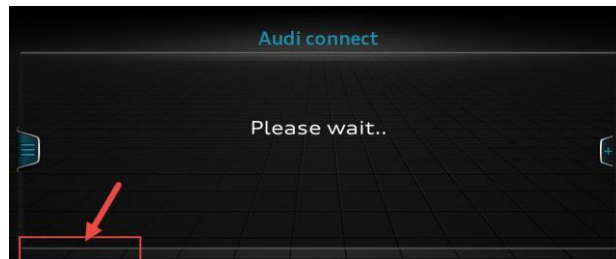
The customer complains that Audi connect is inoperative in the MMI and there is no LTE symbol in the lower left hand corner of the MMI (Figure 1).

The signal bars may be present.

Figure 1. No LTE symbol in MMI.

The incorrect hardware was installed at the factory which prevents the MMI from registering with AT&T. When the MMI is first powered on after coming out of transport mode, the system may show a 2G/3G/4G signal instead of an LTE symbol during the registration process with AT&T.

- If this bulletin is showing for the customer's vehicle then please replace the Information Electronics Control Unit 1 (J794) (address word 5F). If this repair has already been performed previously in the past, then please contact TAC.
- Once the Information Electronics Control Unit 1 (J794) (address word 5F) is replaced, ensure the proper Guided Functions Test Plan is executed to "Replace control module". This will ensure the SVM coding, parameterization, calibration, and activations are performed.
