Technical Bulletin

Model(s)	Year	Eng. Code	Trans. Code	VIN Range From	VIN Range To
Passat	1998-2001	All	All	All	All
Passat Wagon	1998-2001	All	All	All	All

55 16 08 June 9, 2016 **2038999** Supersedes Technical Bulletin V551410 dated December 16, 2014 to update Claim Processing statement.

Corrosion Around Handle On Rear Lid

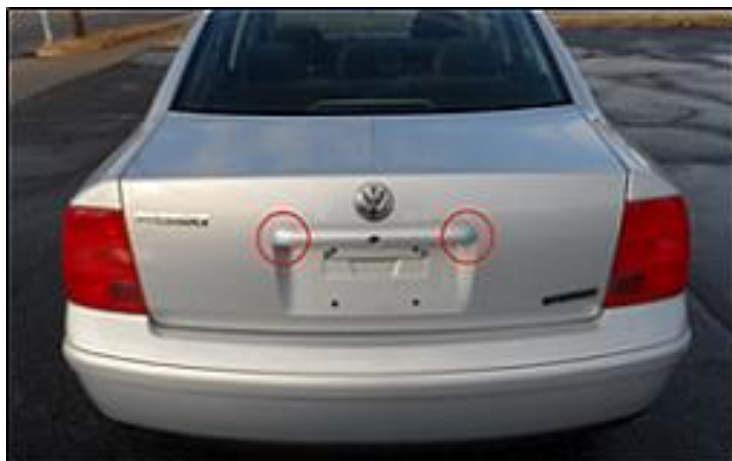
Figure 1 (rear lid handle)

Corrosion where handle contacts rear lid (Figure 1).

- Install the rear window in the new rear lid. See Repair Group 64 in Elsa (Wagon Only).
- Trim protective foil (part number: AKL 448 030 05), or similar clear vinyl tape (locally sourced), to fit in the left and right handle contact surface areas (Figure 1). Attach to rear lid before installing the handle.

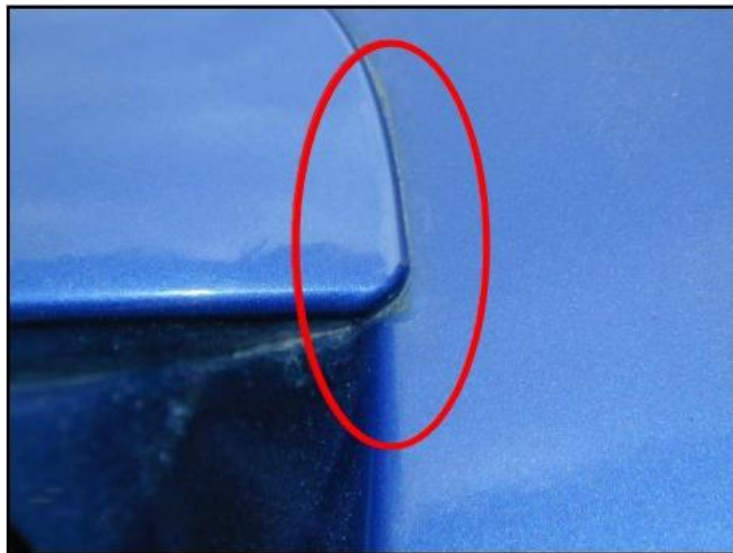
Corrosion on the contact area of the left and right sides of the rear lid / handle (Figure 2).

Figure 2 (corrosion on right side of the rear lid / handle)

Paint abrasion from sharp edge on the contact area on the handle.

1. Replace the rear lid.

2. Repair the rear lid. Only perform this operation if the total repair cost is 80% or less of the total replacement cost.

If the handle contact area in the rear lid exhibits through-corrosion (perforation), DO NOT repair, install a new lift gate.

Before the repair, check the handle contact area in the rear lid. If the handle contact area exhibits through-corrosion (perforation), DO NOT repair, install a new rear lid.

- Remove all necessary parts / trim pieces from the rear lid. See Repair Group 70 and Repair Group 55 in Elsa.
- Remove the rear lid. See Repair Group 55 in Elsa.
- Remove the corrosion with a pneumatic brush grinder. Make sure that the rear lid does not get damaged.
