Technical Bulletin

Model(s)	Year	Eng. Code	Trans. Code	VIN Range From	VIN Range To
Jetta Wagon	2001 – 2006	All	All	All	All

55 16 05 June 8, 2016 **2038994** Supersedes Technical Bulletin V551405 dated December 5, 2014 to update Claim Processing statement.

Corrosion in Corner Area of Rear Lid towards Rear Lights

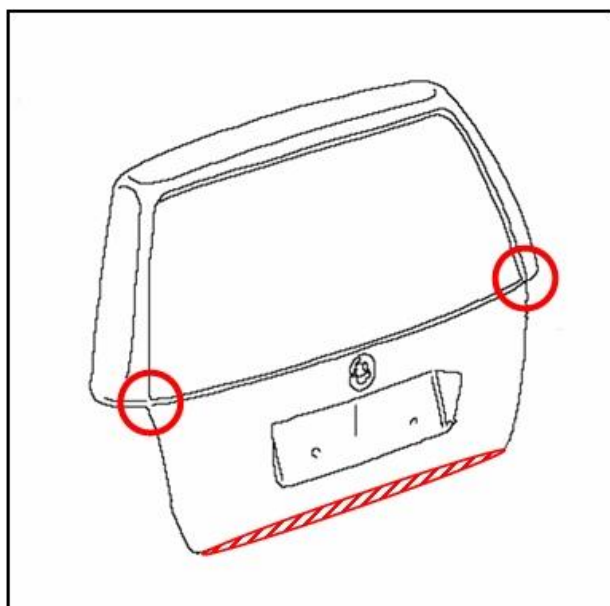
Corrosion in the corner area of the rear lid towards the rear lights (Figure 1).

Figure 1 - Red circles - corrosion on the rear lid

Hatch area - possible fold corrosion on the rear lid

- Insufficient fine seam sealing.
- Edges on the inner panel too sharp.
- Heavy load on corners by relative movement.

1. Replace the rear lid.

2. Repair the rear lid. Only perform this operation if the total repair cost is 80% or less of the total replacement cost.

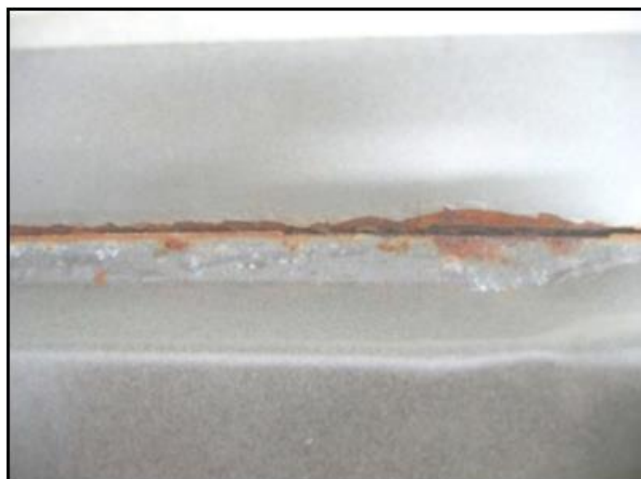
Figure 2

If the lower fold area of the inner rear lid exhibits through-corrosion (perforation) (see Figure 2), DO NOT repair, Install a new rear lid.

Before the repair, check the fold area of the inner rear lid. If the lower fold area of the inner rear lid exhibits through-corrosion (perforation) (see Figure 2), DO NOT repair and install a new rear lid.
