# Technical Bulletin

Model(s)	Year	Eng. Code	Trans. Code	VIN Range From	VIN Range To
Beetle Convertible	2013-2016	All	All	AT_DM800001	AT_GM818889

61 16 01 June 29, 2016 2044681

### Wear/Chafe Marks on Convertible Top Material

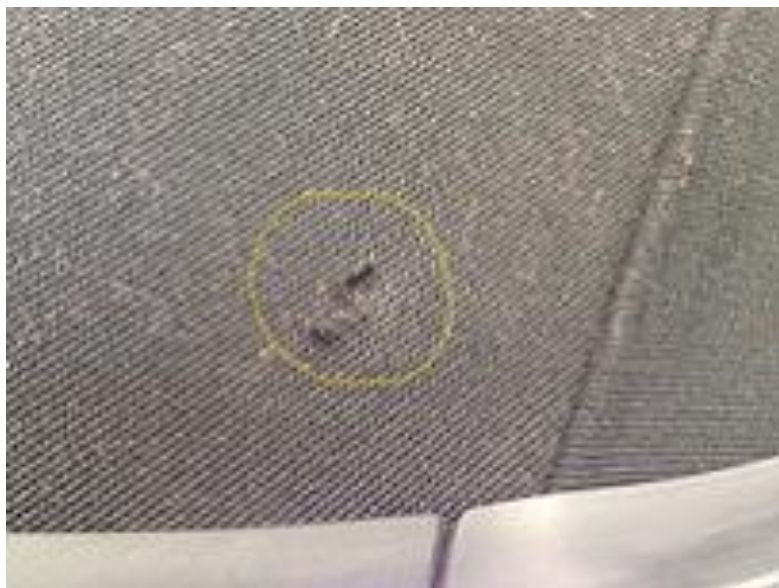
Customer may complain of wear marks on either side of the convertible top (see Figure 1).

Figure 1: Example of wear mark in top material

Improper distance between the fold of the top frame and the fold of the top material allows the top material to rub against itself causing wear over time.

- Replace the convertible top cover according to the repair manual. See Repair Manual Group 61 “Convertible Top Cover, Removing and Installing” in ELSA.

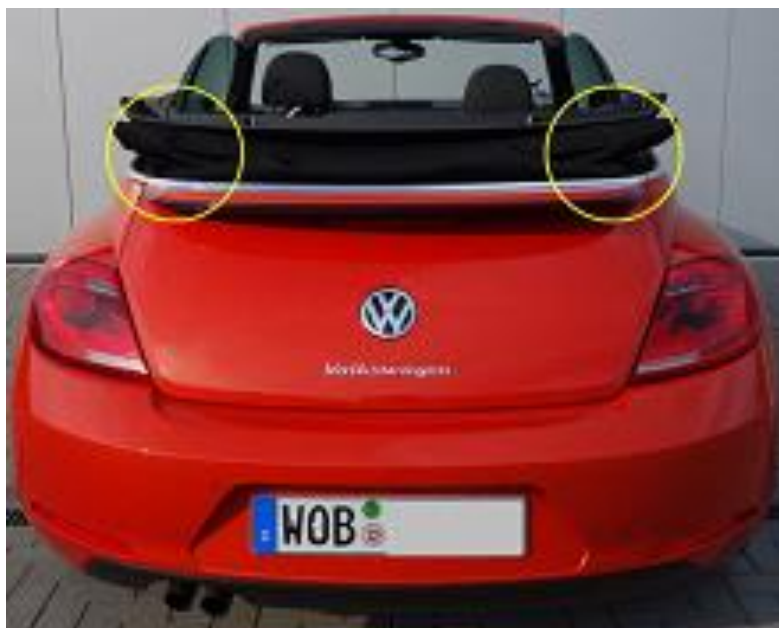
**Figure 2:** Overview of convertible top cover when stored.

- Check the distance between the fold of the linkage and the fold of the convertible top cover on the left and right side when the convertible top cover is stored (Figures 2, 3 and 4).

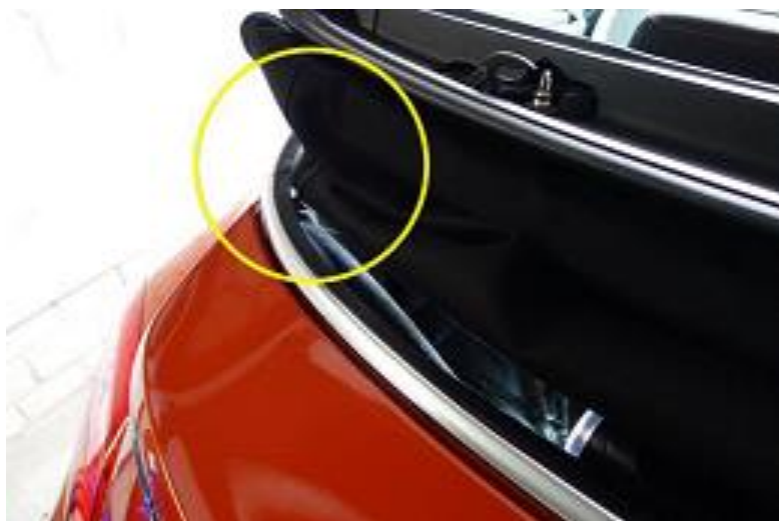
**Figure 3:** Area of concern (both left and right sides)

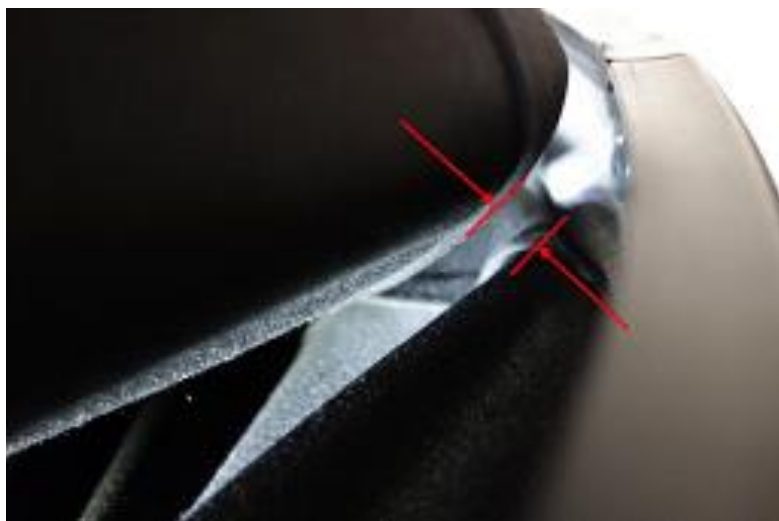
- The distance of the folds between linkage and convertible top cover in the area of the stitched seam must be at least 3 mm (Figure 4).

**Figure 4:** Ensure a 3 mm gap exists between the folds of the convertible top cover when stored (both sides).

There is an adjustment screw in each of the main bearings to change the distance between the folds if the gap is too small (Figure 4).

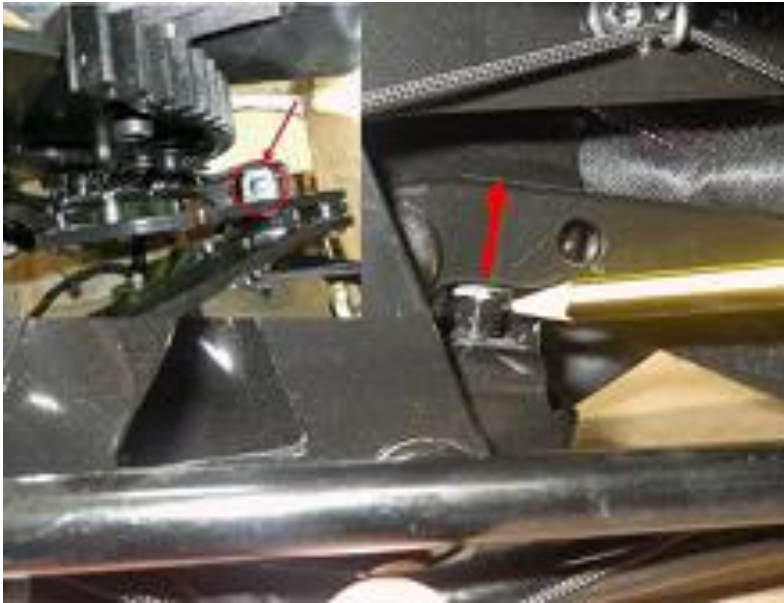
**Figure 5:** Main mounting screw (left and right)

- Adjust the top to have the proper gap between the folds of the convertible top cloth by turning the adjustment screws in the main bearings. One turn on the main mounting screw (Figure 5) equals a distance change between the fabric folds of approximately 6 mm.
