Technical Bulletin

55 16 10 June 9, 2016 **2038996** Supersedes Technical Bulletin V551412 dated December 19, 2014 to update Claim Processing statement.

Corrosion on Rear Lid around License Plate Light / Release Handle Assembly

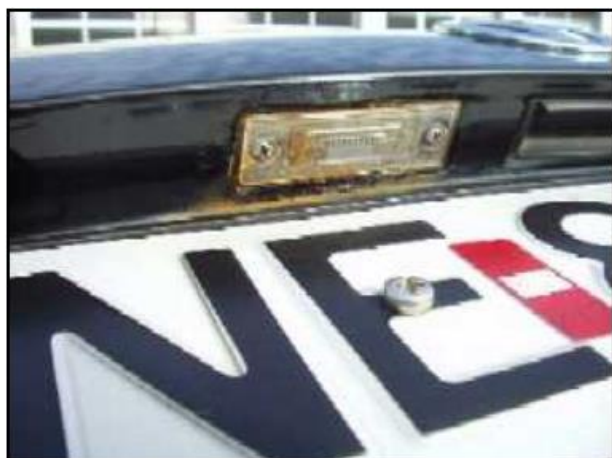
Figure 1 – Corrosion around License Plate Light

Rear lid - edge corrosion in the cut-out sections for the license plate light / handle assembly.

Water ingress through the seal of the license plate light.

1. Replace the rear lid.

2. Repair the rear lid. Only perform this operation if the total repair cost is 80% or less of the total replacement cost.

If the license plate light / handle assembly area in the rear lid exhibits through-corrosion (perforation), DO NOT repair, install a new rear lid.

- Remove all necessary parts / trim parts from the rear lid. See Repair Group 70 and Repair Group 55 in Elsa.
- Remove the rear lid. See Repair Group 55 in Elsa.
- Remove the corrosion with a pneumatic brush grinder. Make sure that the edges of the rear lid do not get damaged.

- Apply a VOC compliant epoxy primer as an anti-corrosion treatment and primer (locally sourced).
- Re-paint the rear lid according to the Volkswagen guidelines.
- Install the rear lid. See Repair Group 55 in Elsa.
- Replace the lock cylinder carrier (license plate light / release handle assembly). See Repair Group 55 in Elsa.
- Install all remaining parts / trim pieces previously removed. See Repair Group 70 and Repair Group 55 in Elsa.
- Adjust the rear lid fit according to the repair manual. See Repair Group 55 in Elsa.

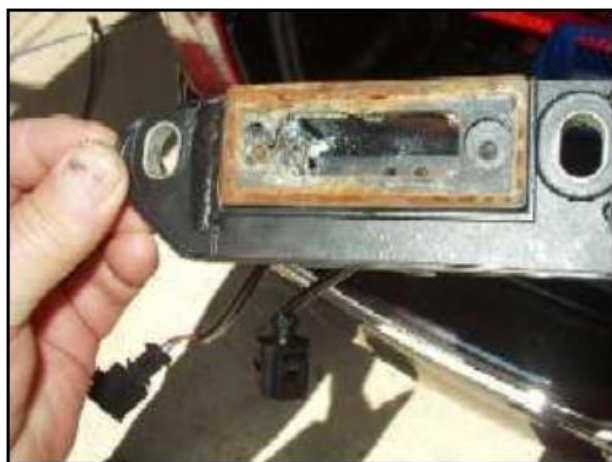
Figure 2 – Corrosion around License Plate Light

Rear lid – corrosion in the contact area (inside and outside) of the license plate light / handle assembly.
