Technical Bulletin

Model(s)	Year	Eng. Code	Trans. Code	VIN Range From	VIN Range To
Passat Wagon	2006 – 2010	All	All	All	All

55 16 09 June 9, 2016 2039197 Supersedes Technical Bulletin V551411 dated December 16, 2014 to update Claim Processing statement.

Corrosion On Rear Lid Around Rear Lights

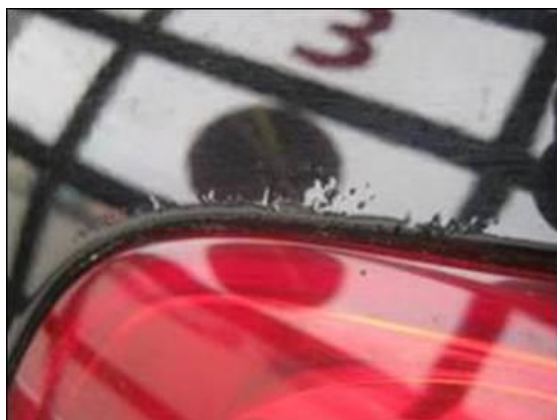
Figure 1: Example: rear lid when rear light is installed

The surface area of the rear lid becomes chafed from movements between the components.

Repair the rear lid (remove corrosion/restore paint structure).

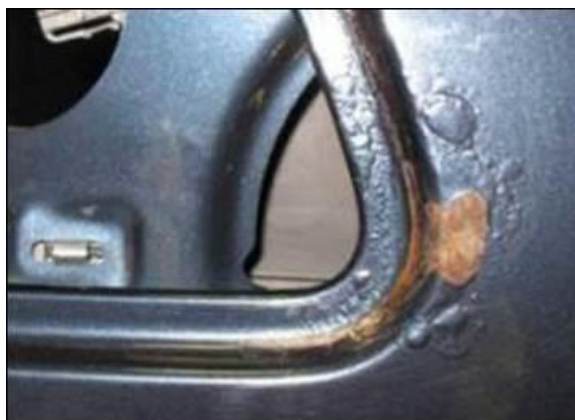
Figure 2: Example: rear lid when rear light is removed

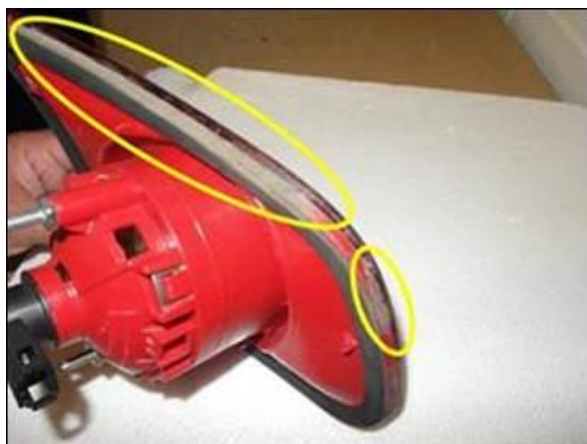
Dirt between the rear lid surface and rear lights can cause paint damage (Figure 3).

Figure 3 Dirt on rear lights

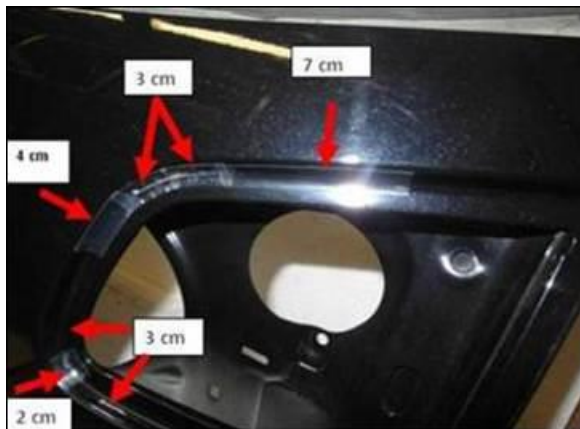
Figure 5 Foil installation on right lift gate tail light surface.

Cut out the anti-chafing foils per side from the part number: AKL 448 030 05 (Figure 5, red arrows)

- For top area: 1 x 7 cm long, 2 x 3 cm long, 1 x 4 cm long.
- For bottom area: 1 x 2 cm long, 2 x 3 cm long.
- Thoroughly clean the contact surface of the rear lights in the rear lid with silicon remover
- Stick on the cut-out foils (illustration 5, red arrows).

When applying the anti-chafing foil make sure that the edge to the outside is equal and is covered by the rear lights.
