## Service Information Bulletin

SUBJECT	DATE
TCM SPN 520999 FMI 7	March 2016

## 2 SPN 520999/FMI 7

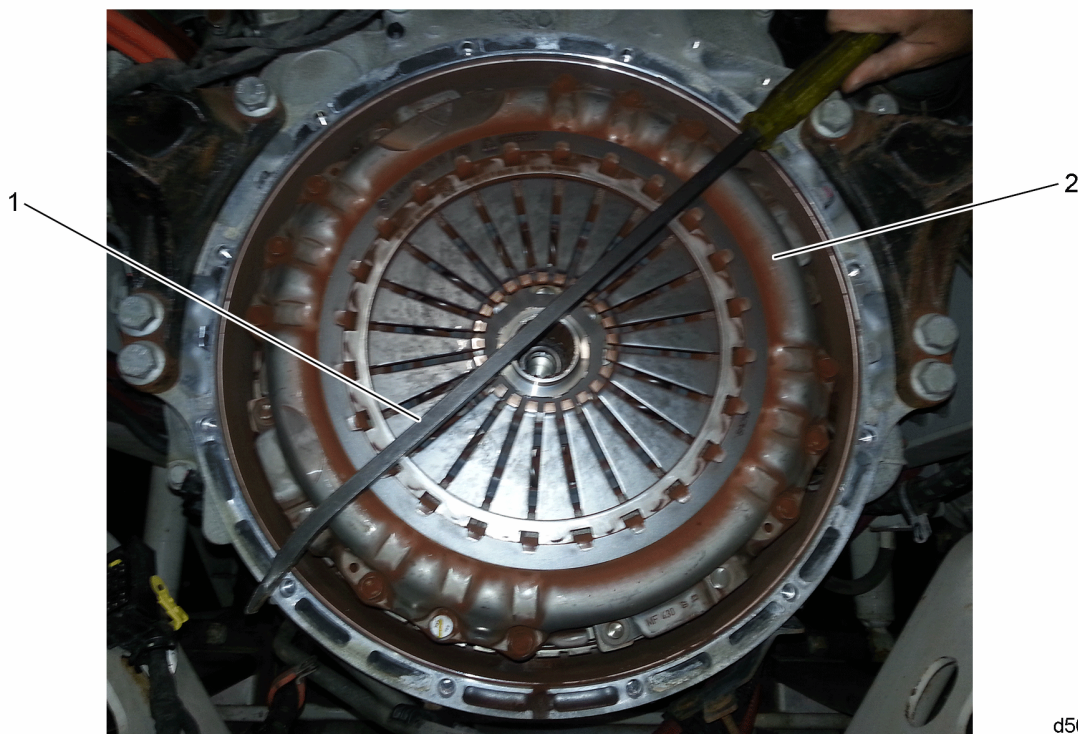
d500250

- a. Yes; Go to step 8.
  - b. No; obtain a driving log file and contact Detroit™ Transmission Support at 855-253-0428 for further assistance.
8. Remove the transmission. Refer to section "Removal of the Transmission".
  9. Keep the pressure plate and clutch disk installed on the engine.
    - a. Lay a straightedge (1) on the raised portions on the pressure plate (2).

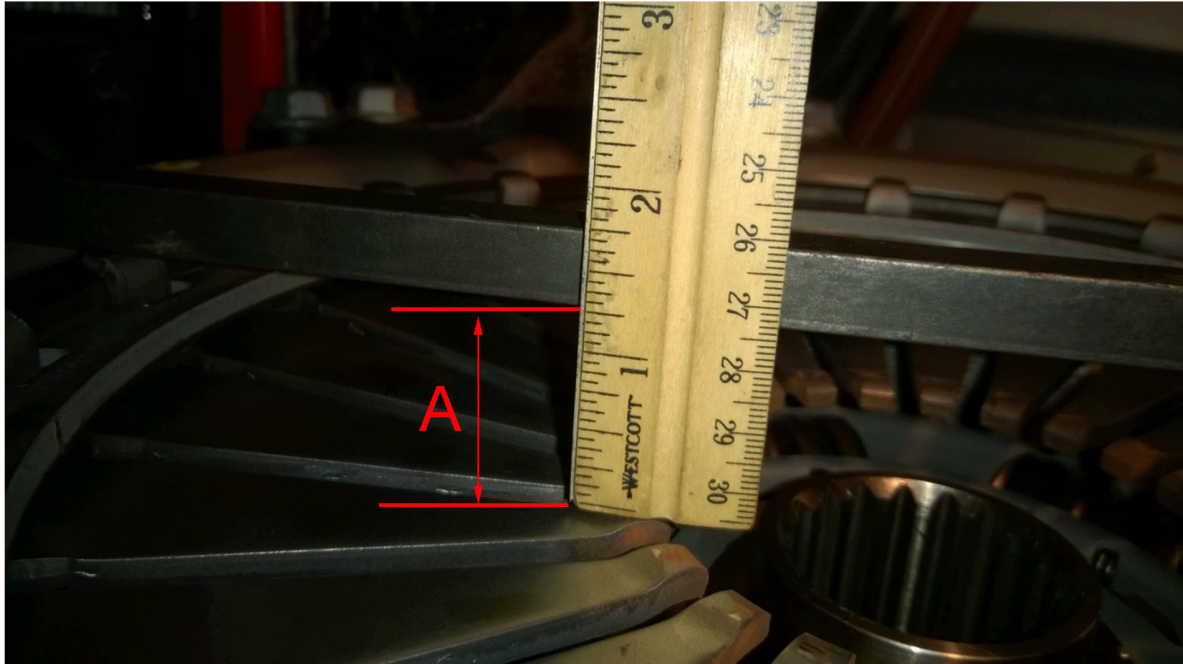
d500249

- b. Use a ruler to measure the distance (A) from the straightedge to the contact apex of each release finger.

10. Is the measurement greater than 2.54 cm (1 in.) or pressure plate fingers warped?
  - a. Yes; replace pressure plate, pressure plate mounting bolts and clutch disc. Refer to section "Installation of the Clutch".
  - b. No; replace the Concentric Pneumatic Clutch Actuator (CPCA). Refer to section "Removal of the Clutch Actuator Assembly".
