**S16YN**

**April 11, 2016**

**Subject:** S16YN  
Rear Air Disc Brake Axle Shaft Flange Nut Replacement

**Models Affected:** Model Year: Certain 2015-2017  
Model: Vision and All American  
School Bus and Non-School Bus

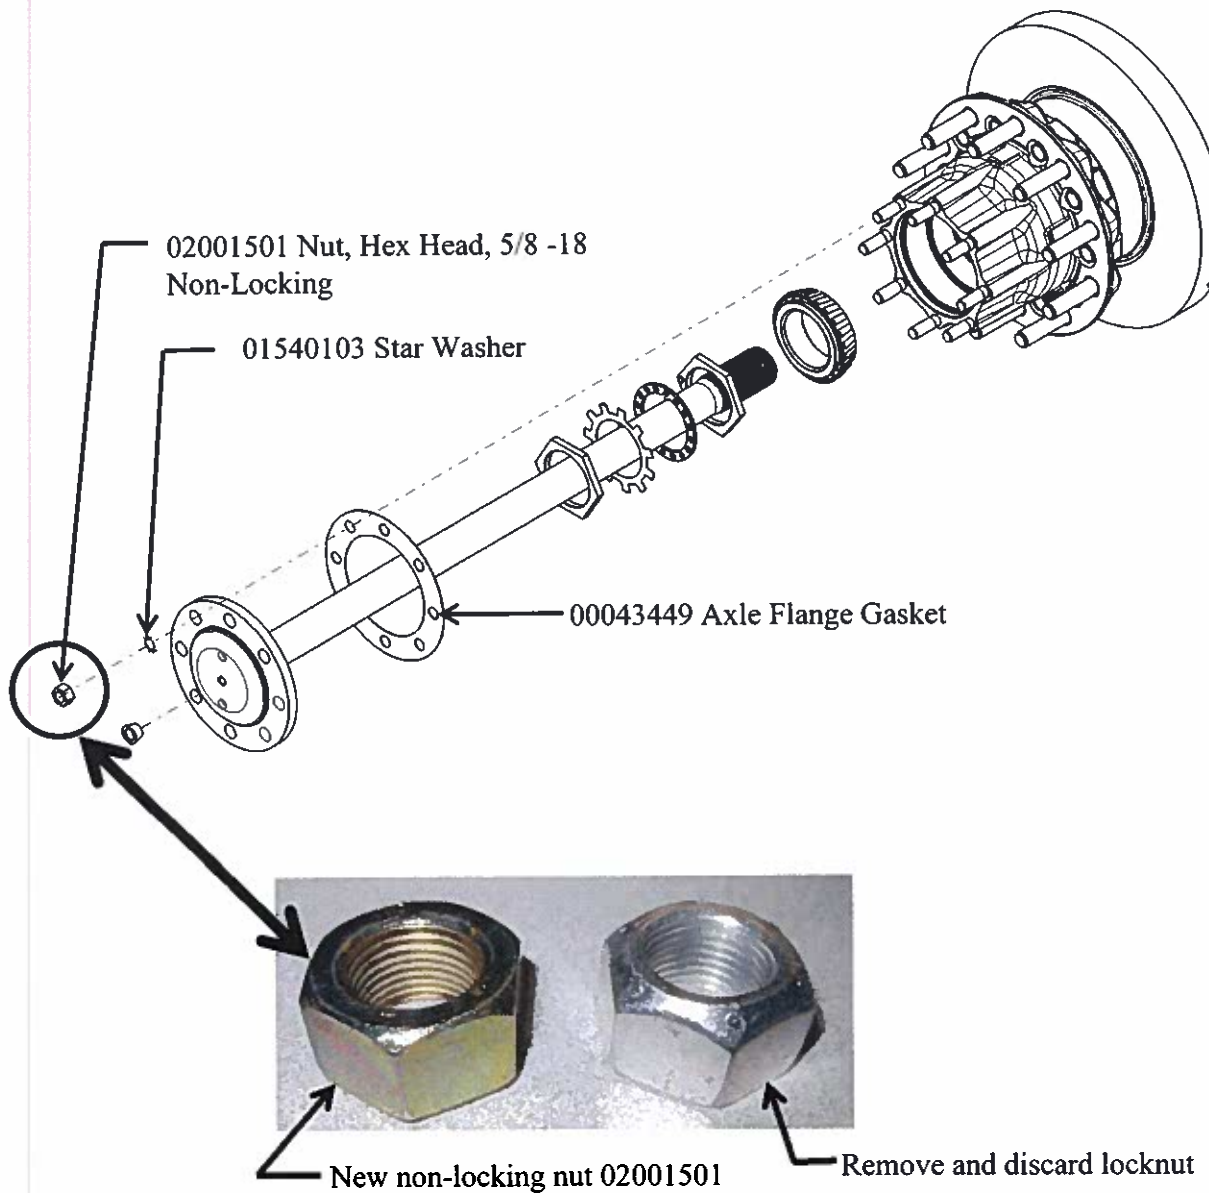
## REAR AIR DISC BRAKE

Rear axle shaft flange nut torque reduces allowing for oil leak between the axle shaft and hub.

Replace the existing rear axle flange lock nut with a new non-locking nut and star washer. Request that the Service Manual be updated by technician to show new nut and torque.

1. Park bus on level surface, turn off engine, remove ignition key, and chock wheels.
2. To reduce the possibility of the stud being removed when removing locknut, remove the paint from the existing rear axle shaft flange studs.
3. Remove and discard the first lock nut and star washer.
4. Replace the hardware in Step 3 with a new star washer 01540103 and a new non locking nut 02001501.
5. Torque nut to 60-70 ft-lb.
6. If a stud comes out during removal of locknut, remove the locknut from the stud and reinstall the stud into the hub. Torque stud to 60 to 70 ft-lb.
7. Remove the next lock nut and star washer in a "star" pattern.
8. Repeat Steps 3 to 6 until all eight star washers and lock nuts are replaced.
9. Re-torque all nuts to 170-180 ft-lb. in a "star" pattern.

**NOTE 1:** If there is a leak at the rear axle flange gasket, remove and discard all eight locknuts and star washers. Replace gasket, install axle shaft, and install eight new star washers 01540103 and new non-locking nuts 02001501. Torque all eight nuts per Step 9 above.
