**S16YU**

**Subject:** S16YU, Rear Air Disc Brake Axle Shaft Flange Gasket Replacement  
*S16YU Replaces S16YN*

**Models Affected:** Model Year: Certain 2015-2017  
Model: Vision and All American  
School Bus and Non-School Bus

## Rear Air Disc Brake Axle Shaft Flange Gasket Replacement

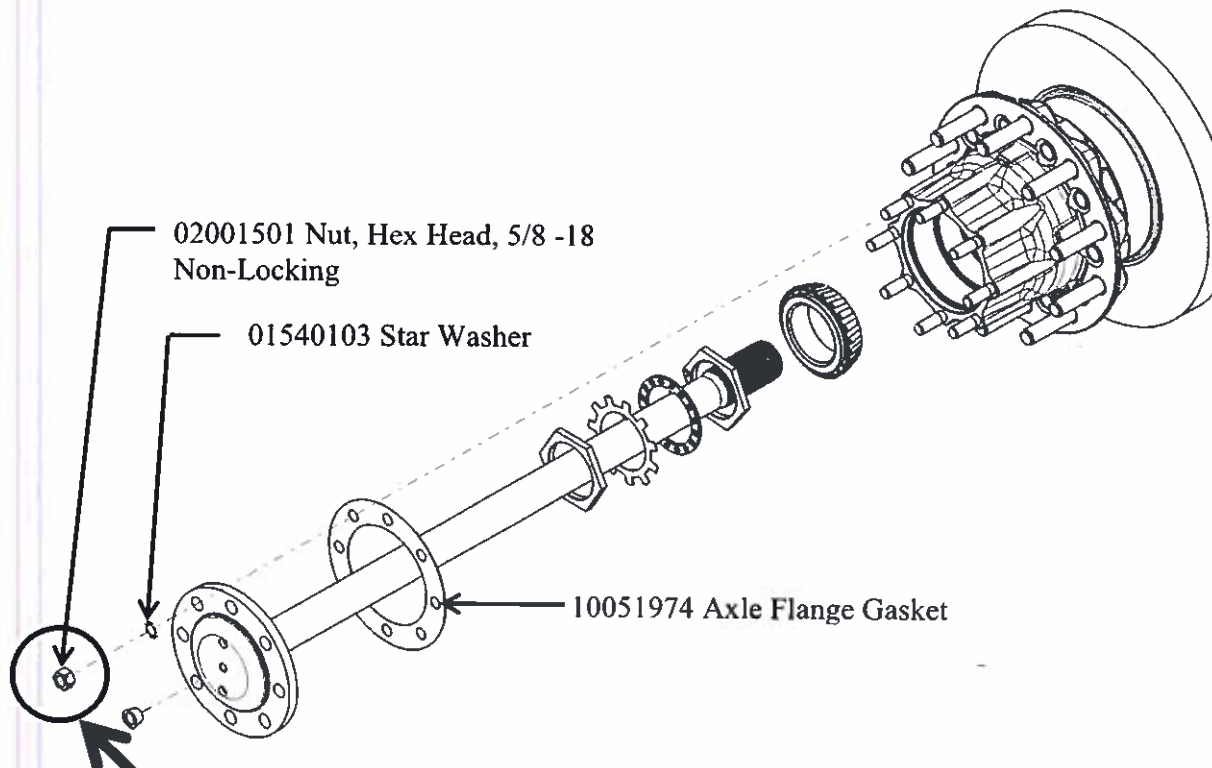
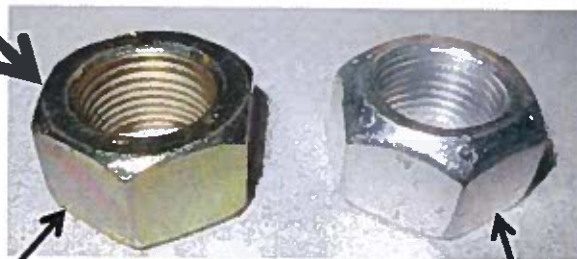
### REAR AIR DISC BRAKE

Non-locking nut 02001501

If there are locknuts on the rear axle studs, remove and discard lock nuts and washers.
