# Technical Bulletin

**87 16 24** November 22, 2016 **2037255** Supersedes Technical Bulletin V871502 dated March 11 2016 to add radio removal time for vehicles built after 9/30/2014.

**Whistle Noise from Center Vent Area; Blower Set on 3 or 4 with Full Heat Selected**

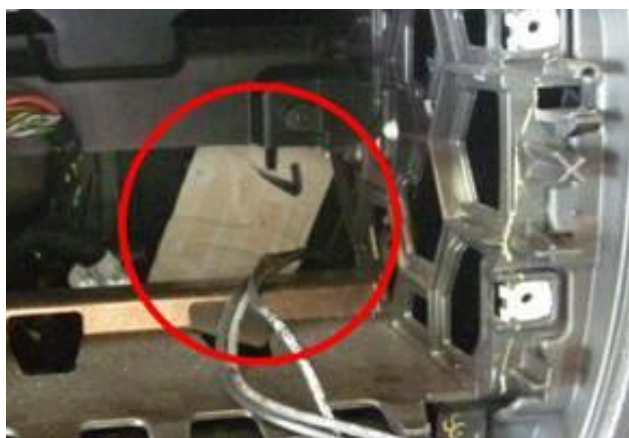
Figure 1

The label on the air distribution unit is located on the front of the distribution unit assembly (Figure 1).

- Remove the radio, see Repair Group 91 in Elsa.

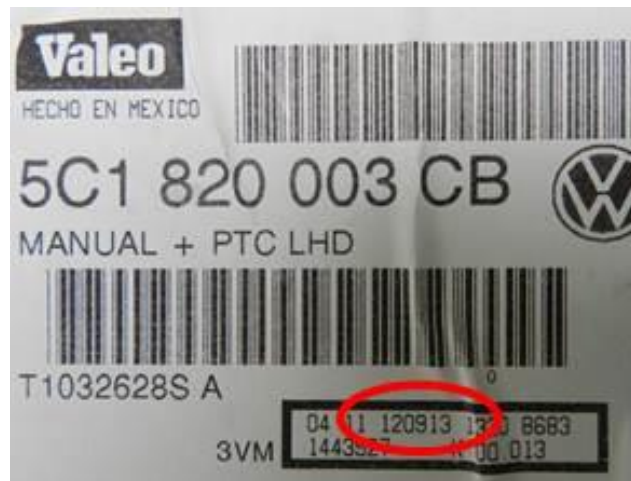
Figure 2

Check the production date of the air distribution unit (Figure 2).

**The production date is Day/Month/Year (120913 = Sep 12<sup>th</sup> 2013) (Figure 2).**

**All air distribution units built before 9/30/2013 will require both the left and the right temperature flap levers.**

**Air distribution boxes built between October 1<sup>st</sup> 2013 and March 20<sup>th</sup> 2014 will require only the right (Black) temperature flap lever.**

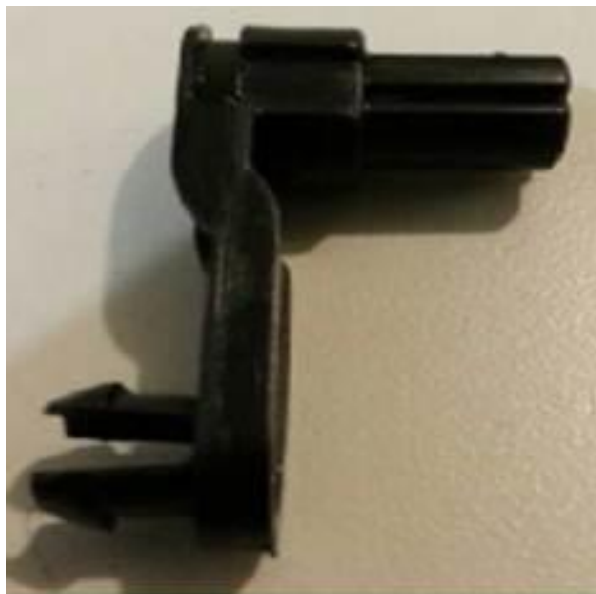
Figure 10

**The lever position shown in Fig 10 is when the temperature flap is in the full heat position**

Installation of the passenger side temperature flap lever. (Black)
