Technical Bulletin

87 16 23 November 3, 2016 **2045815**

Air Conditioning Blows Warm, Compressor-Condenser Refrigerant Hose

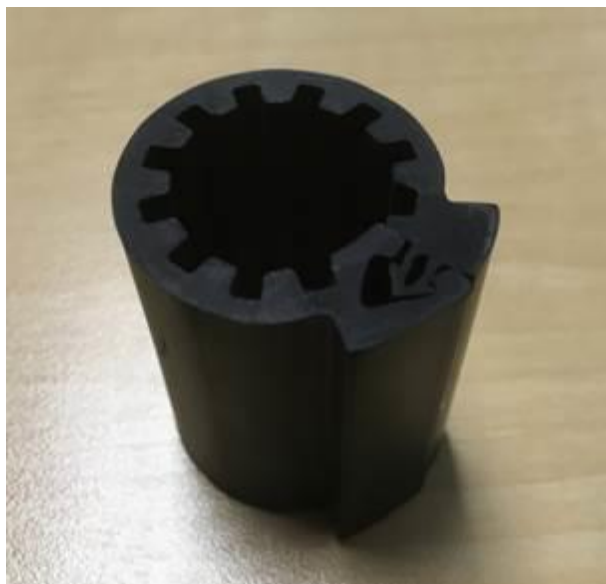
Production Solution

New rubber retainer ring N 107 675 01.

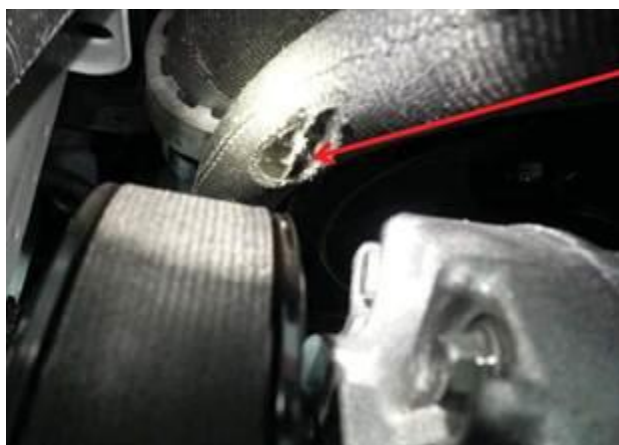
Figure 1: AC line contact with A/C pulley

The air conditioning refrigerant hose may come in contact with compressor pulley due to engine vibration.

Inspect refrigerant hose between condenser and compressor. If hose is not damaged this technical bulletin does not apply. Further diagnosis is required.

1. Inspect refrigerant hose between condenser and compressor (Figure 1).

Replace the Compressor/Condenser A/C line if damaged, see Repair Manual Group 87 in Elsa.
