Technical Bulletin

60 16 08 November 22, 2016 **2045403** Supersedes Technical Bulletin V601606 dated September 28, 2016 due to updated title with applicable model clarification.

Water leak from the Sunroof (Panoramic Roof)

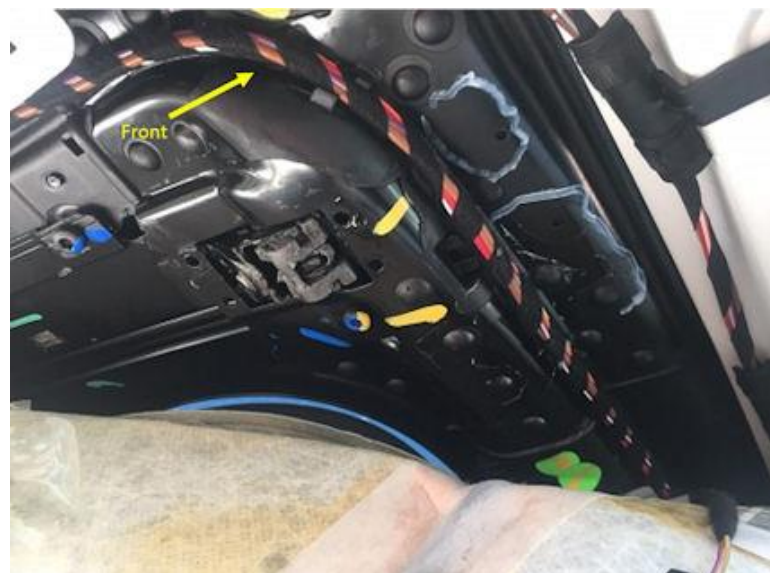
Verify the customer complaint. Water leaks occur near the A-Pillars in the corners of the sunroof water channel.

Figure 1 (Water leaking through corner of water channel)

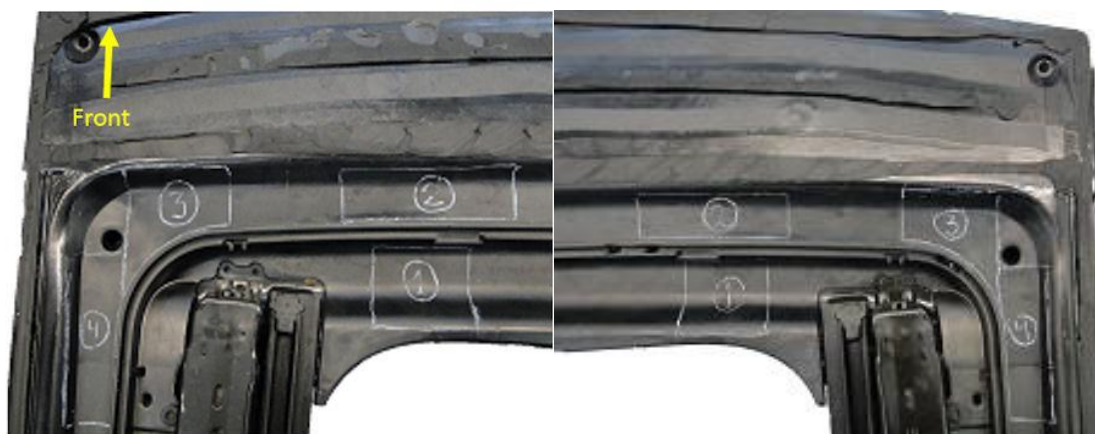
Figure 3 (Inspections zones for stress cracks / application zones and sequence for foil application)

12. Apply the foil tapes one at a time according to the sequence shown in Figure 14.

Foil tapes must be applied in all 8 positions regardless if there is a crack or not.

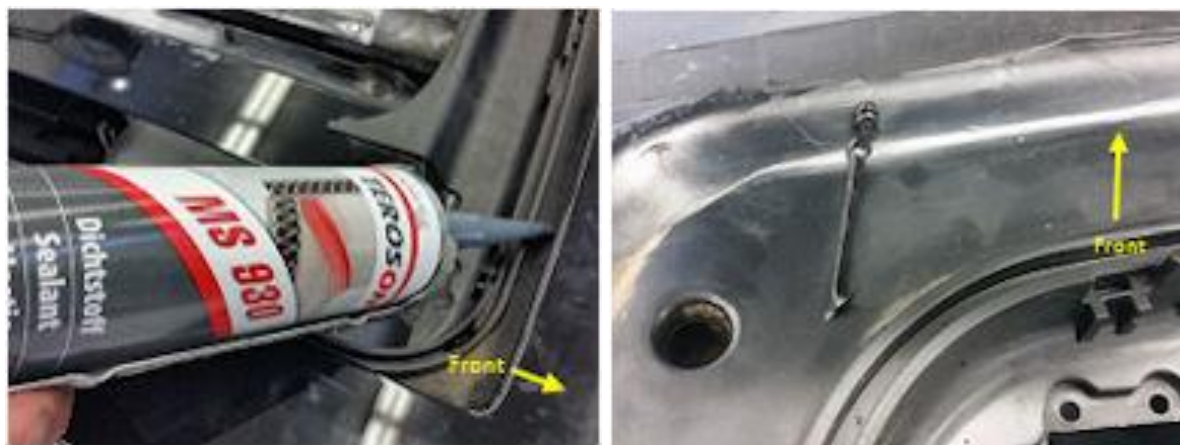
Figures 10 and 11 (Sealant application)

7. For all cracks, put a 1 mm bead of sealant (Teroson MS-930, part number D 172090A2) over any existing cracks, 1 at a time. Start the sealant bead as far under the sunroof trim as possible and pull the bead to the end of the crack.

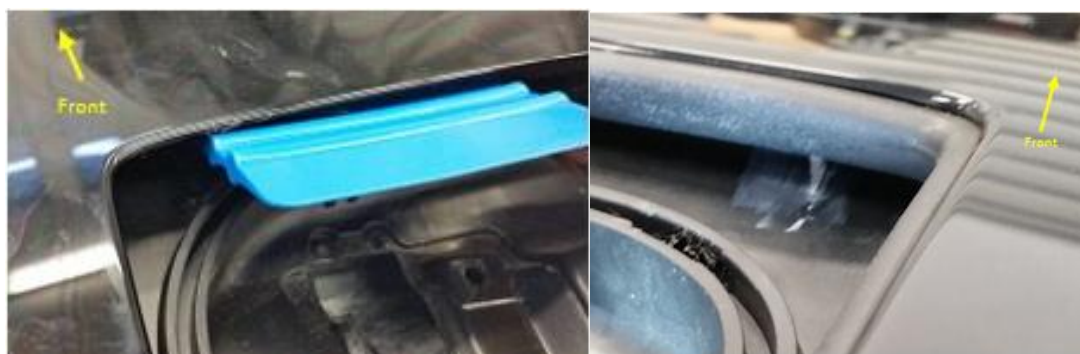
Figures 12 and 13 (Spread sealant working from sunroof opening to underneath the trim panel. Sealant should fill crack and there should be no excess sealant on the water channel.)

9. Remove all excess sealant from the water channel. There must not be any excess sealant that may prevent the foils from being applied completely flat to the water channel. The crack should be filled with sealant with no excess sealant around the crack (See figures 12 and 13).

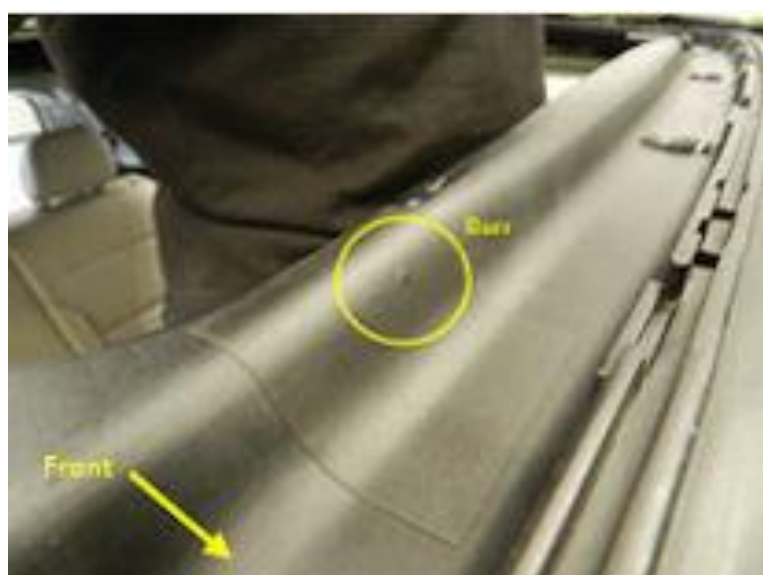
There may be a burr on the water channel in this location that appears to be an air bubble. This is normal and an acceptable condition after applying the foil (Figure 17).

Figure 17 Burr under foil position 1.

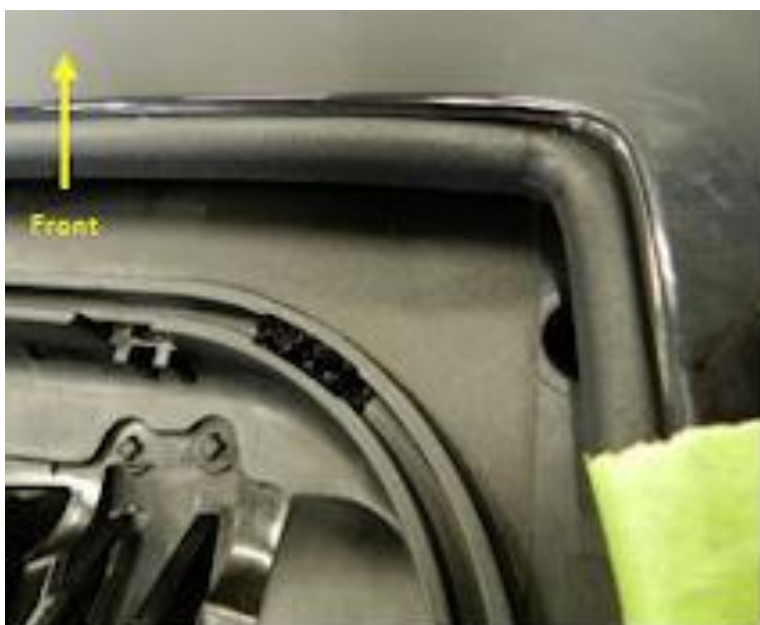
Figure 20 Foil position 3 incorrectly applied covering witness line around drain.

15. In position 3, peel half of the backing tape off starting at the pointed edge in the radius and fold it over to use to hold the foil during application. Carefully align the radius of the foil to the radius of the seal channel and ensure the drain hole and witness mark around the drain will not be covered. Apply the foil working it forward using the included squeegee to ensure there are no air bubbles or wrinkles and that there are no gaps under the foil. Peel backing tape off as you work. Use the squeegee to work the tape down smooth and as far underneath the trim panel as possible (Figure 19).

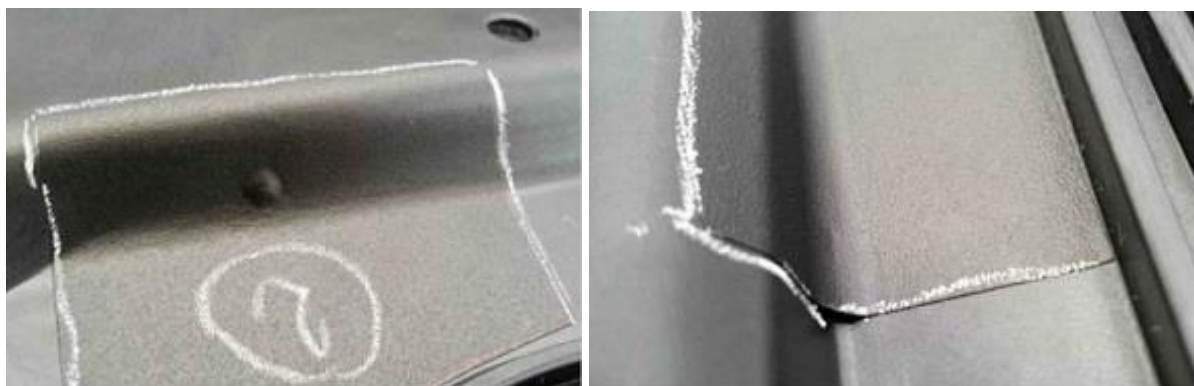
Figures 23 and 24 Air bubble under foil, air gap underneath foil.

18. Once all 8 foils have been applied to the water channel, inspect the foils to ensure they are completely flat to the water channel and that there are no air bubbles or gaps underneath the foil. Use the squeegee to help push out any defects (Figures 23 and 24).

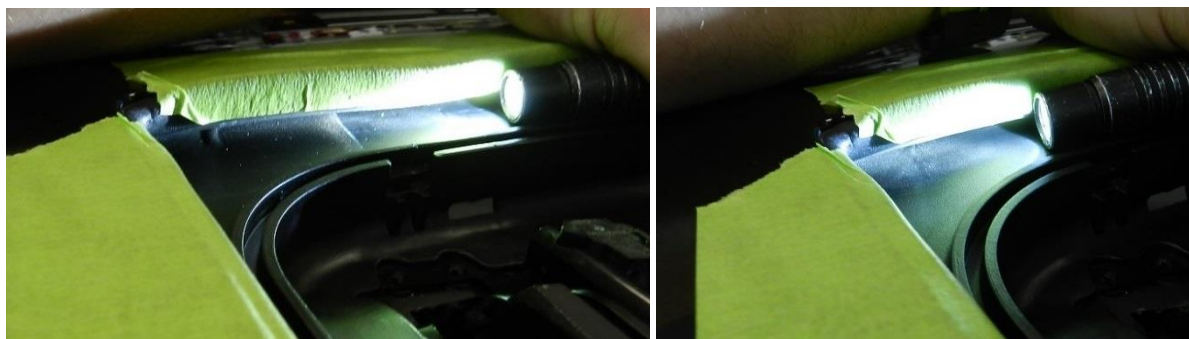
Figure 25 and 26 use a flashlight to help identify any air bubbles in the foils and use the squeegee to work out any defects.

Use a flashlight at different angles to help identify any air bubbles. If any foil needs to be removed and reinstalled, discard the foil and use a new piece (Figures 25 and 26).

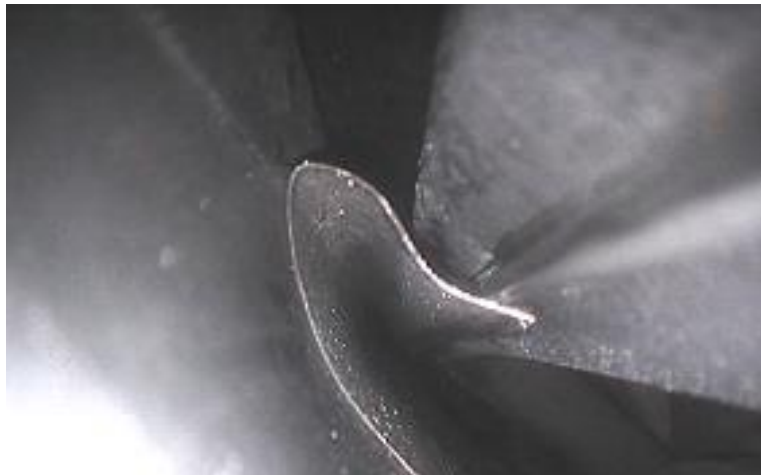
Figure 27 Foil folded and not adhered underneath trim panel

The foil must be fully applied underneath the trim panel. If the foil is folded over, it should be removed and a new piece applied (see figure 27). Use the squeegee to work the foil down on to the water channel as far underneath the trim panel as possible.
