Technical Bulletin

15 16 03 November 23, 2016 2045939

MIL ON – DTC P0011 and or P0016 Stored in ECM Fault Memory – Engine May Run Rough At Idle

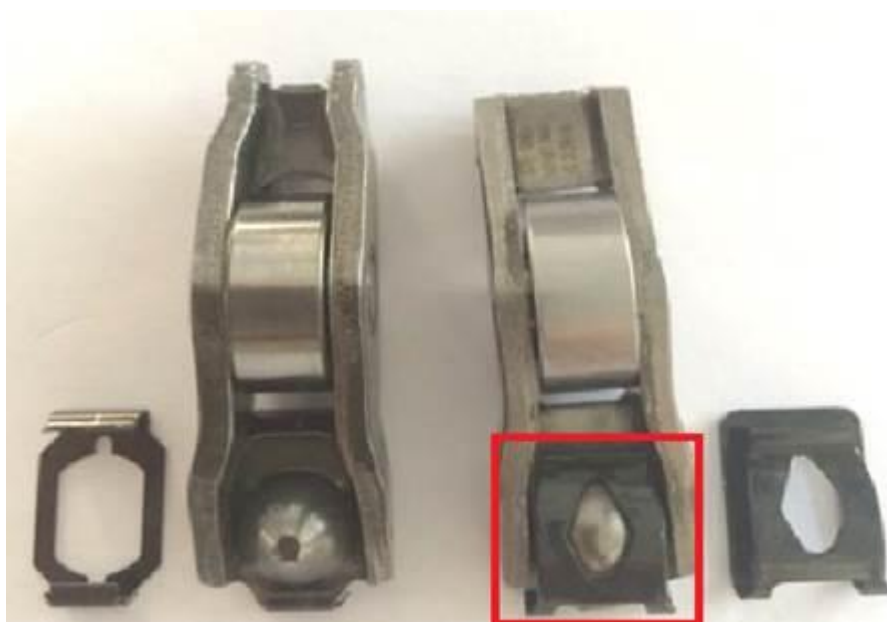
Figure 1

Left in figure 1: INA rocker arm (retaining clip not visible)

Right in figure 1: GT rocker arm (retaining clip visible, in red)

- **INA rocker arm (illustration 1, left):**
 - Rocker arms do **not** have to be replaced.
- **GT rocker arm (illustration 1, right):**
 - Replace the intake rocker arms according to the repair manual.
- Remove the camshaft bearing bridge according to the repair manual. Check the bearing bridge for damage. (as shown in figure 2).

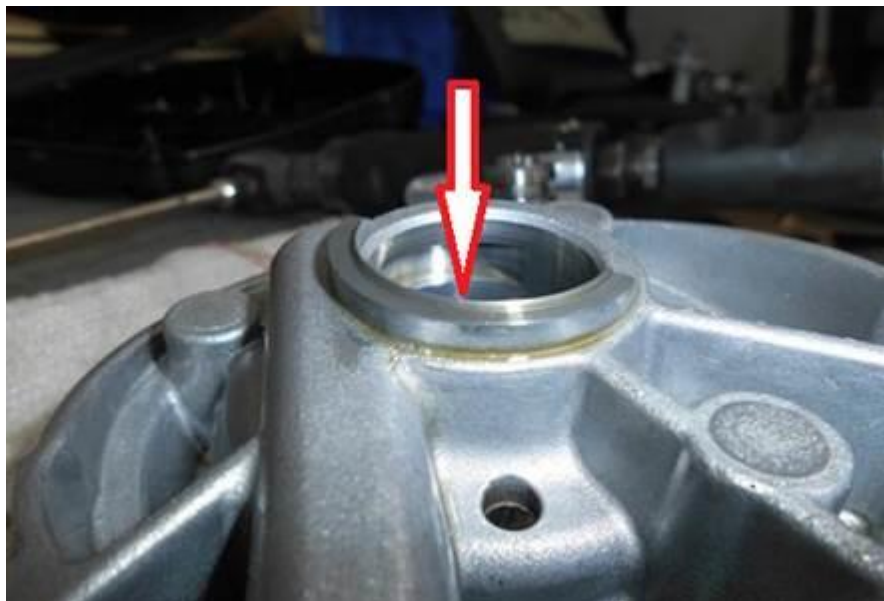
Wear of the camshaft bearing bridge can cause axial movement of the camshaft resulting in faults stored.

Figure 2) example of worn camshaft bearing bridge

- If the bridge is damaged as shown in figure 2 the following components must be replaced:
- Drain the engine oil of the warm engine according to the repair manual.
- Replace the engine oil filter according to the repair manual.
- Replace the following components according to the repair manual.
 - Intake camshaft
 - Camshaft bearing bridge
 - Intake camshaft rocker arms (if necessary)
- Fill up the engine oil according to the repair manual.
