Technical Bulletin

00 16 08 November 22, 2016 2036935 Supersedes V001506 dated November 2, 2015 to include updated information, and additional model year applicability.

By-Pack at Delivery

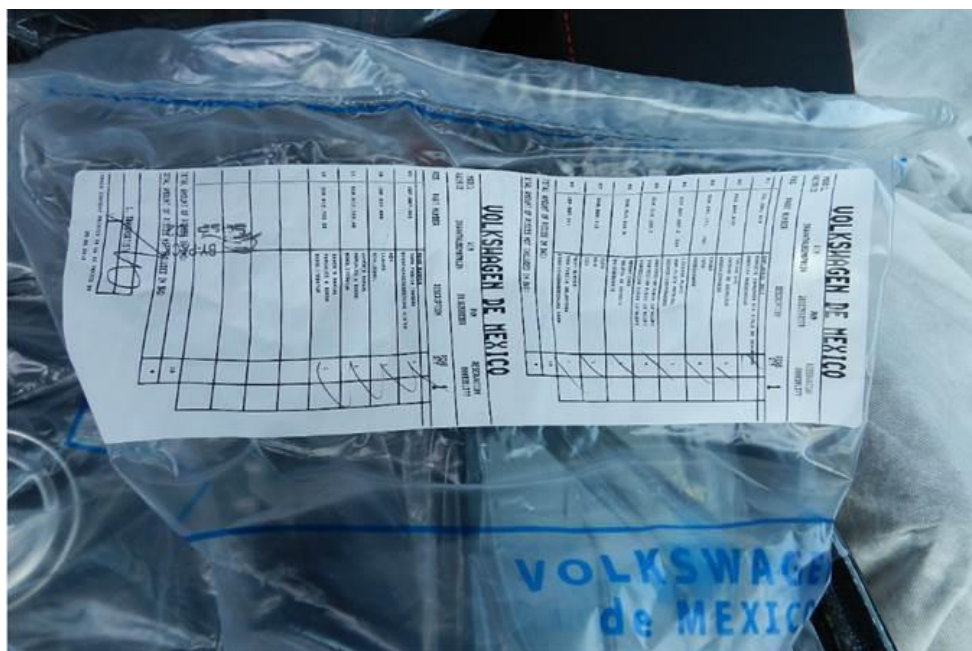
By-Pack is the term used to describe the bag that is delivered with the vehicle that contains the parts to be installed at PDI, i.e. Wheel Center Caps, Lug Caps, Wiper Blades, Etc. Figure 1.

By-Pack components may be missing, incorrect or damaged at delivery.

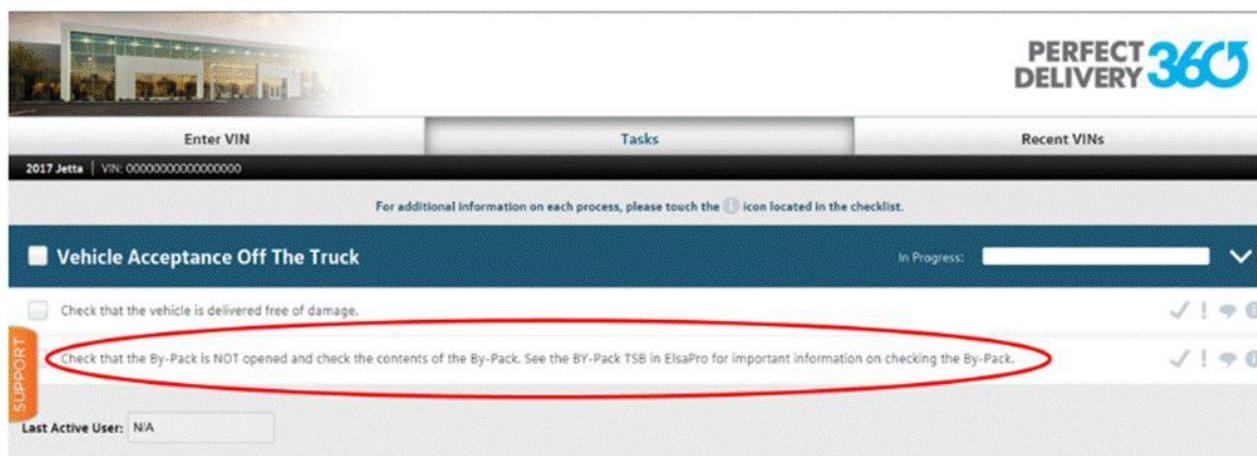
Figure 2.

Please note that the ePDI form has been updated to include the By-pack condition and content check at vehicle acceptance off the truck (Figure 2).

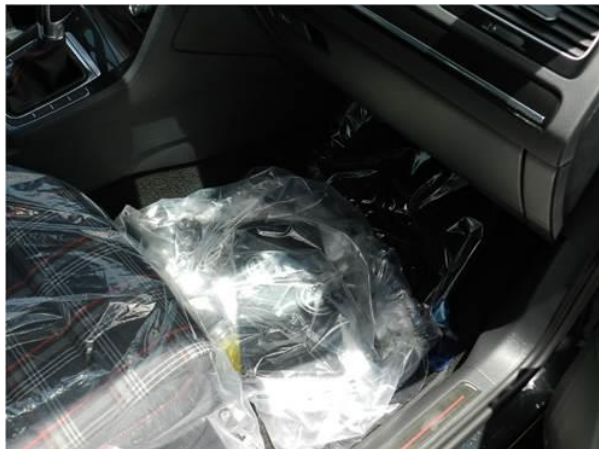
Figure 5. By-pack Location for cars produced in Mexico

- For VW Models produced in Mexico (Jetta, Golf, GTI, Golf Sportwagen, Beetle & Beetle Convertible) the By-pack is located in the front passenger's side floor, Figure 5. The By-pack has separations (pouches) for the Key(s) and Tow Hook Covers and other components depending on trim level (Figure 6). Vehicles equipped with keyless entry (KESY) have both keys in the By-pack.

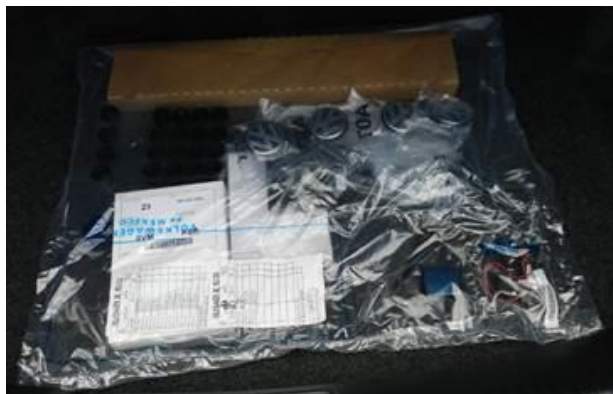
Figure 7.

Best Practice - At PDI before opening the By-Pack spread out the By-pack on a work bench or table exposing all the contents as best as possible and take a picture of the front and rear of the By-Pack (Figures 7 and 8). Make sure that the components labels with VIN is captured in the photo and check for missing components during this time.
