# Technical Service Bulletin

## 01 Engine hesitation, various warning lights on

01 16 90 2046007/1 November 30, 2016.

Model(s)	Year	VIN Range	Vehicle-Specific Equipment
A6	2016	000001 - 178135	4 cylinder engines

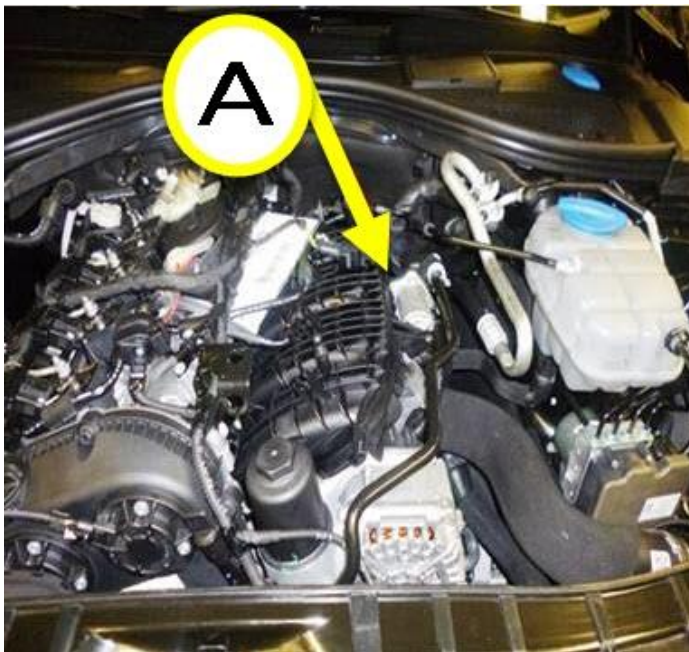
The engine wiring harness may come into contact with an engine coolant hose clamp.

*Figure 1. Inspect the engine wire harness in location (A).*

1. Validate customer concern:
  - If customer concern corresponds with information provided in the Condition section of this TSB, then continue. If not, perform diagnostics outside of this TSB.
2. Inspect the engine harness for possible damage. Location shown in Figure 1 and Figure 2.

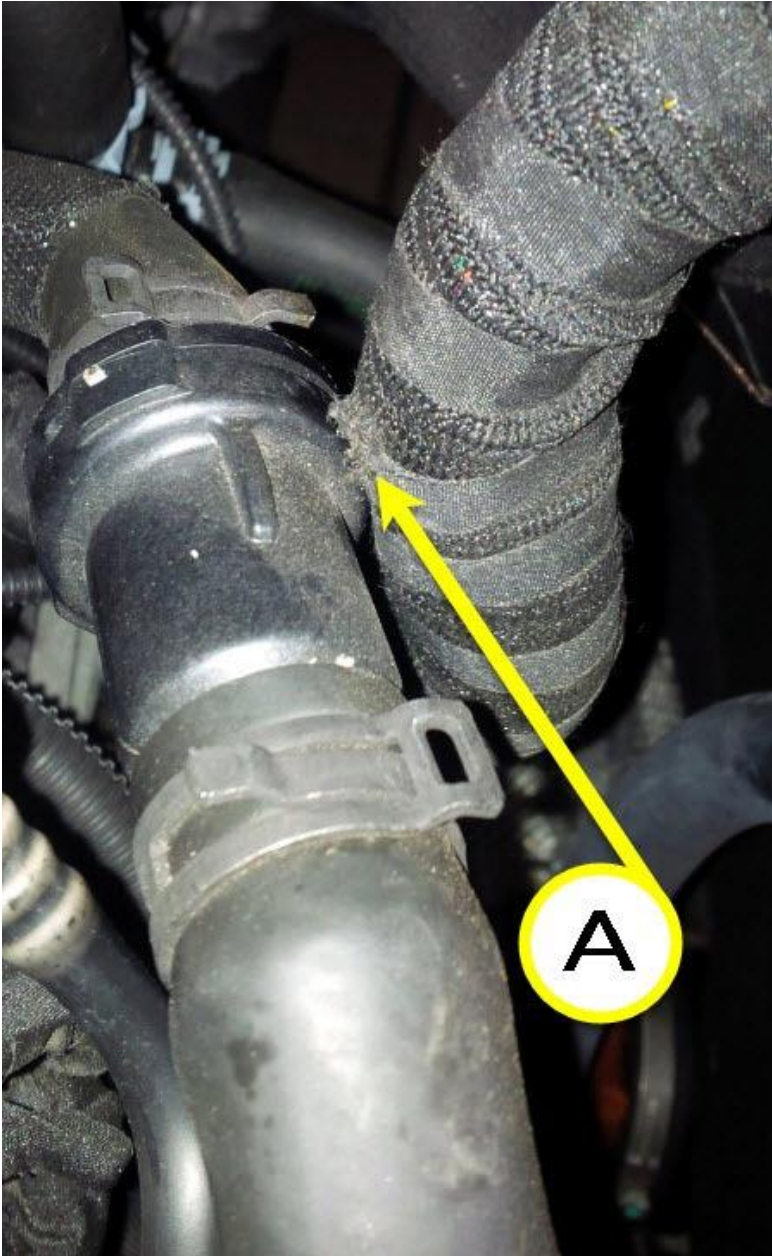
*Figure 2. Location of possible harness damage (A) from contact with coolant clamp.*

3. If damage is found to wiring, repair all damaged wires inside the harness:
  - Consult the repair manual for instructions on harness repair with the VAS1978 Wiring Harness Repair Set.
  - Wrap the repaired section of the wiring harness with Cloth Webbed Adhesive Tape (N10592002).
4. Rotate the coolant clamps 25 degrees counter clockwise, so the tabs face away from the engine harness (Figure 3).
