66 Front license plate bracket installation

66 16 59 2045963/2 November 21, 2016. Supersedes Technical Service Bulletin Group 66 number 16-58 dated November 15, 2016 for reasons listed below.

Model(s)	Year	VIN Range	Vehicle-Specific Equipment
А3	2017 All Front license plate		Front license plate

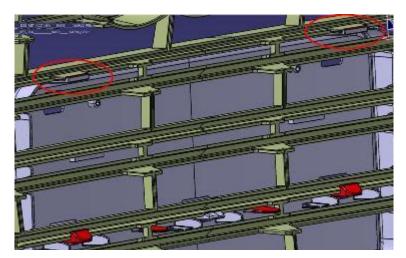
1. The part drawing shown in Figure 2 shows the installation position of the retaining clips.

Figure 2. Installation position of the retaining clips.

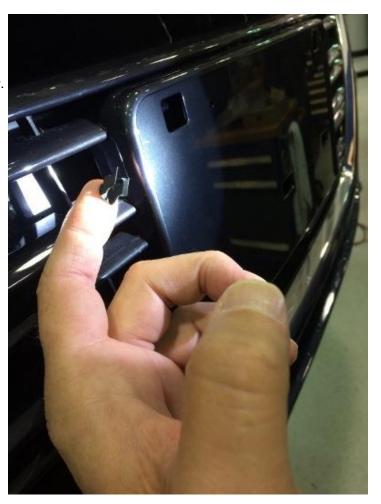
Figure 3. Applying a tacky substance to keep the clip on the end of your finger.

Install the front license plate bracket into the grille such that the upper tabs align. Apply a tacky substance to your finger tip strong enough to keep the retaining clip on your finger.

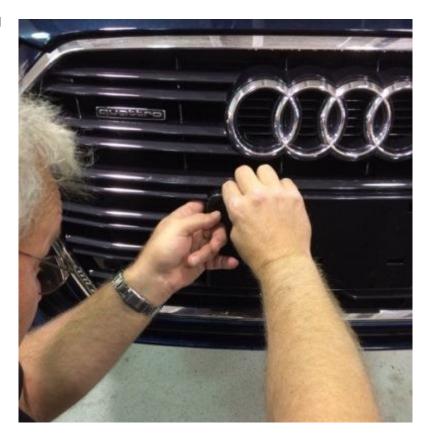
Figure 4. Installing the clip from the side of the license bracket.

Reach to the side of the bracket and install each clip such that both the tab on the grille and the mating tab on the license bracket are both bound together by the clips.

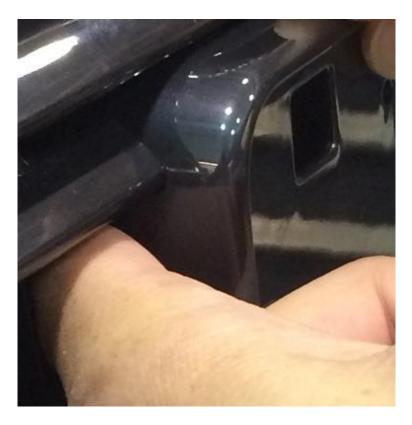
Figure 5. Pushing the clip into position.

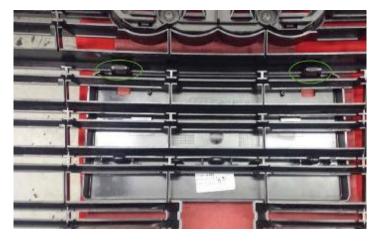
4. The illustration to the right shows the retaining clips correctly installed as viewed from inside the grille. Again, the grille does not need to be removed and this is only for illustration.

Figure 6. Correctly installed retaining clips as viewed from inside the grille.
