Technical Service Bulletin

87 Air conditioning does not blow cold

87 16 78 2042340/3 November 9, 2016. Supersedes Technical Service Bulletin Group 87 number 16-73 dated June 28, 2016 for reasons listed below.

Model(s)	Year	VIN Range	Vehicle-Specific Equipment
Q3	2015 - 2016	All	Not Applicable
Q3	2017	000001 - 007836	Not Applicable

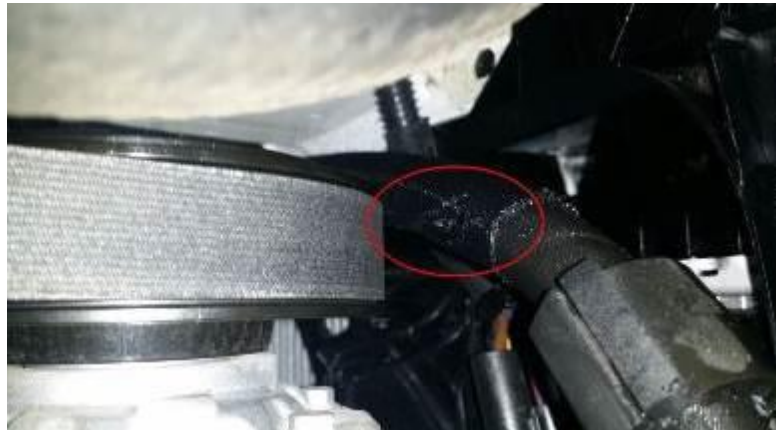
The technical diagnosis reveals that there is no refrigerant in the circuit. The refrigerant hose that connects the suction side of the compressor to the condenser is found to be damaged, as the rubber portion of the hose is making contact with the compressor pulley (Figure 1 and Figure 2).

A production issue with the assembly gauge used during assembly of the hose was found. This issue caused the hose to be assembled with an incorrect geometry. As a result, the lie intended to keep the hose away from the air conditioning compressor pulley was compromised.

Figure 1. Point of hose contact with air conditioning compressor pulley.

Replace the damaged refrigerant hose and ensure that the natural lie of the hose is away from the air conditioning compressor pulley. Evacuate and recharge the refrigerant circuit and replace any lost PAG oil that may have been discharged from the system. Failure to maintain the correct total amount of PAG oil in the circuit will lead to premature air conditioning compressor failure.

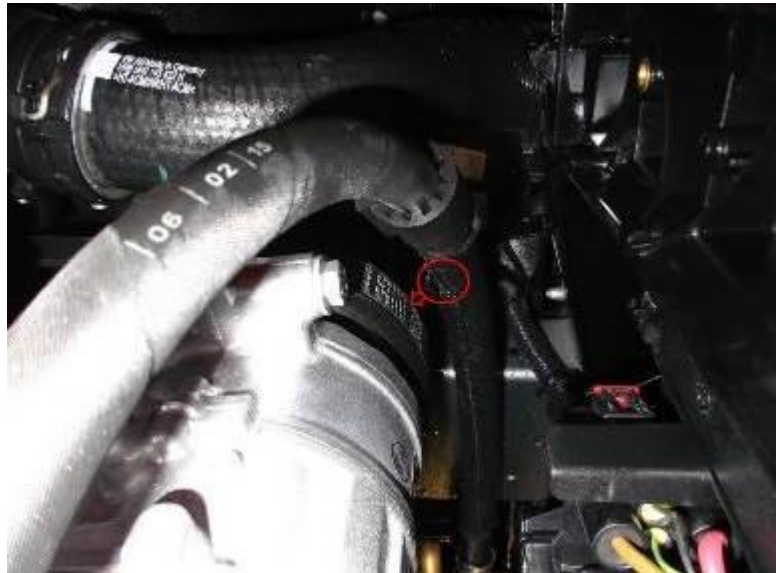
Figure 2. Point of hose contact with air conditioning compressor pulley – rear view.
