Technical Service Bulletin

91 Rearview backup camera is inoperative

91 16 87 2045730/1 November 7, 2016.

Model(s)	Year	VIN Range	Vehicle-Specific Equipment
A3	2013 - 2016	All	Rearview camera

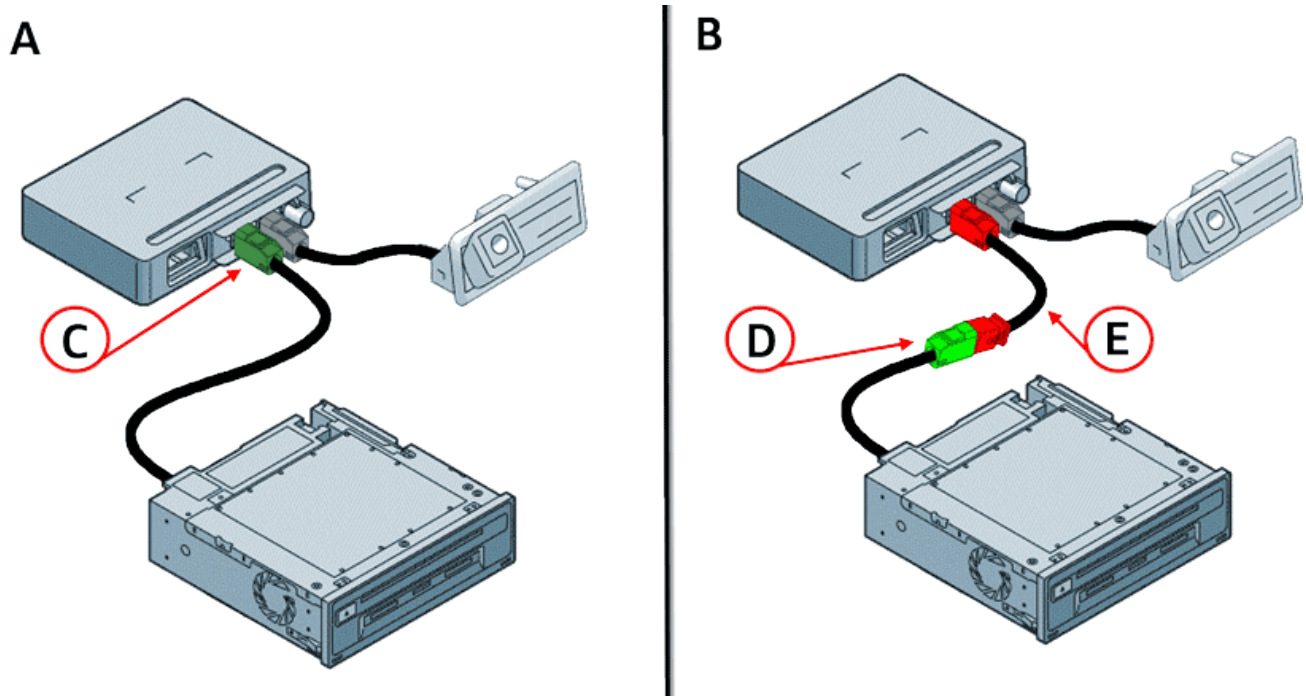
Figure 1. Image A: original reverse camera image wiring configuration. Image B: modified reverse camera wiring configuration. Modified wiring configuration replaces original green Fakra connector (C) by installing aerial plug adapter 000098710A (E). Original harness is modified with the installation of a new female Fakra connector (D).

2. After the concern has been duplicated, and isolated to the Fakra connector at the rearview camera system control module J772 (address word 006C). A replacement of the green 90° Fakra connector must be made:
- Aerial plug adapter 000098710A will need to be installed (Figure 1A, Image E).
 - A female coax terminal will need to be installed on the vehicle harness (Figure 1B, Image D).

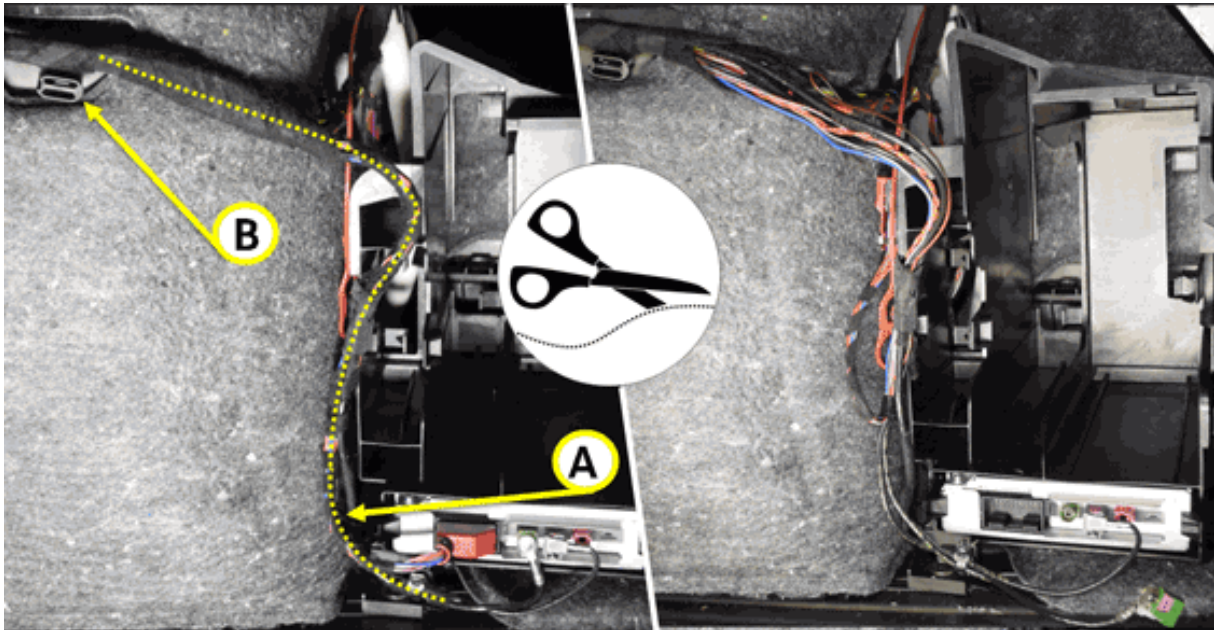
Figure 2. Remove the fleece tape along the body harness (A). Utilize lacing tape cutters, or similar tooling when removing the fleece tape to help ensure that there is no damage to the wire harness. The harness body retainer clip (B) should remain in place to ensure proper harness length during the repair.

3. Gain access to the rearview camera system control module J772 (address word 006C) in the right rear trunk by removing the luggage compartment side trim. Consult the repair manual for instructions.
4. Gain access to the coaxial wire:
- Remove the fleece tape along the body harness (Figure 2, Image A). Be sure to utilize lacing tape cutters, or similar tooling when removing the fleece tape to help ensure that there is no damage to the wiring harness.
 - The harness body retainer clip (Figure 2, Image B) should remain in place to ensure proper harness length during the repair.

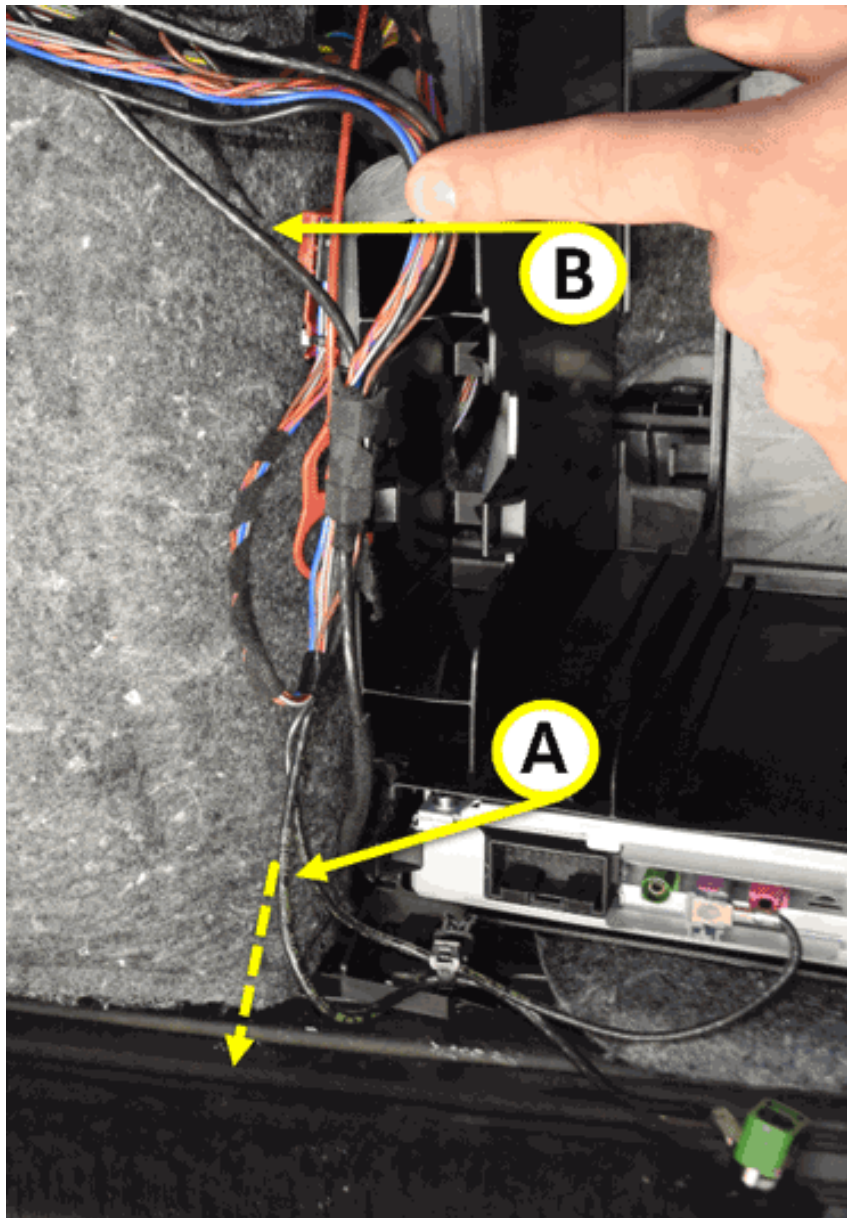
Figure 3. Image A: pull down on the coaxial wire attached to the green Fakra connector, this will apply tension to the upper section of the coaxial wire (B), making it easier to identify.

5. With the wiring exposed, locate the coaxial wire that is attached to the green Fakra connector. Pull down on the coaxial wire attached to the green Fakra connector (Figure 3, Image A), this will apply tension to the upper section of the coaxial wire (Figure 3, Image B), making it easier to identify. Mark this wire for later use, and pull the wire back into place.

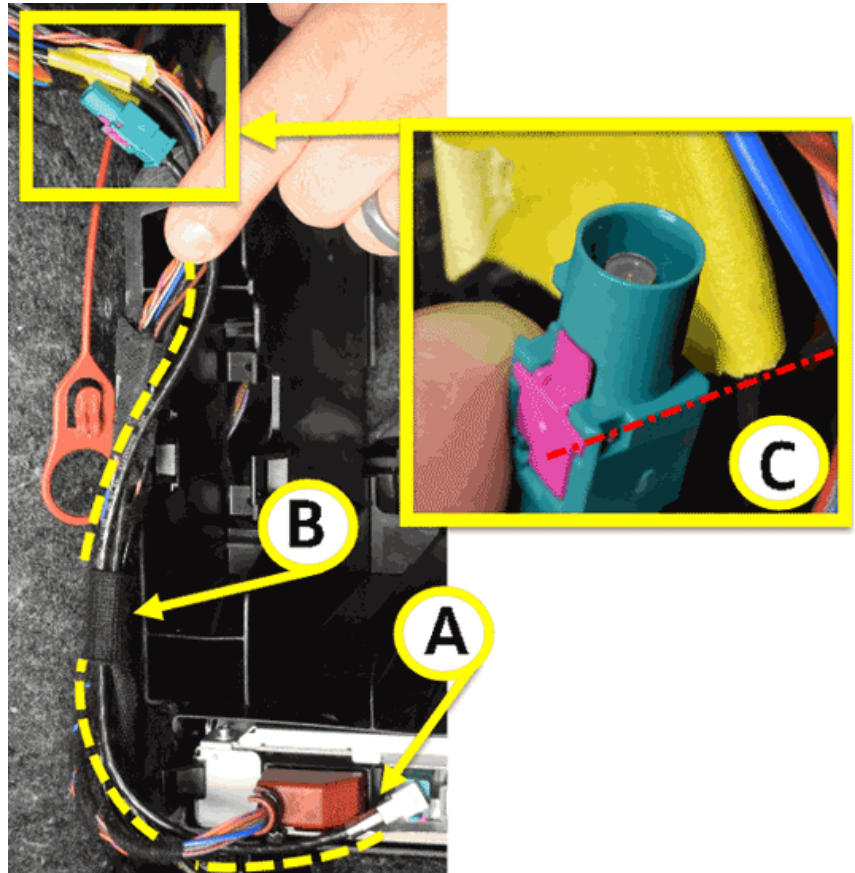
Figure 4. Attach the 90 degree end of the aerial plug adapter 000098710A onto the reversing camera control unit J772, replacing the original green Fakra connector, route the aerial plug adapter along the existing body harness, as shown by the dashed yellow line (Image A). Mark a cut line reference onto the coaxial wire that was identified in step 4. The cut line reference should match up with the aerial plug adapter's lower connecting point (C).

- Attach the 90 degree end of aerial plug adapter 000098710A onto the reversing camera control unit J772, replacing the original green Fakra connector and route along the existing body harness (Figure 4, Image A).
- Secure the aerial plug adapter to the original body harness with a small piece of wrapping tape (Figure 4, Image B).
- Mark a cut line reference onto the coaxial wire identified in Step 4.
- The cut line reference can be marked utilizing tape or permanent marker. The cut line reference should match up with aerial plug adapter's lower connecting point (red dashed line - Figure 4, Image C).
- Confirm that all mounting clips of the body harness are properly secured to the vehicle when marking the cut line to ensure proper harness length.

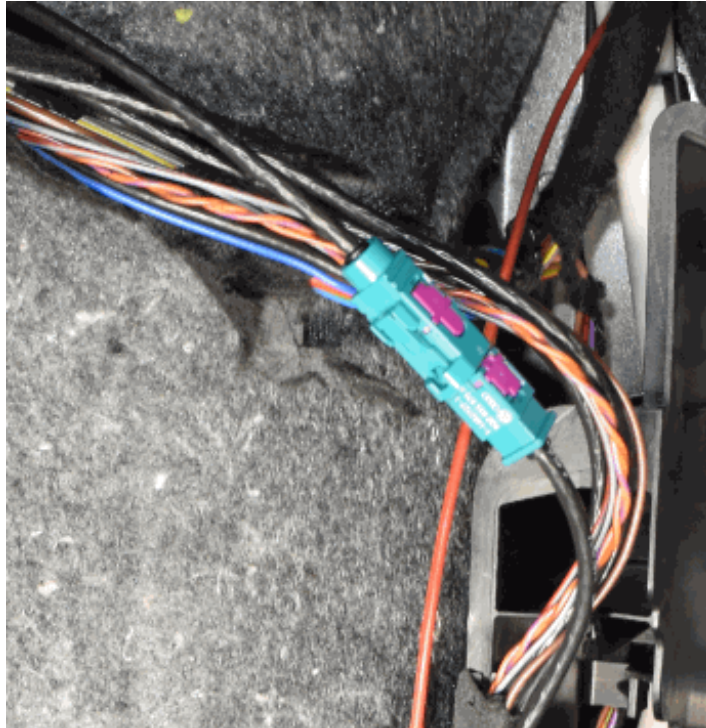
Figure 5. Modified body harness with new female Fakra connector installed, connected to antenna adapter cable.

7. Using the VAS6720 Antenna (Aerial) Cable Repair Set, modify the vehicle side of the coaxial harness by installing the new female Fakra connection and attach it to the antenna adapter cable (Figure 5):

- Cut the coaxial cable at the cut line reference from Step 5.
- Install the new female Fakra connection on the vehicle side of the harness.
