# Technical Service Bulletin

## 91 Navigation, Bluetooth, Smartphone Interface, Voice Recognition, Drive select, ACC, or Cruise Control Not Available

91 16 91 2042506/4 November 17, 2016. Supersedes Technical Service Bulletin Group 91 number 16-64 dated July 26, 2016 for reasons listed below.

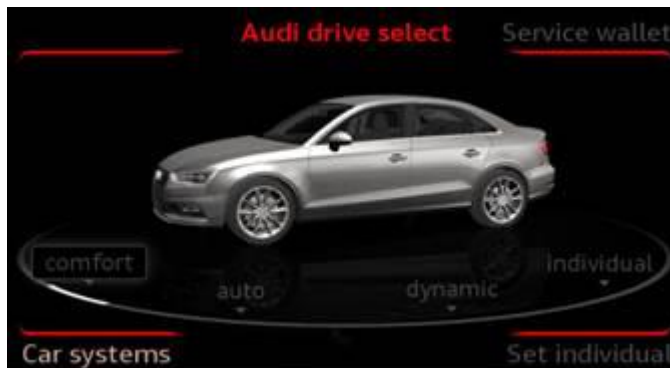
- Audi drive select functions cannot be selected (Figure 1).
- Cruise control does not work (in A3, TT, R8, B9, or Q7 only) and **DTC P161200** (ECM incorrect coding) is stored in one or more of the control units on the Powertrain CAN bus (address word 0003 (ABS)), (address word 0001 (ECM), etc.).
- Navigation is not activated (Figure 2 and Figure 3).
- Bluetooth is unavailable.
- Audi smartphone interface, including CarPlay or Android Auto, is not available.
- Voice recognition is unavailable (in all cars except A3 cabriolet. For A3 cabriolet, see TSB 2038136).

**Figure 1.** Audi drive select functions unavailable and greyed-out.

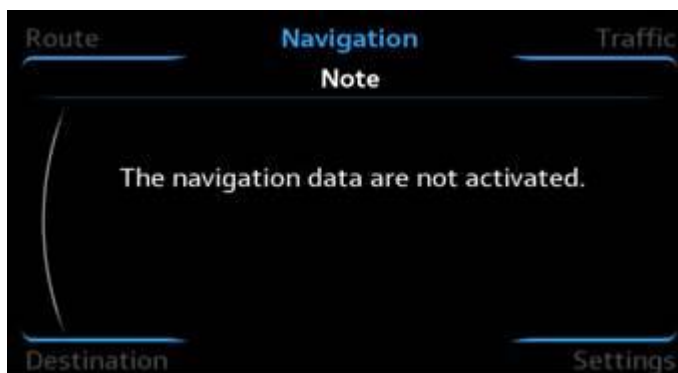
**Figure 2.** Navigation not activated message (Original MIB HMI).

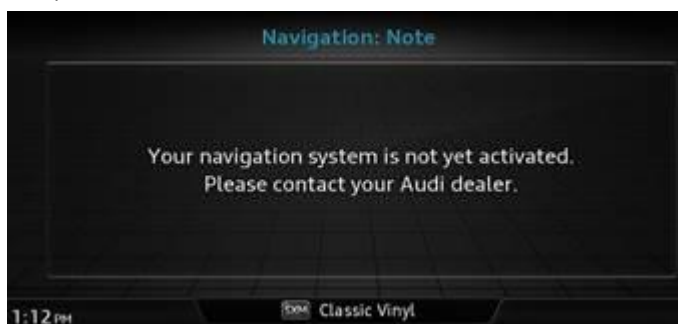
**Figure 3.** Navigation not activated message (New MIB2 HMI).

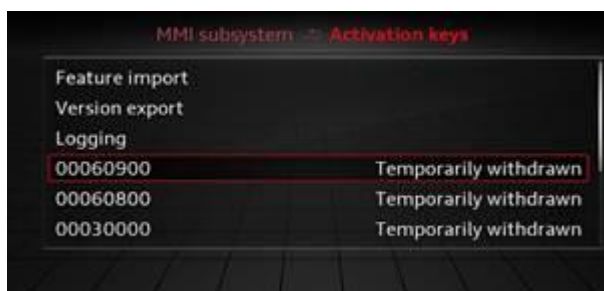
**Temporarily withdrawn or Temp illegal** = This indicates that the SVM activation test plan was not completed (Figure 4). This status is normal for all parts that have been swapped from a different vehicle. Perform the SVM Activations test plan as indicated below, under *Repair Procedure*.

**Figure 4.** Activation keys showing "Temporarily withdrawn."
