Technical Service Bulletin

91 MIB2 High Scale (MMI Radio Plus): SiriusXM is greyed out in MMI and shows "Initializing" when selected

91 16 92 2045047/1 November 17, 2016.

Model(s)	Year	VIN Range	Vehicle-Specific Equipment
A4	2016	All	MMI radio plus without SiriusXM
A4	2017	000001 - 009927	MMI radio plus without SiriusXM

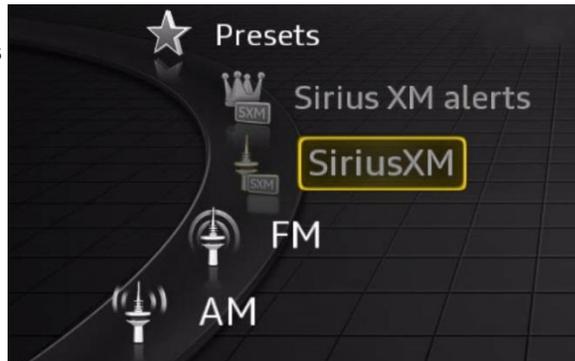
The customer states that the MMI shows a message of "Initializing" when trying to access satellite radio. This occurs after selecting the "greyed out" radio source "SiriusXM" in the band selection (Figure 1). The customer's vehicle has MMI Radio Plus.

Figure 1. SiriusXM option is greyed out.

The MMI Radio Plus software incorrectly lists the band selection of "SiriusXM" when the vehicle is not equipped with the hardware to support this feature. The MMI Radio Plus is also known as the MIB2 High Scale system. It is important to note that some variants of the MIB2 High Scale system do have SiriusXM support, but the B9 A4 Premium package vehicles, which do not have the Convenience package, do not support Satellite Radio.

The service solution is to update the MMI software to SW0081 to remove the SiriusXM from the radio source selections.

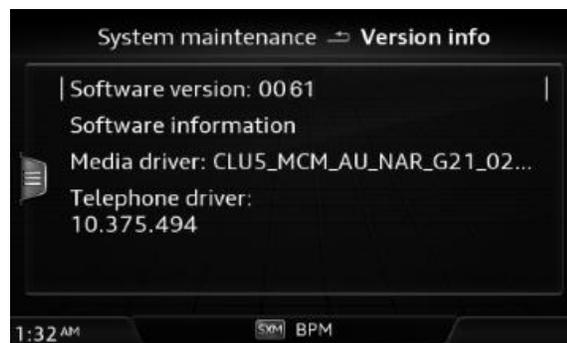
1. Verify the customer's MMI requires the software update by going to the *Main Menu>>Settings>>Left drawer option>>Version Information* (Figure 2).

Software version 0061 is only the version which needs to be updated. If the MMI is at a level greater than 0061 (e.g. 0081, 0110, 0112, or 0118), then this TSB does not apply.

Figure 2. MMI version information.
