Audi  
Truth in Engineering

**Technical Service Webinar**  
November, 2016

# Technical Service Webinar

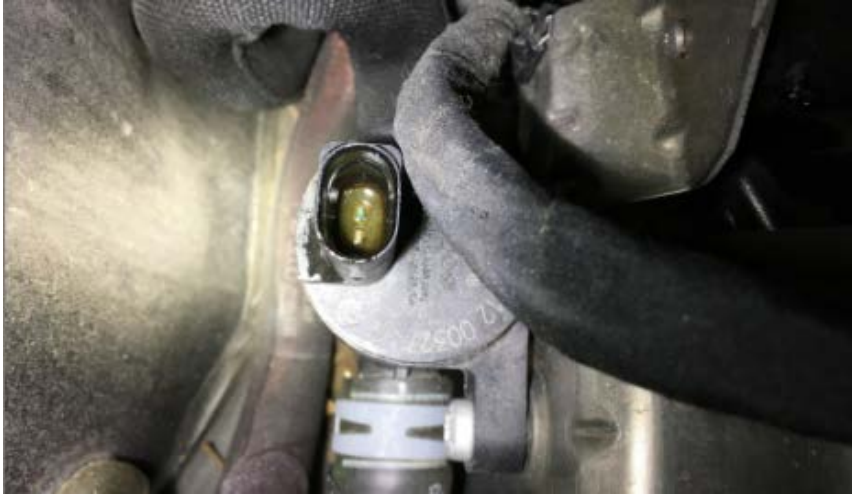
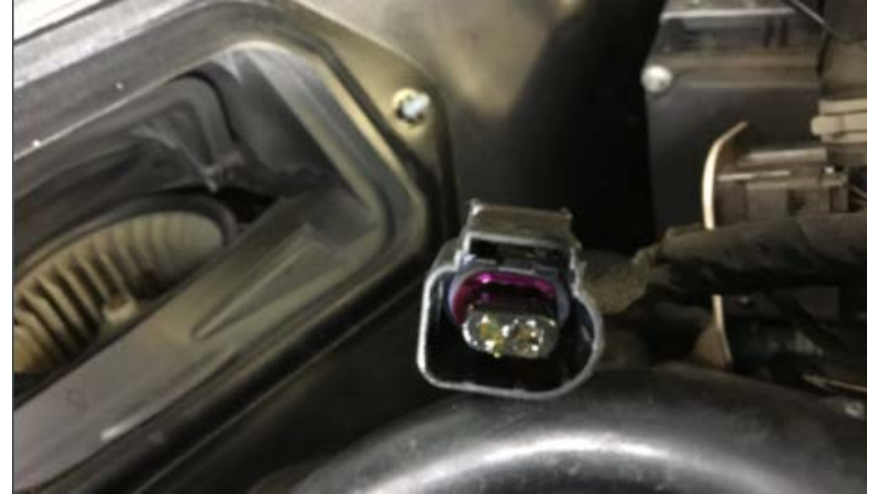
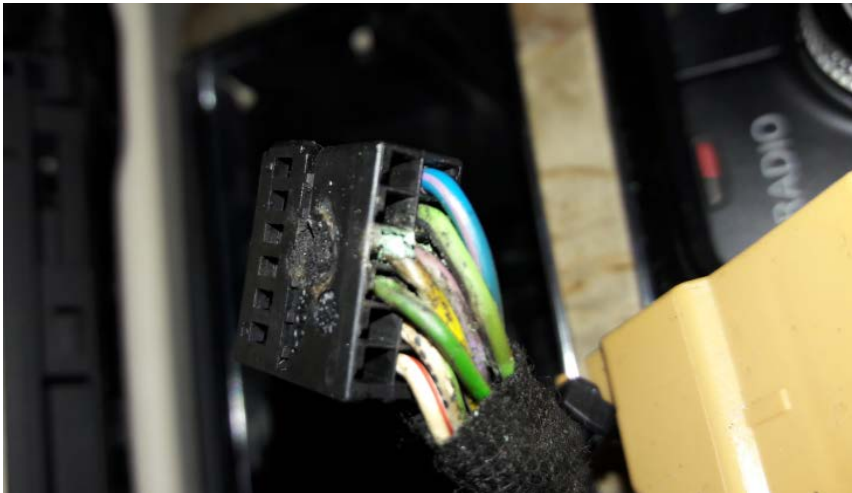
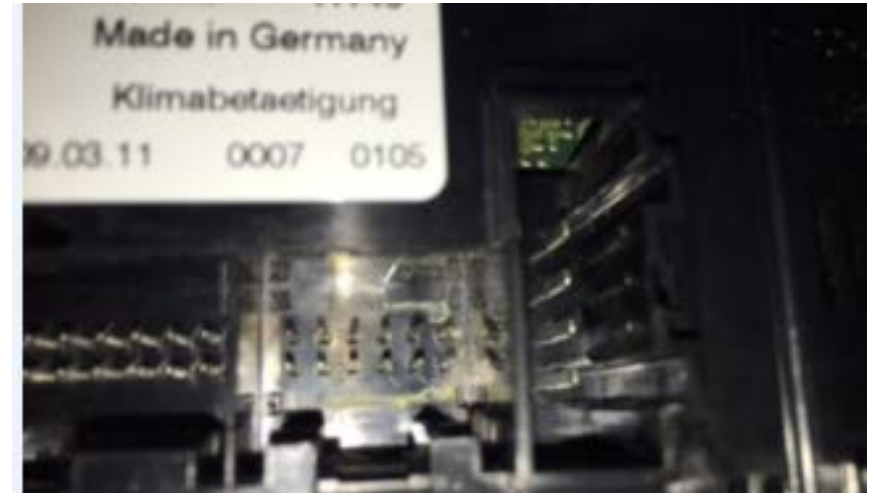
# 80B8 Campaign

On Audi A8 vehicles without auxiliary heating manufactured within a specific period, the coolant shut-off valve N82 may sporadically stick. If this happens, the heating output of the air conditioner will be reduced.

Inspect the N82 valve and valve connector

- If coolant ingress is not found at N82, follow the campaign instructions.
- If coolant ingress is found in the N82 connector, inspect plug connections at J255
- If coolant is found at J255, replace the N82, N82 connector, J255, associated pins and wiring
- If coolant ingress is found at N82 but not at J255, replace N82, connector and wiring back to the J255

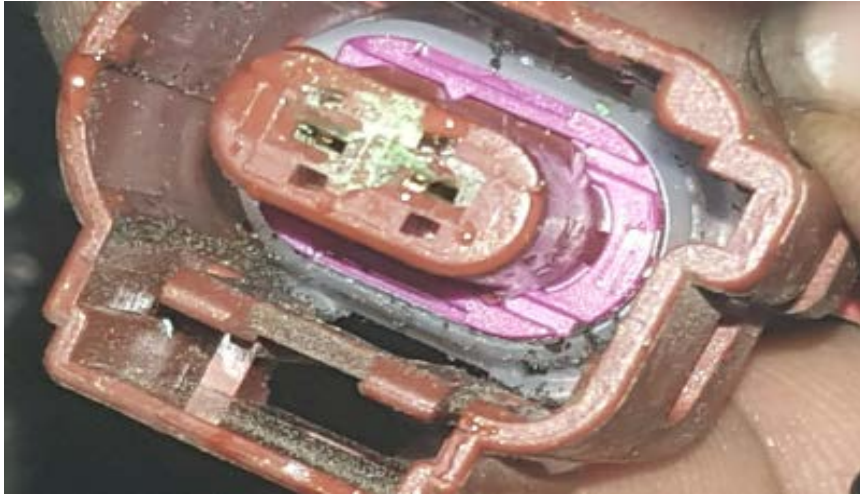
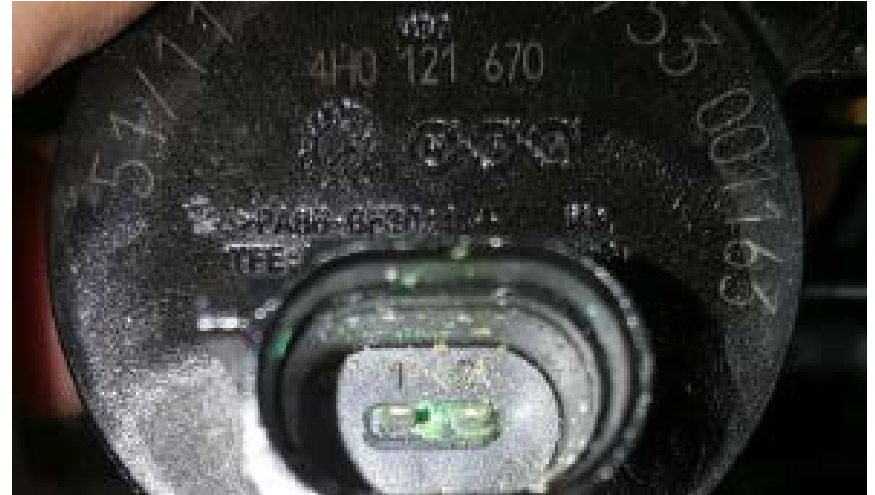
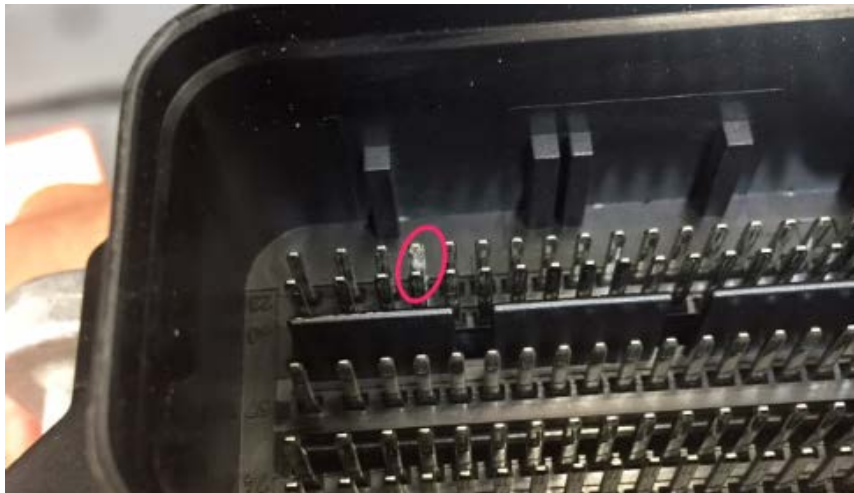
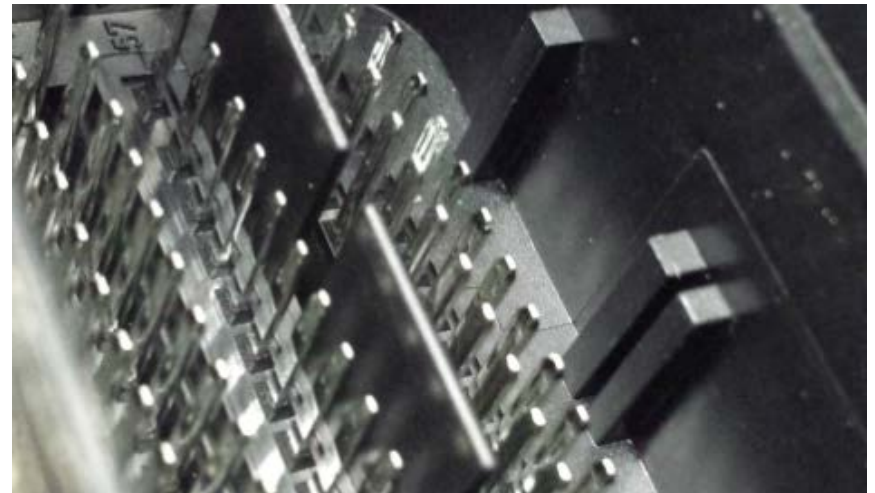
# 80B9 Campaign

Over time, it is possible for coolant to leak through a coolant valve wire connection, causing coolant migration into the engine control module. If this happens, it can cause a short circuit, placing the vehicle into "limp-home mode," or possibly even cause a stall without warning. Stalling can lead to a vehicle crash.

Replace affected coolant valve and inspect for coolant leaking through the valve electrical connector.

- TAC case not required unless coolant is found in the connector
- Inspect the N488 valve and connector for coolant and/or corrosion
- If coolant is present **-STOP-** and take a picture of the N488 harness connector and create a technical assistance case for further direction of repair.
- If coolant is not present then complete the repair outlined in the campaign.

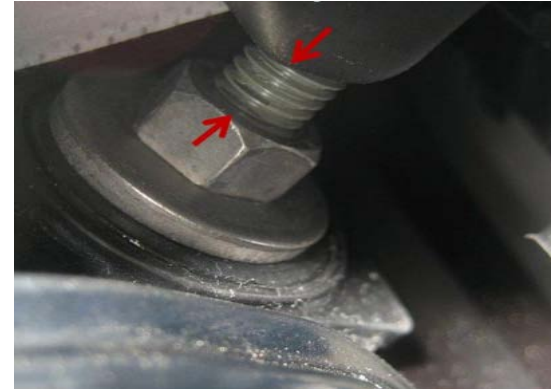
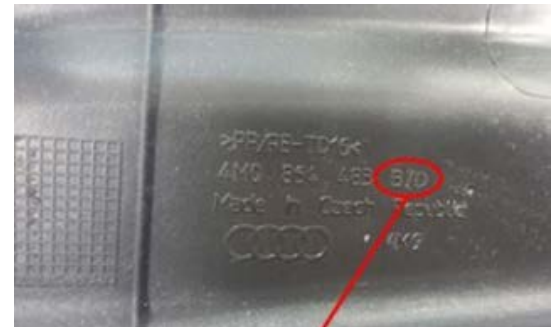
Perform a visual inspection of the clearance between the latch striker mounting studs to the lock carrier trim. If the lock carrier trim is correctly installed, there should be no more than five threads visible between the head of the nut and the lock carrier trim. If more than 5 are present it is possible that the trim carrier is being pushed upwards thus moving the sensors out of position, installation of the striker should then be checked.

Inspect the inside of the trim for the part number index and version, replace if the older version is found or the part is physically damaged.

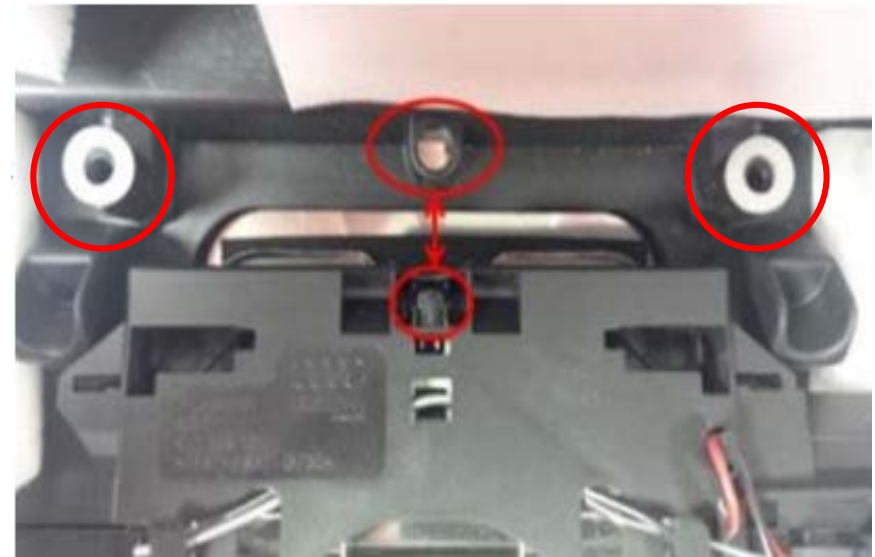
Inspect the installation of the sensor assembly to the trim panel.

Ensure the washers are installed between the sensor assembly and the trim panel.  
(washer part number N 912 006 01)

Ensure the sensor assembly fits correctly at the screw points and the indexing pin is fit inside the locating hole on the trim panel.

Incorrect installation of the trim to the body or the sensor assembly to the trim panel can cause incorrect readings from the Rear Lid Closed sensors.

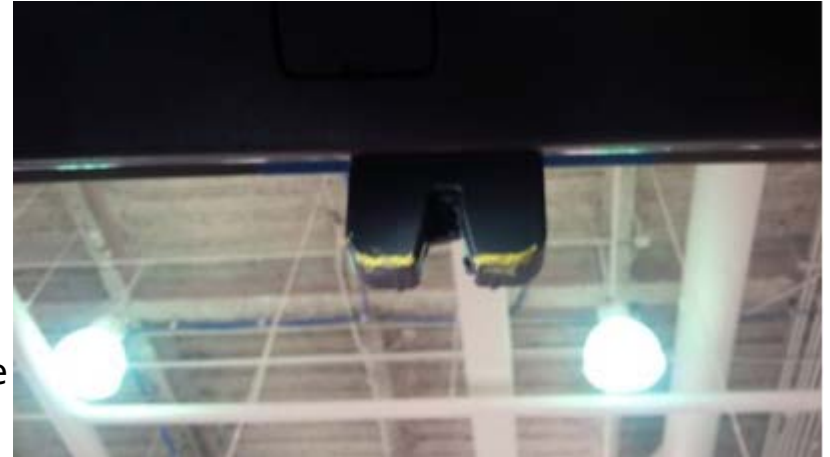
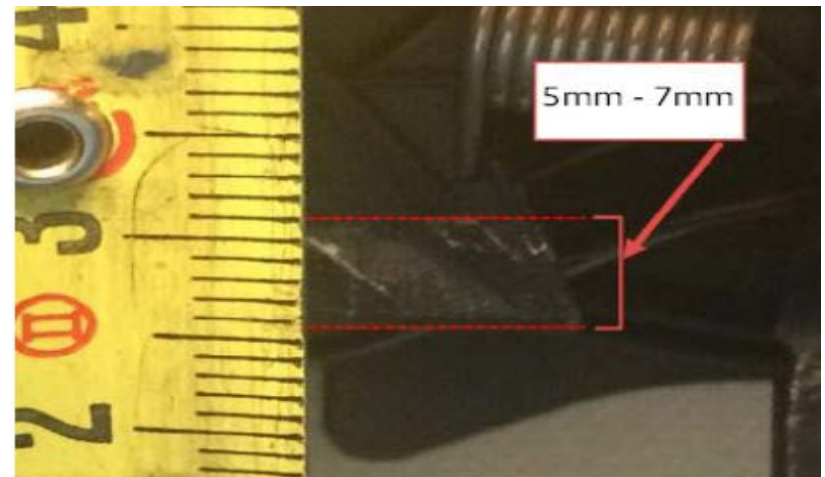
- Apply a marking medium on the inner edge of the Rear Lid Latch.
- Close the rear lid normally, then open it normally. This will allow a mark to be transferred to the paddle surfaces.
- Measure the width of the mark transferred to the paddles. The ideal width is 6mm +/- 1mm.
- If this dimension is achieved, no further work is necessary.
- If the Rear Lid Latch angle is out of adjustment the contact width will be approximately 4mm or less. If this is the case, the Rear Lid Latch angle will need to be adjusted inward for higher contact with the paddles.

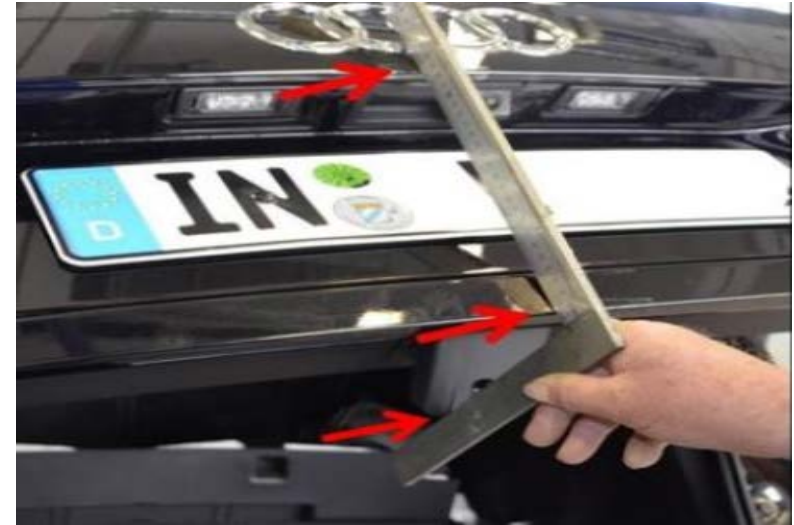
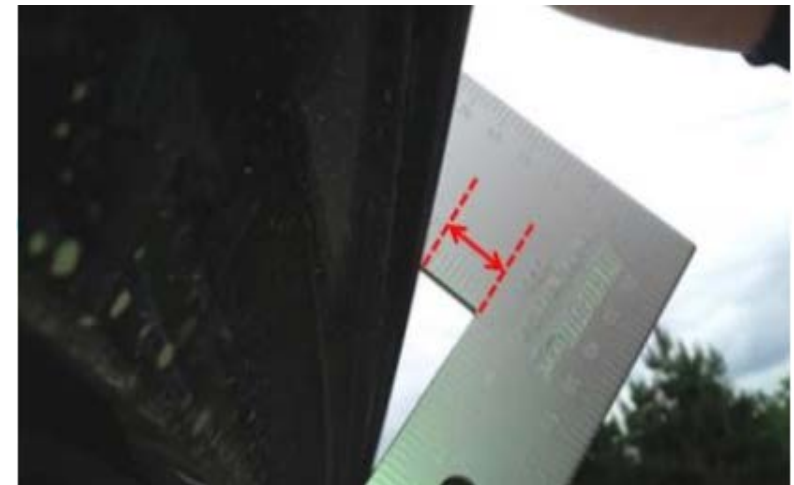
- Source a carpenter's square with metric graduation.
- Apply a small piece of tape to the areas that will come in contact with the square to protect the paint. Apply the square to the three points on the rear lid shown in the illustration.
- The lower axis of the square must contact the lug of the rear lid latch
- The gap between the lower edge of the rear lid and the square should ideally be 15mm +/- 1mm.

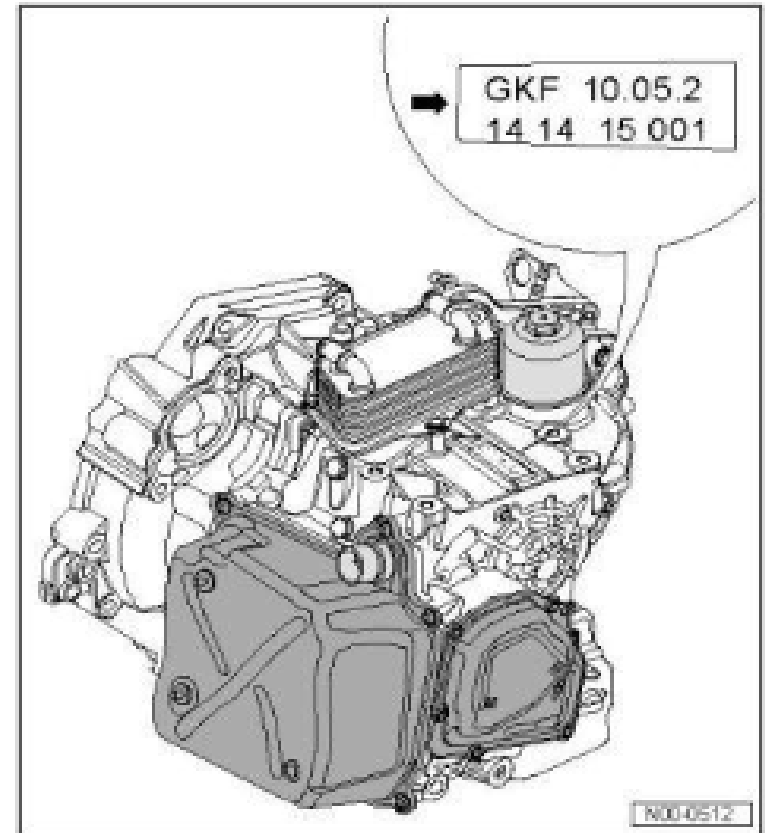
**Figure 1.** The location of the 3-letter gearbox code. In this example, “GKF” is the 3-letter gearbox code.
