Subject: ParkSmart HVAC Modules

Models Affected: Specific Freightliner Cascadia vehicles manufactured March 25, 2014, through November 9, 2015 and equipped with a certain ParkSmart Auxiliary HVAC system.

June 2016
FL703A
NHTSA #16V-143
Transport Canada #16-113
REVISED NOTICE

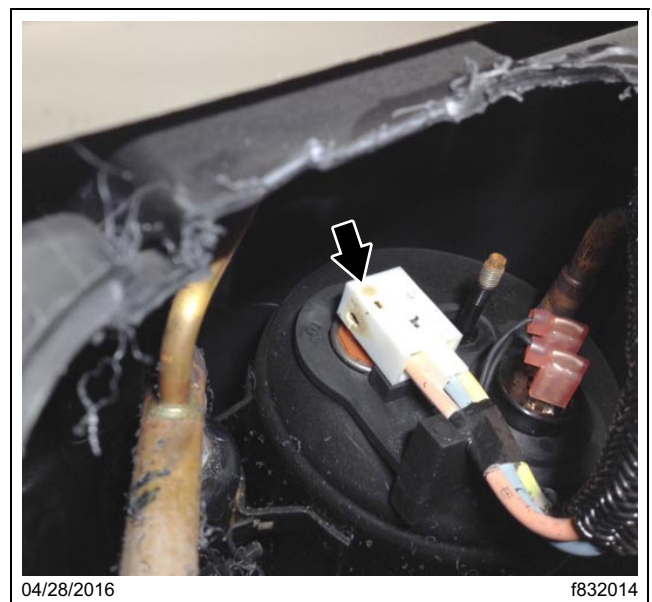
Fig. 8, Yellow Discoloration and Melting of the Block Connector

14. Using a mirror as needed, inspect all sides of the block connector for evidence of heat damage such as discoloration and/or melting. See **Fig. 8**.

If the block connector shows evidence of heat damage, go to "Compressor Harness Replacement" on page 12 of these work instructions.

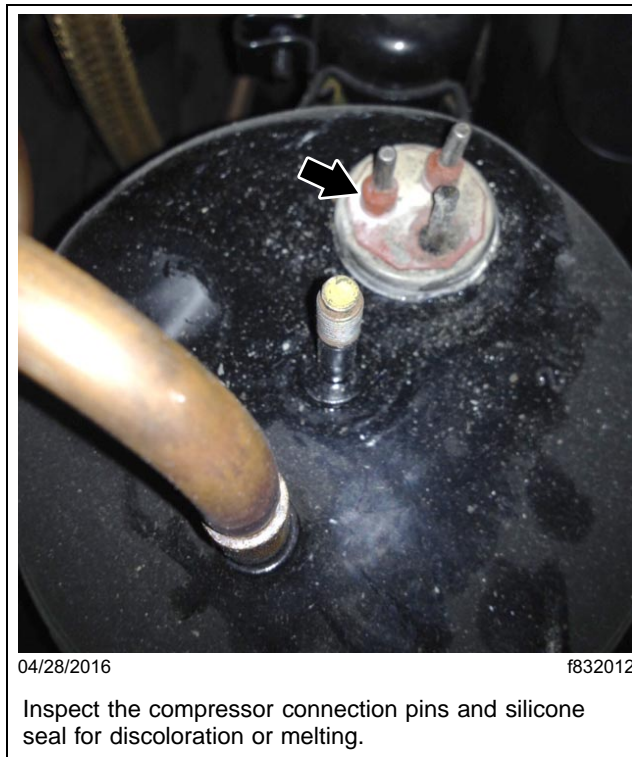
Fig. 11, Melted Silicone Insulator and Compressor Pin Damage

3. Disconnect the harness block connector from the compressor.
4. Clean up any debris around the pins, and use alcohol wipes to clean the pins.
5. Inspect the compressor connection pins and surrounding orange silicone insulator. See **Fig. 11**.

If the orange silicone insulator around the compressor connection pins shows evidence of heat damage, go to "Refrigerant Loop Assembly Replacement" on page 16 of these work instructions.
