GLOBAL SAFETY FIELD INVESTIGATIONS
DCS4217
URGENT - DISTRIBUTE IMMEDIATELY

Subject: 16069 - Customer Satisfaction Program
Rear Prop Shaft Not Fully Seated

Models: 2017 Buick LaCrosse
Equipped with All-Wheel Drive (AWD) (RPO F46)

Reference Number: N16207106

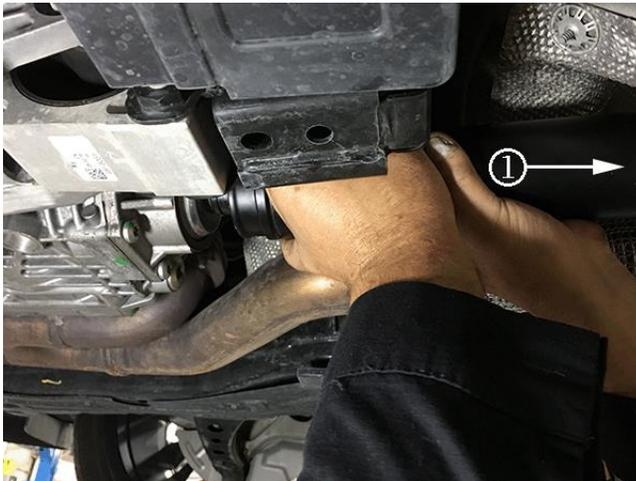
4600427

The prop shaft spline may NOT have been fully seated in the power transfer unit (PTU) output shaft or rear differential carrier assembly shaft during vehicle assembly. The end spline of the PTU and rear differential carrier assembly has C-clip that seats within PTU or rear differential carrier assembly interface. Perform a prop shaft retention check at the PTU and rear differential carrier assembly locations to ensure the prop shaft is fully seated.

3. Place your hands around the propeller shaft tube just behind the interface and push away from the PTU, (1) on the propeller shaft tube without using leverage or body weight. The intention is to check that the retaining ring has snapped into position.
 - If there is no prop shaft movement, the retaining ring is snapped into position and the prop shaft is installed correctly at this location. No further action is required at the PTU location. Proceed to step 6.

- If there is prop shaft movement, the retaining ring is NOT snapped into position and the prop shaft is installed incorrectly at this location. Proceed to step 4.
4. Using your hands, push the prop shaft forward toward the front of the vehicle until the PTU output shaft is fully engaged into the spline of the prop shaft. The retention ring will snap into position when the prop shaft is installed properly.
 5. Ensure the prop shaft is installed properly at the PTU location by placing your hands around the propeller shaft tube just behind the interface and pulling away from the PTU on the propeller shaft tube without using leverage or body weight. No prop shaft movement should be detected.
 6. Locate where the prop shaft connects to the rear differential carrier assembly.
