Service Update

31170 Rear Suspension Shackle Bolt Contacts HVAC Line

Reference Number: N16203117

Release Date: October 2016
Revision: 00

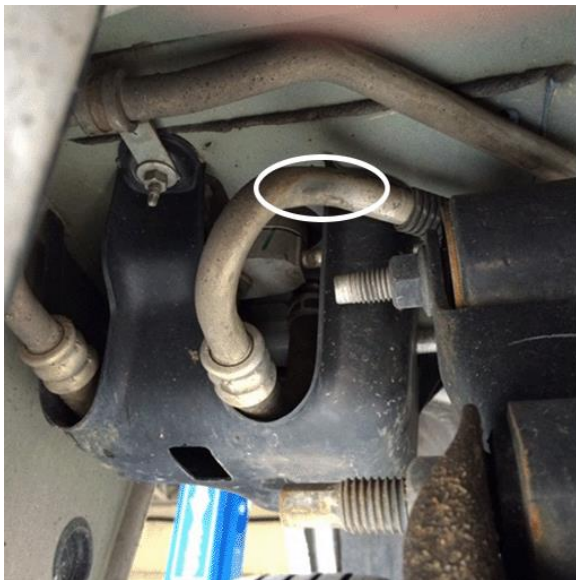
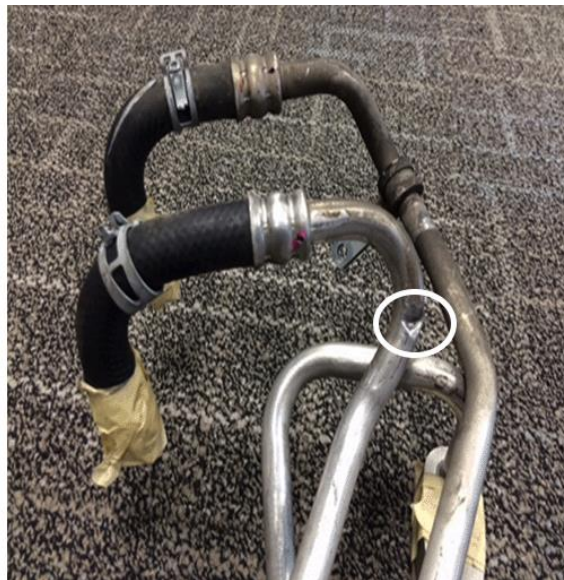
4593757

Note: If there are any signs of damage to the auxiliary heater hose or evidence of the auxiliary heater hose contacting the spring shackle to leaf spring mounting bolt, the auxiliary heater hose **MUST** be replaced.

8. Inspect the auxiliary heater hose for any signs of damage or evidence of the auxiliary heater hose contacting the spring shackle to leaf spring mounting bolt.
 - If there are **NOT** any signs of damage to the auxiliary heater hose or evidence of the auxiliary heater hose contacting the spring shackle to leaf spring mounting bolt, no further action is required.
 - If there are any signs of damage to the auxiliary heater hose or evidence of the auxiliary heater hose contacting the spring shackle to leaf spring mounting bolt, replace the auxiliary air conditioning evaporator hose or auxiliary
