| <b>Countries:</b> | BAHAMAS, BOLIVIA, BRAZIL, BELIZE, CANADA, CHILE, COLOMBIA, COSTA RICA, DOMINICAN REPUBLIC, ECUADOR, EL SALVADOR, TRINIDAD AND TOBAGO, UNITED STATES, URUGUAY, VENEZUELA, MEXICO, ARUBA, NICARAGUA, PERU, PUERTO RICO, Curaçao, GUATEMALA, GUYANA, HAITI, HONDURAS, JAMAICA, PANAMA | <b>Document ID:</b> | IK0800522 |

**Title:** Repair Information for Damaged Headlight Connector

**Applies To:** Certain DuraStar, CE / BE Bus, WorkStar, 1300, TranStar

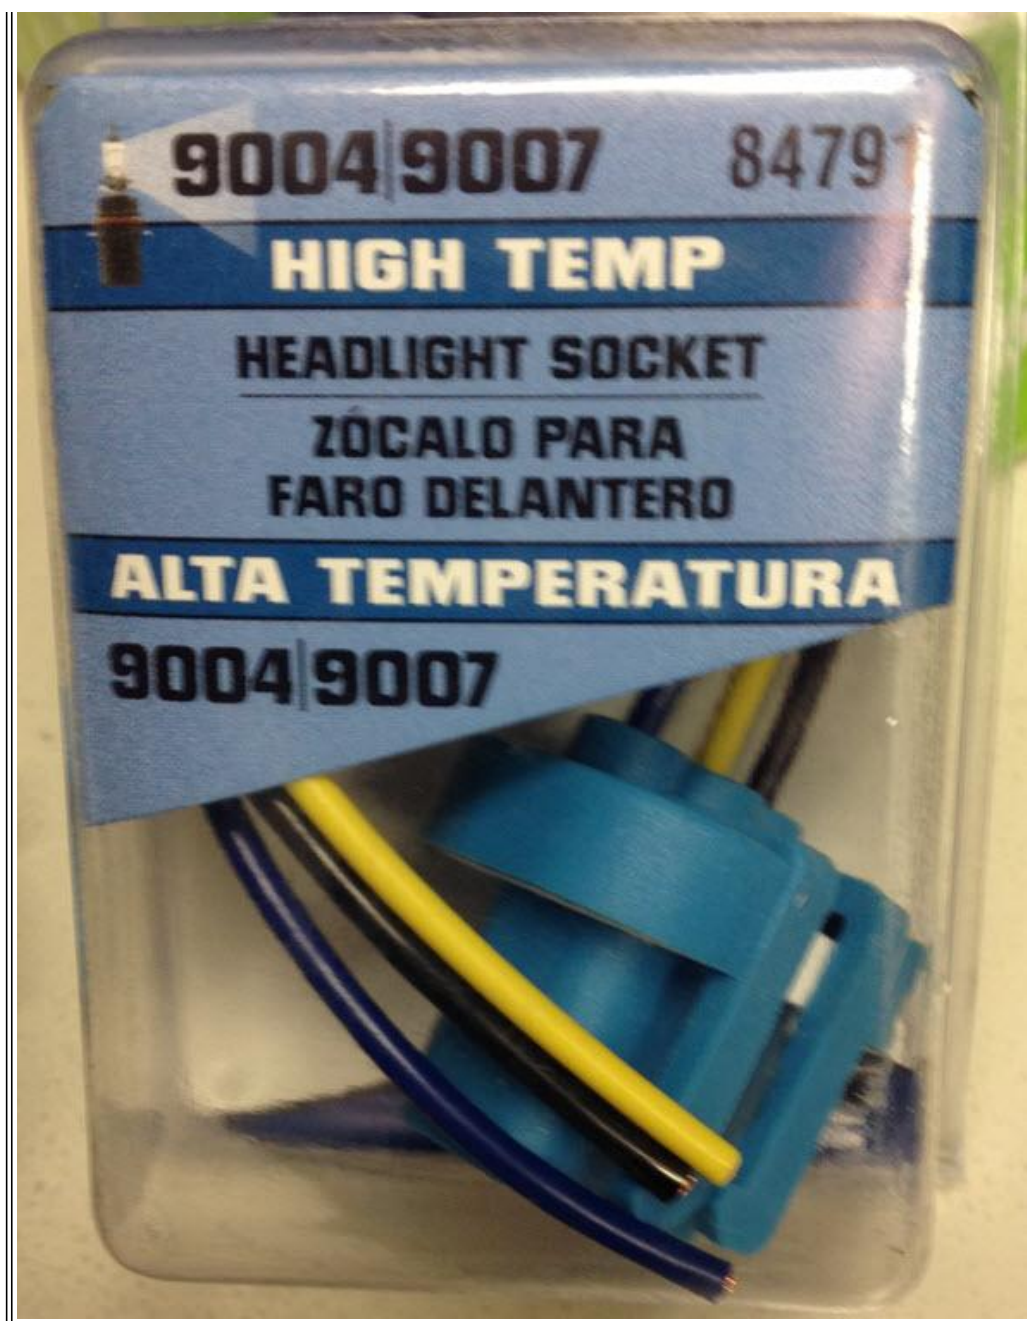
**Figure 1**

| Kit Description | Part Number | Quantity Required | Notes |
|---|---|---|---|
| Dorman Light Bulb Socket 84791 | 84791 | 1-2 | Must be "High Temp"<br>*Obtain Locally (Figure 1 below) |

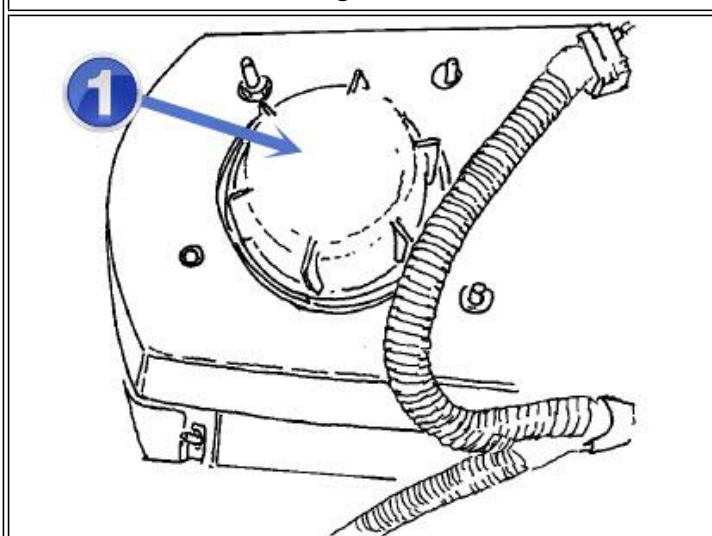
**Figure 3**

1. Headlight Socket Cover

1. To inspect the headlight connector, unlatch hood on both sides and tilt hood forward.
2. Locate the rear side of the headlight housing.
3. Turn the socket cover and remove. See Figure 3 below.

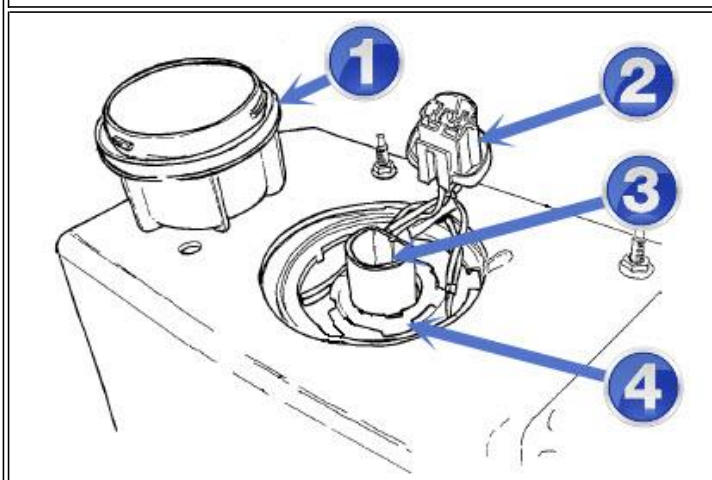
**Figure 4**

1. Headlight Socket Cover  
 2. Headlight Socket Pigtail Plug  
 3. Headlight  
 4. Headlight Retaining Bezel

4. Remove light socket pigtail plug. See Figure 4 Item 2 below.

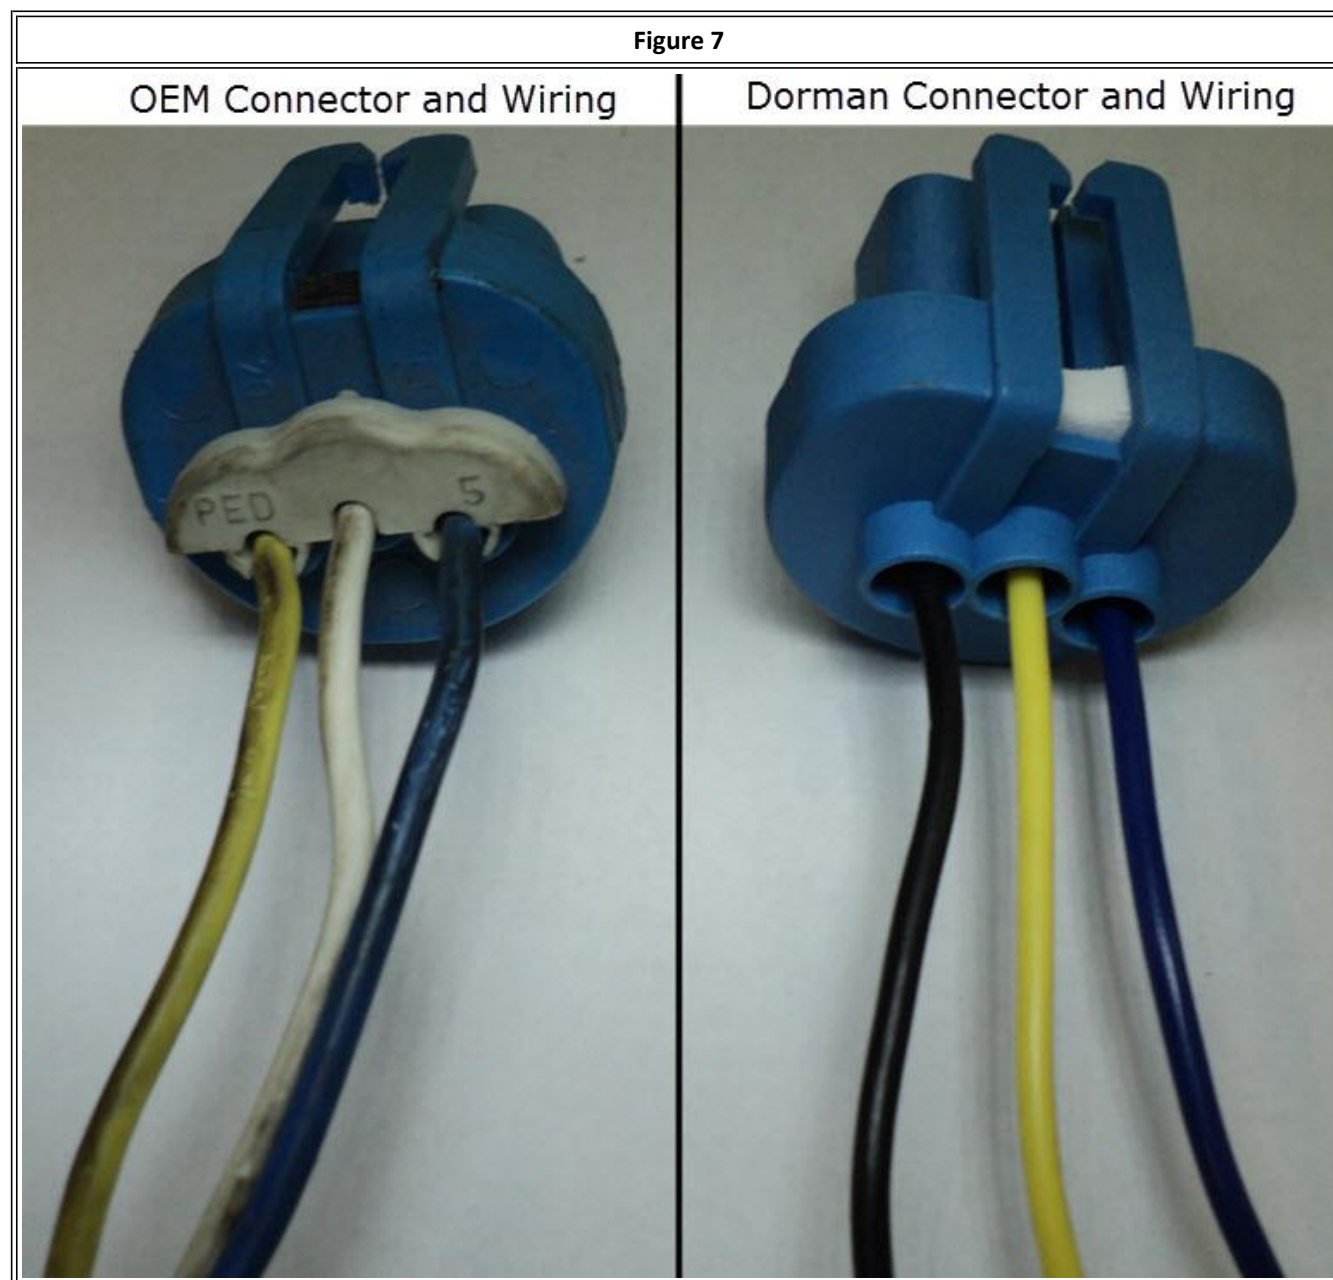
The wire color orientation is not the same between the OEM connector and the Dorman connector with pigtail. To maintain the proper wire color orientation, you can de-pin and swap the locations of the yellow and black wires on the replacement Dorman connector. See Figure 7 below.

Replace the damaged connector with the Dorman 84791 High Temperature Socket Pigtail. Replace the headlight bulb if damage is present. It is recommended to replace the headlight bulb in pairs.
