## FIELD SERVICE CAMPAIGN – 16123

20 October 2016

Bus Door Rework – Add Backup Plate to Stop Tab

CE Bus, RE Bus

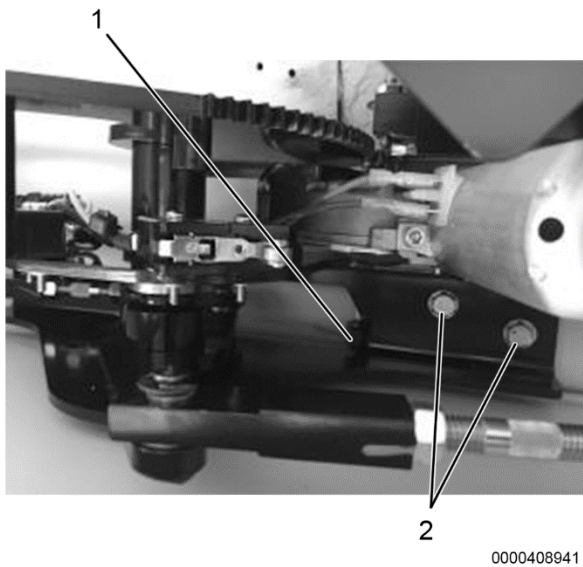
**Figure 2. Stop Tab**

On certain bus models, the mechanical door stop may bend out of position resulting in over travel limit switch allowing continuous running of the electric motor.

1. Tab
  2. Bolt (2)
7. Rotate entry doors to about halfway closed. This will allow clearance between bell crank and stop tab (Figure 2, Item 1).
  8. Inspect door module mechanism to determine if Support Bracket (Figure 3, Item 2) has already been installed.
    - a. If bracket is present, proceed to Step 14.
    - b. If bracket is not present, proceed to Step 9.
  9. Using an adjustable wrench, bend stop tab back to approximately 11 degrees from perpendicular.
  10. Remove two bolts (Figure 2, Item 2) on right side of door module. Save fasteners for reuse.
