## FIELD SERVICE CAMPAIGN – 16126

26 October 2016

HX™ Bluetooth Microphone Inoperative

HX™ Series

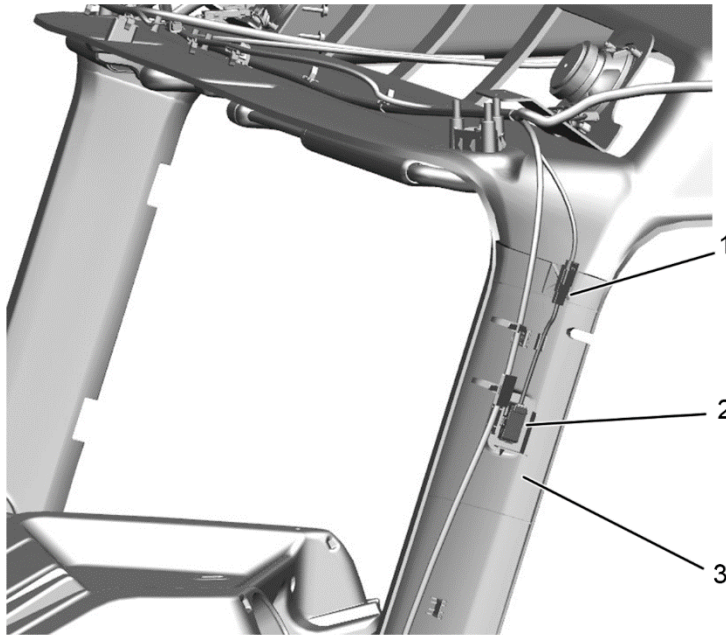
**Figure 1. Exterior Driver-Side View (Metal Body Panels Hidden / Transparent)**

The wiring harness for the Bluetooth microphone on certain HX™ units may have been assembled incorrectly, resulting in the microphone not functioning.

1. Bluetooth microphone connector
  2. Bluetooth microphone
  3. A-pillar trim
5. Remove driver-side A-pillar trim (Figure 1, Item 3). Locate Bluetooth microphone connector (Figure 1, Item 1).
  6. Disconnect upper (female) portion of connector from lower (male) portion.
