## FIELD SERVICE CAMPAIGN – 16129

14 October 2016

HX™ Series Front Turn Signals

HX™ Series

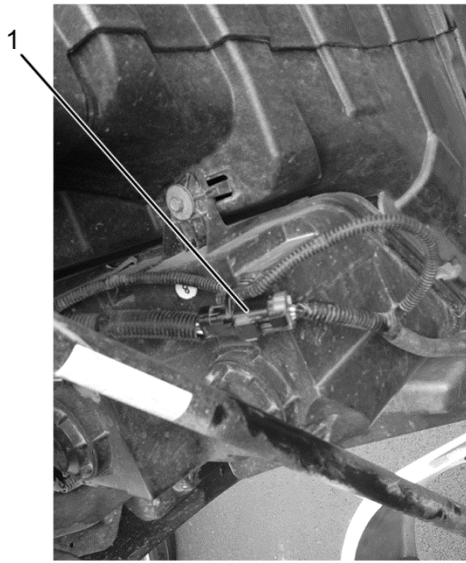
**Figure 1. Headlight and Turn Signal Main Harness Connector**

On certain HX™ Series vehicles, built between 08 December 2016 and 24 August 2016, when operating in extreme heat with the headlights on and when either turn signal is activated, the front turn signal may stop flashing and remain on steady.

1. Connector
5. Access operator-side headlight harness. Disconnect harness connector (Figure 1, Item 1).
6. Install jumper harness into both sides of connector. Ensure secondary locks are secure.
7. Using cable wire tie, secure jumper harness to main hood harness.
8. Repeat Steps 5 through 7 on passenger side of vehicle.
9. Close and latch hood.
10. Remove wheel chocks.
