NUMBER: 12-207-16

SERVICE BULLETIN

APPLICABILITY: 2012-2017MY Impreza Models

SUBJECT: Production Change to Rear Door Glass Assembly

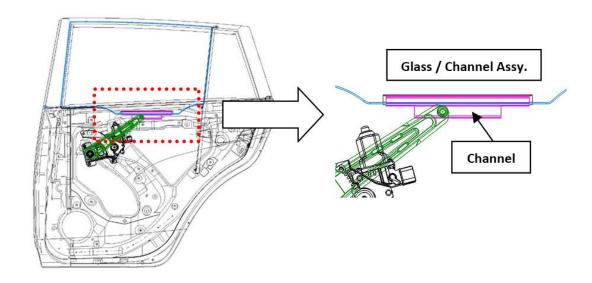
This bulletin announces a change to the procedure used in production of the rear door glass assembly. The bottom edge of the door glass is pressed into a metal channel lined with rubber. The channel attaches the door glass assembly to the window regulator. In below-freezing temperature conditions, water freezing in the channel combined with the door glass sticking to the door weatherstrip can increase chance of the glass separating from the channel when attempting to operate (lower) the window. A lubricant has been added to the rubber portion to insure the glass gets fully seated during assembly which maximizes the clamping force of the channel on the glass.
