## SERVICE BULLETIN

**APPLICABILITY:** 2012-16MY Impreza 2.0L Models  
 2015MY-2017MY WRX and STI Models

**SUBJECT:** Rattling Sound from Rear Package Shelf Area

**NUMBER:** 12-189-15R  
**DATE:** 09/23/15  
**REVISED:** 09/22/16

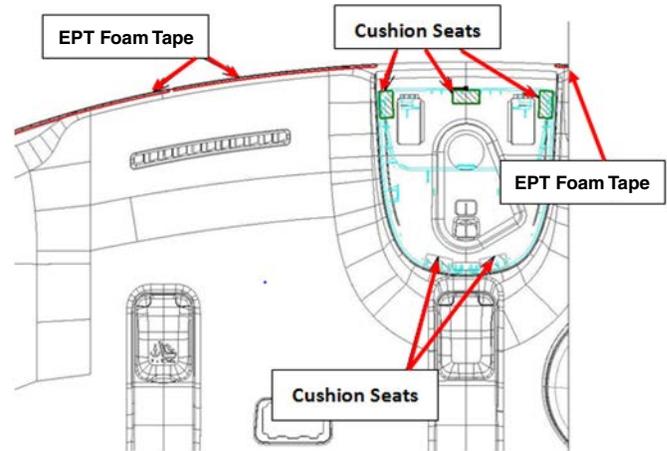
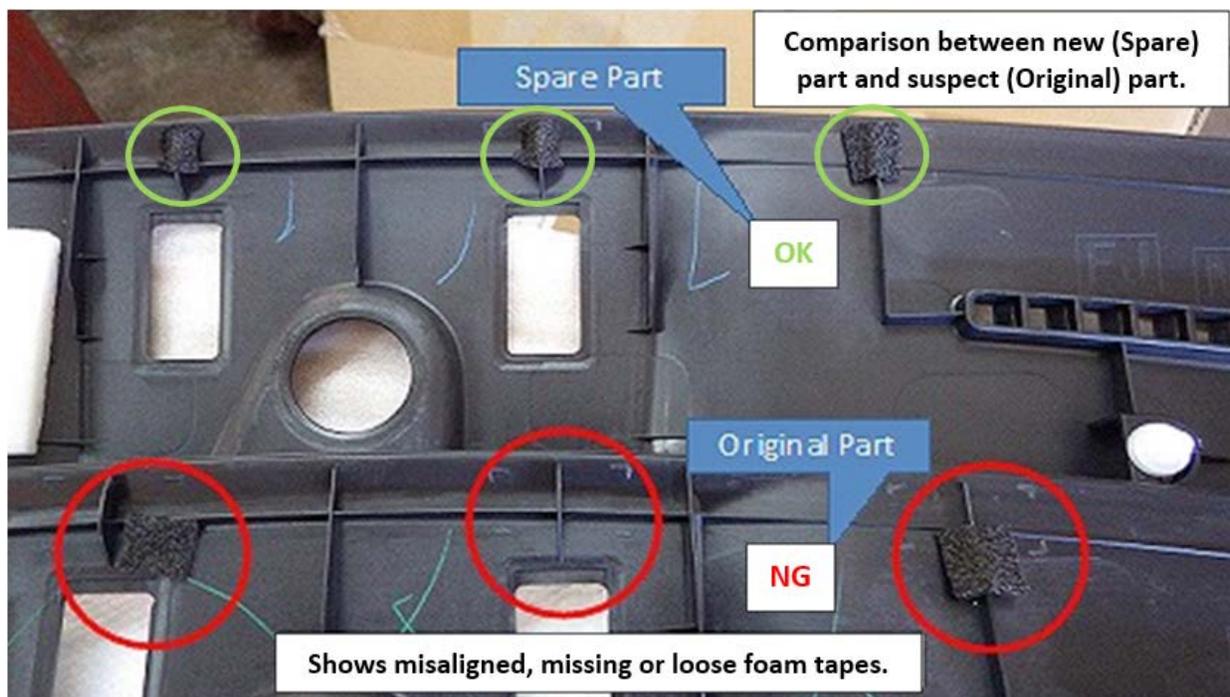
The changes made to the new shelves include:

- addition of 5 non-woven tape “cushion seats” in the area of the center stop lamp
- EPT foam tape added along the rear edge of the shelf to insulate it from contacting the rear glass.
- EPT foam tape added to the ribs and stands which are molded into the underside of the package shelf to insulate them from the vehicle body.
