## SERVICE PROGRAM BULLETIN

**APPLICABILITY:** 2015 MY WRX 2.0L DIT Models  
 2014-2015 MY Forester 2.0L DIT Models  
**SUBJECT:** Engine Control Module (ECM)  
 Reprogramming

**NUMBER:** WQW-58R  
**DATE:** February 10, 2016  
**REVISED:** September 27, 2016

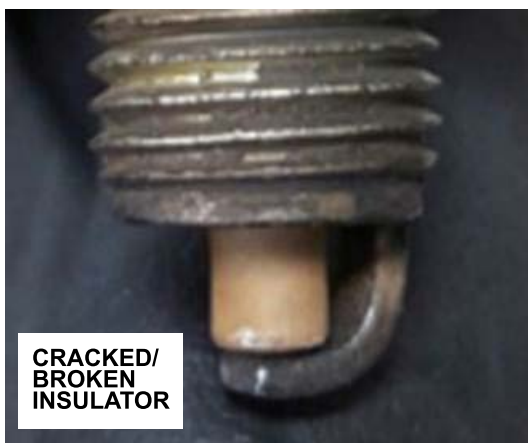
**Step 4:** Remove and inspect the spark plugs closely for any damage, erosion or melting. Inspect, rotate, turn upside-down and shake each spark plug to check for a cracked or loose porcelain insulator around the center electrode. Take note which cylinder(s) have spark plugs with verified damage and mark each plug, damaged or not, with the corresponding cylinder number.

**NOTE:** Any damage to the spark plug porcelain outside of the cylinder head is not a result of this condition.

- If the inspections performed in **Step 4** above revealed spark plug damage, the engine assembly must be replaced (refer to Part 3 of Flow Chart) following the procedure in the applicable Service Manual.
