SERVICE PROGRAM

APPLICABILITY: 2017 MY Subaru Forester (non-Turbo) with CVT **NUMBERS:** WTJ-70

SUBJECT: Service Campaign – Forester CVT Low Fluid Level **DATE:** 09/1/16

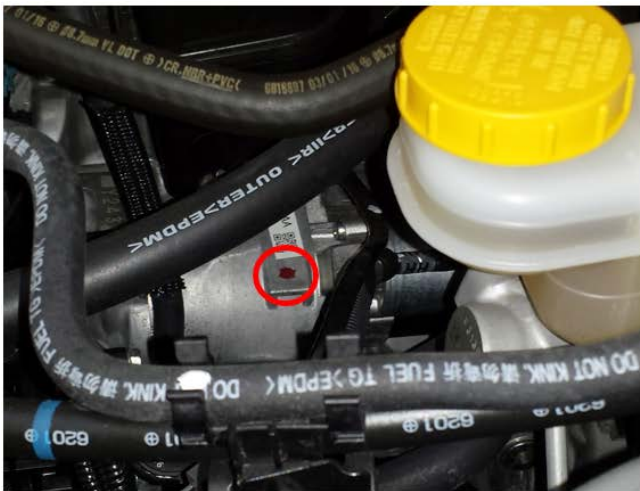
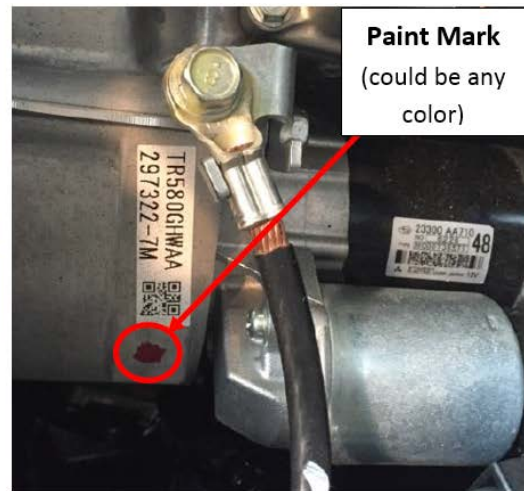
- If you find a paint mark in this area, this procedure has already been completed. **STOP.** No further action is required.
- If there is not a paint mark, proceed with the balance of this bulletin.

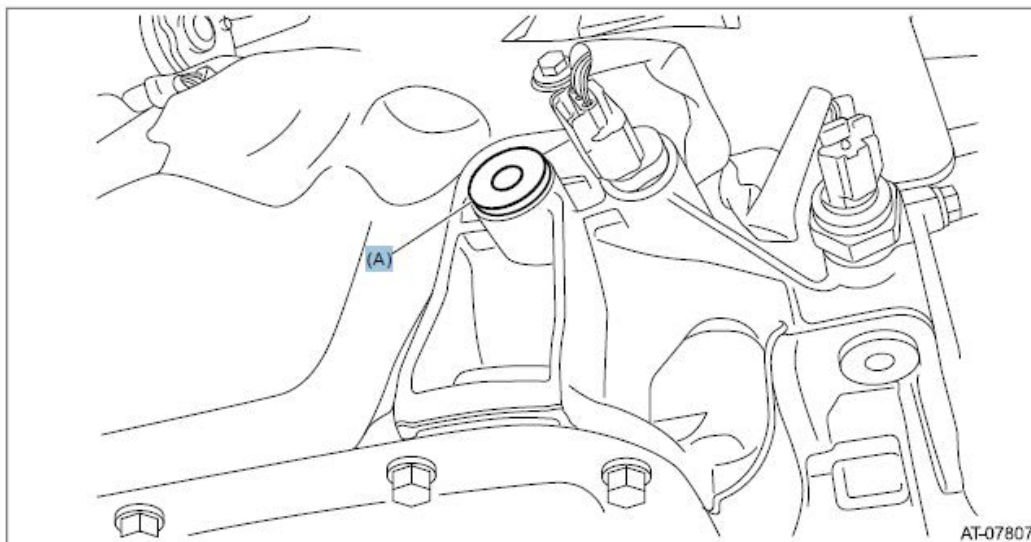
(A) Filler plug

Note: CVTFII is at the specified level when it is up to the filler plug hole lower section.

5. Remove the filler plug.

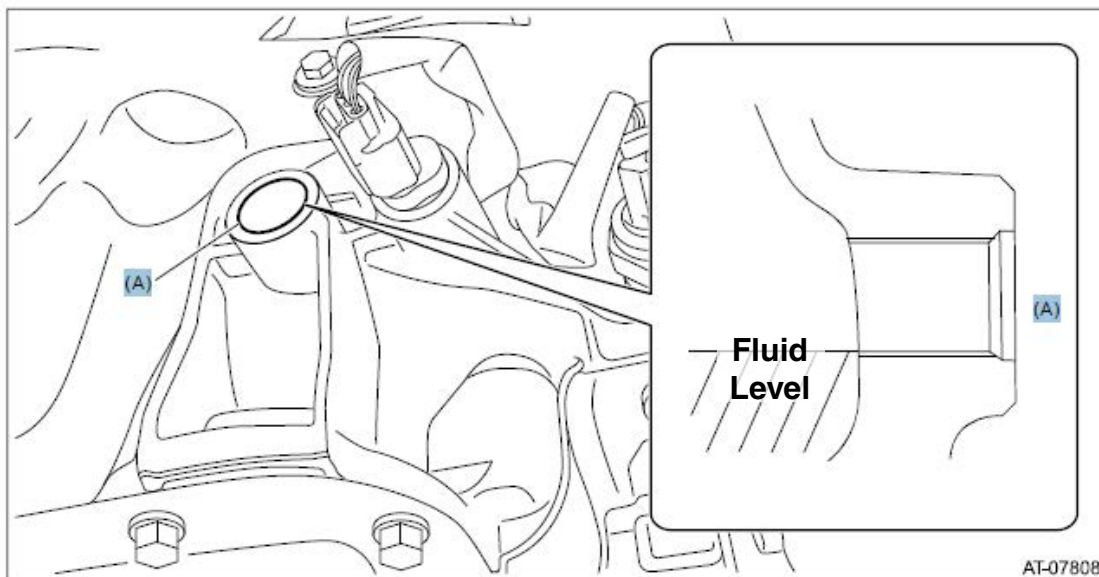
(A) Filler plug hole

Note that when CVTFII is added up to the lower section of filler plug while the transmission is in cold condition, overfilling of CVTFII occurs, causing the oil to spill out.

6. When there is no CVTFII leakage from the transmission, add the specified fluid up to the filler plug hole lower section.
A small amount of CVTFII may drain initially from the plug hole due to the presence of residual fluid in the access port. It is expected that 700 ml of fluid will need to be added to achieve correct fill in all cases. If the CVT appears to need significantly more or less than 700ml, confirm that the fluid temperature is still correct for inspection and that the engine is running.
