Abnormal ("Squeak") Noise From Rear Suspension Over Uneven Road

Service Category Suspension

Section Rear Suspension

YEAR(S)	MODEL(S)	ADDITIONAL INFORMATION
2014	Highlander, Highlander HV

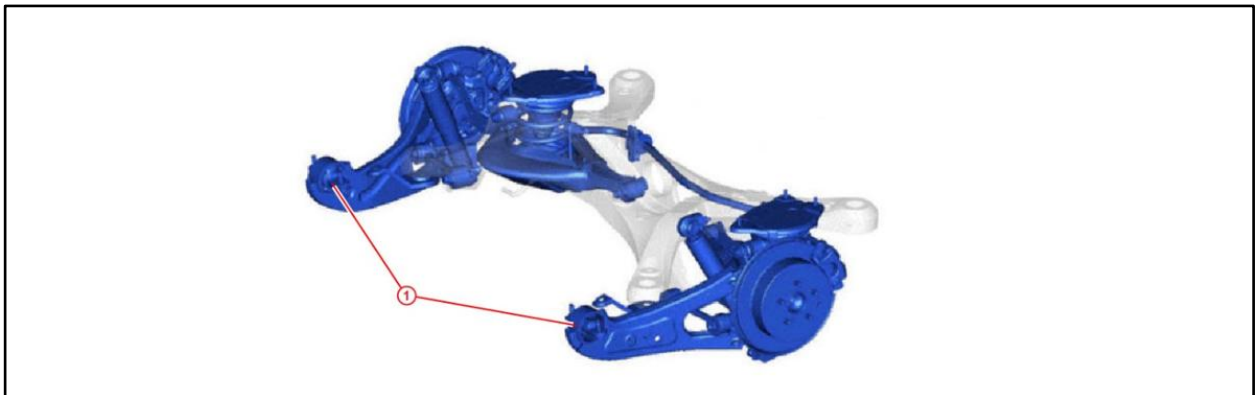
Figure 1.

Some 2014 model year Highlander and Highlander HV vehicles may exhibit an abnormal noise, like a "squeak/squawk/groan" type noise, from the rear suspension when traveling over uneven roads which may become more pronounced in colder ambient temperatures. The abnormal noise may be caused by the Rear Trailing Arm bushing. An updated Rear Trailing Arm Assembly is available. Follow the Repair Procedure in this bulletin to address this condition.

1	Rear Trailing Arm Assembly Bushing
----------	------------------------------------

- **YES** — Go to step 3.
 - **NO** — This bulletin does NOT apply. Continue diagnosis using the applicable Repair Manual.
3. Replace BOTH Rear Trailing Arm Assemblies even if only 1 side is emitting the "squeak/squawk/groan" type noise.
