MIL "ON" P023400 - Turbocharger/Supercharger "A" Overboost Condition

Service Category Engine/Hybrid System

Introduction

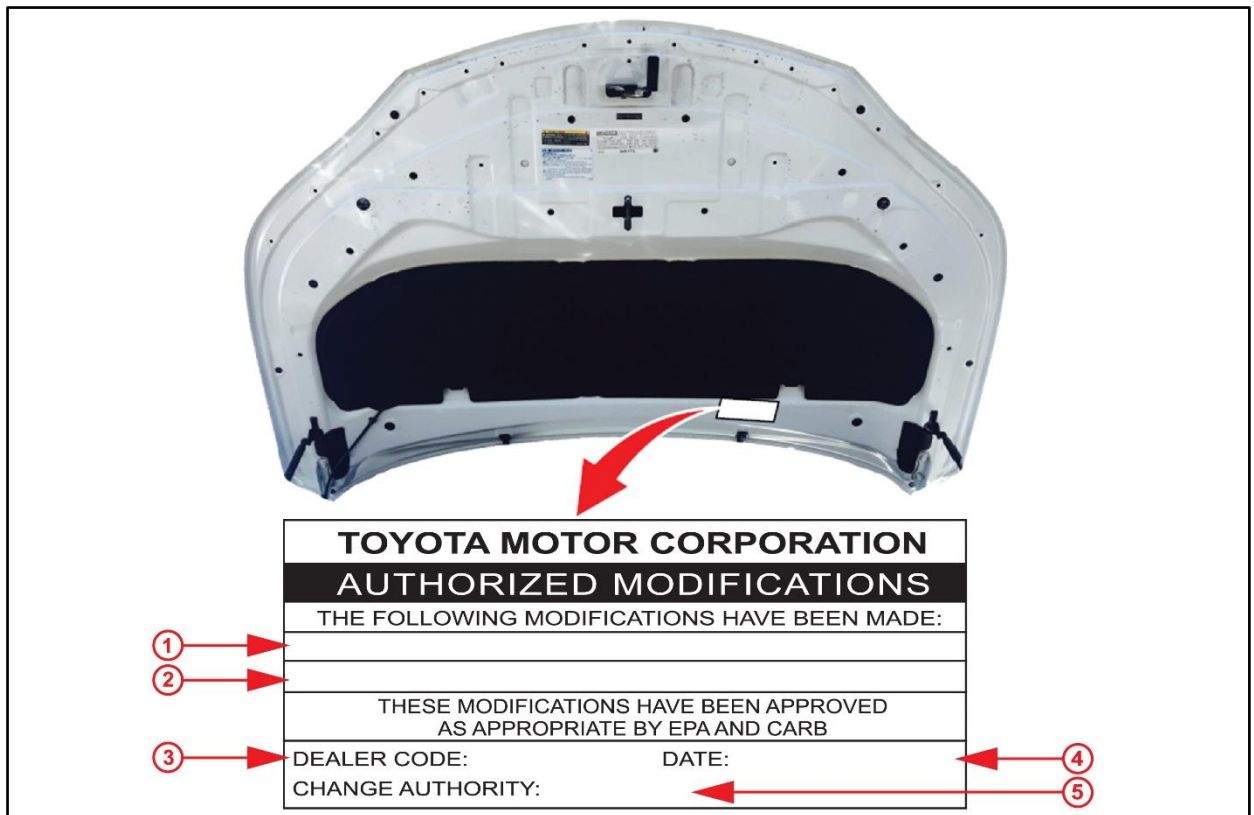
Figure 1. Location of Authorized Modifications Label on 2015 – 2016 NX 200t

1	Replacement ECM (PCM) Part Number (i.e., 89661-78053 or 89661-78063)
2	New Calibration ID (i.e., 896637805500 or 896637806500)
3	Dealer Code

4	Date Completed
5	This SB Number

4. Install the Authorized Modifications Label.
 - A. Using a permanent marker, enter the following information on the label:
 - ECM part number [*Refer to the **Parts Information** section for the **NEW PART NUMBER***]
 - Calibration ID(s) [*Refer to the **Calibration Information** section for the **NEW CALIBRATION ID***]
 - Dealer Code
 - Repair Date
 - Change Authority [**This bulletin number**]
 - B. Affix the Authorized Modifications Label to the vehicle at the location shown in Figure 1. The Authorized Modifications Label is available through the MDC, P/N 00451-00001-LBL.
5. Test drive the vehicle to confirm the DTC does NOT reset.
