Door Check Arm Noise

Service Category Vehicle Exterior

Section Door/Hatch

YEAR(S)	MODEL(S)	ADDITIONAL INFORMATION
2008 - 2016	Sequoia	
2007 - 2017	Tundra

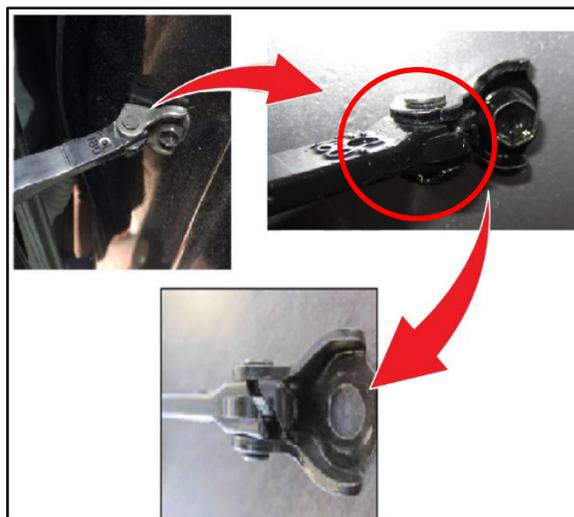
Some 2008 – 2016 Sequoia and 2007 – 2017 model year Tundra vehicles may exhibit a loud popping noise when operating the front doors. Noise is due to a fracture/crack in the plastic over mold of the door check arm by the pivot area. Follow the Repair Procedure in this bulletin to address this condition.

2. Visually inspect for fracture/cracking or ANY damage on the plastic resin of the check arm by the pivot area as shown in Figure 1.

Is there ANY fracture/cracking on the plastic over mold of the check arm?

- **YES** — Check arm MUST be replaced.
- **NO** — Continue to Step 3.

4. Replace the Check Arm Assembly with the NEW part.

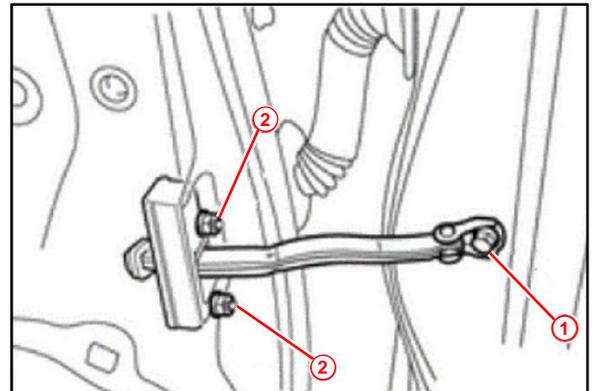
Figure 2.

3. Confirm the torque value of the 3 check arm mounting fasteners:

Bolt (1):

Torque: 29 N*m (296 kgf*cm, 21 ft*lbf)

Nuts (2):

Torque: 8.5 N*m (87 kgf*cm, 75 in*lbf)

1	Bolt
2	Nut (2)
