TECHNICAL INSTRUCTIONS

SPECIAL SERVICE CAMPAIGN G0Z

POWERTRAIN ECU SOFTWARE UPDATE

CERTAIN 2017 MODEL YEAR SIENNA

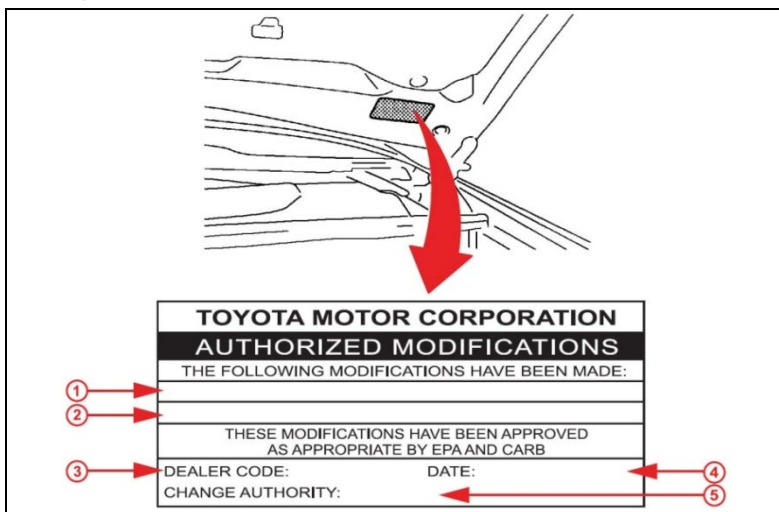
1	Powertrain ECM P/N
2	New Calibration ID
3	Dealer Code
4	Date Completed
5	Campaign Code (G0Z)

- Fill out the label.
- Affix the label to the under-side of the hood.
