TB-18-20-02**MODEL:** Karma Revero**DATE:** March 2018**TITLE:** Sensor Harness Routing Inspection**First Release****PRIORITY:** On Complaint**APPLICABILITY:** MY17 and MY18 Revero**MARKET REGION:** North America**PURPOSE:** Inspect the oxygen sensor harness routing

TB-18-20-02

TITLE: Sensor Harness Routing Inspection

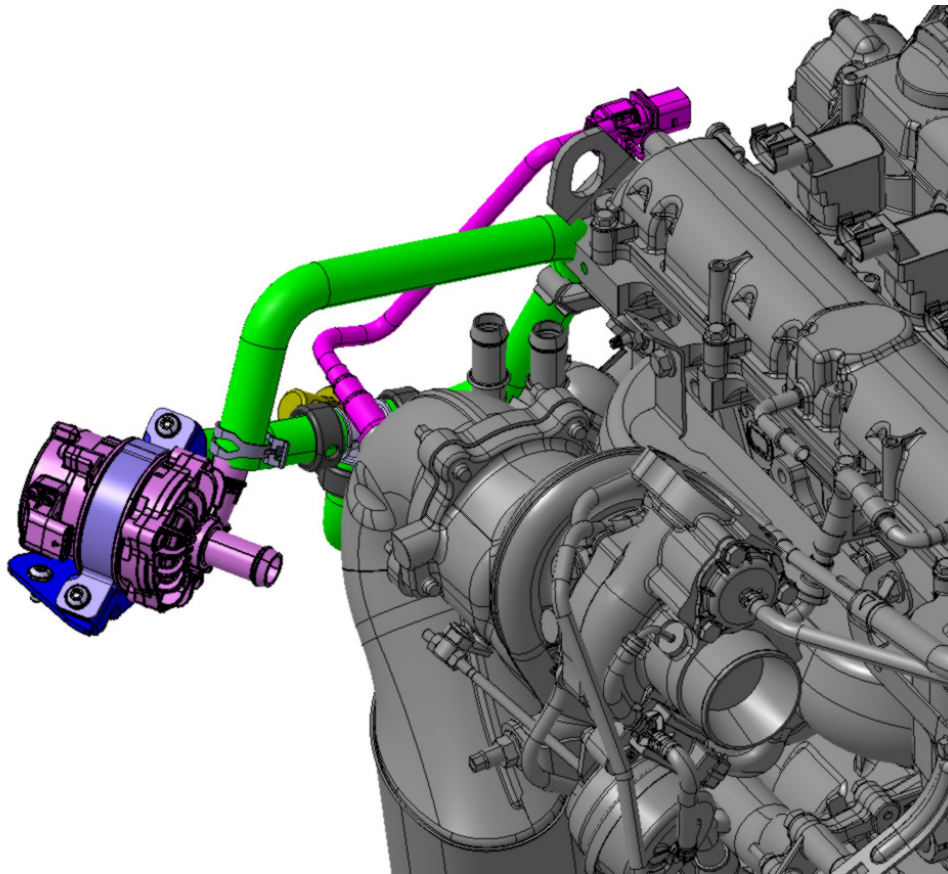
Some vehicles may be found with the oxygen sensor wiring improperly routed possibly causing a kink in the low temperature front pump to inverter-generator hose assembly. This can be remedied by disconnecting the oxygen sensor harness from the secure engine location and rerouting as described in this bulletin.

O2 sensor harness (purple) should be routed inside loop of (green) hose (P/N C13111811002).

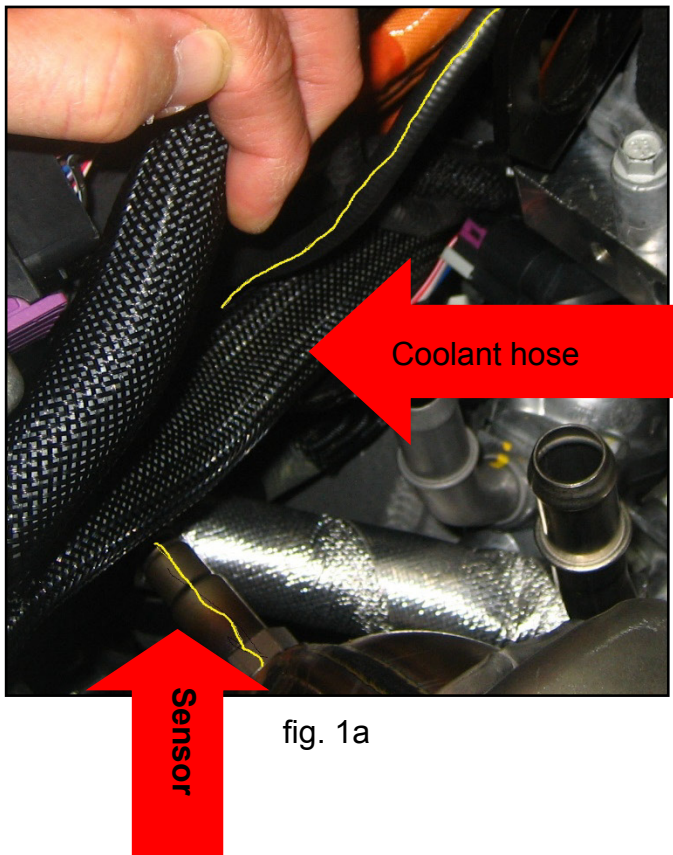
The O2 sensor wire should be under the hose as shown (fig. 1a) and pass under the coolant hose and route behind and up to the connector.

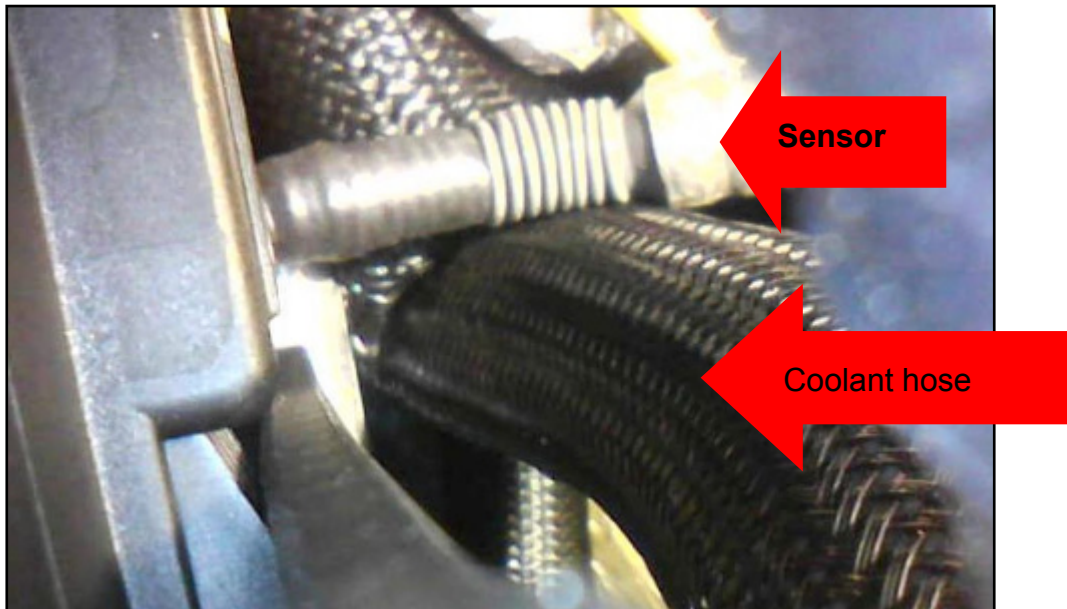
fig. 2a

Incorrect routing would be readily visible. Detail view in the vehicle this is seen in (fig. 2a).

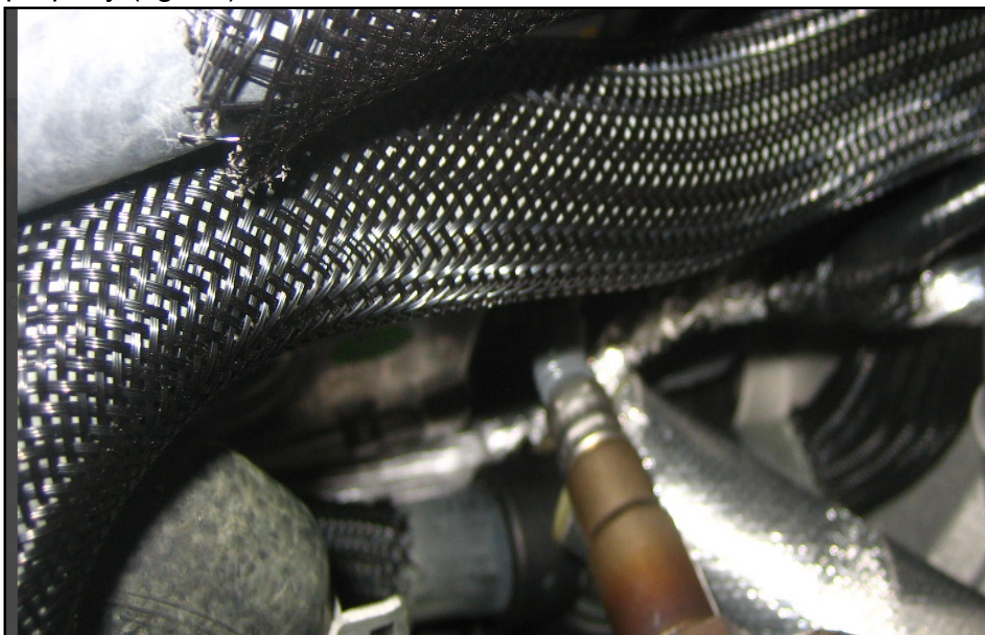
fig. 2b

Shown routed properly (fig. 2b).
