TECHNICAL INSTRUCTIONS

SSC G0G

CERTAIN 2015-2016 MY SIENNA

OXYGEN SENSOR REPLACEMENT

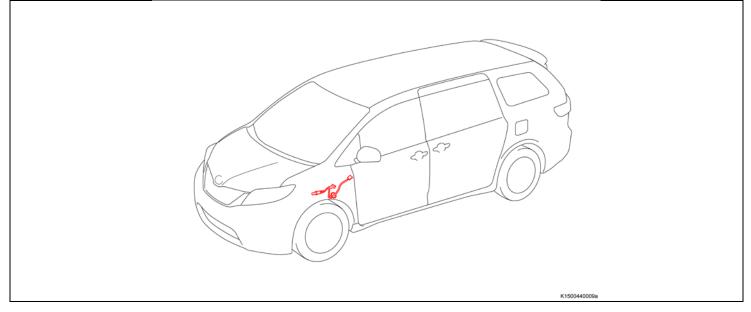
The subject vehicles are equipped with an Oxygen Sensor which could experience wire degradation inside the Oxygen Sensor wiring harness caused by vehicle vibration during normal operation. If this occurs, the vehicle will illuminate the check engine light.
